**Simulations**  
**Photos**  
**All Graphics (no plans)**

Site: Street view north side of house: 6713 E Granada Rd. 85257

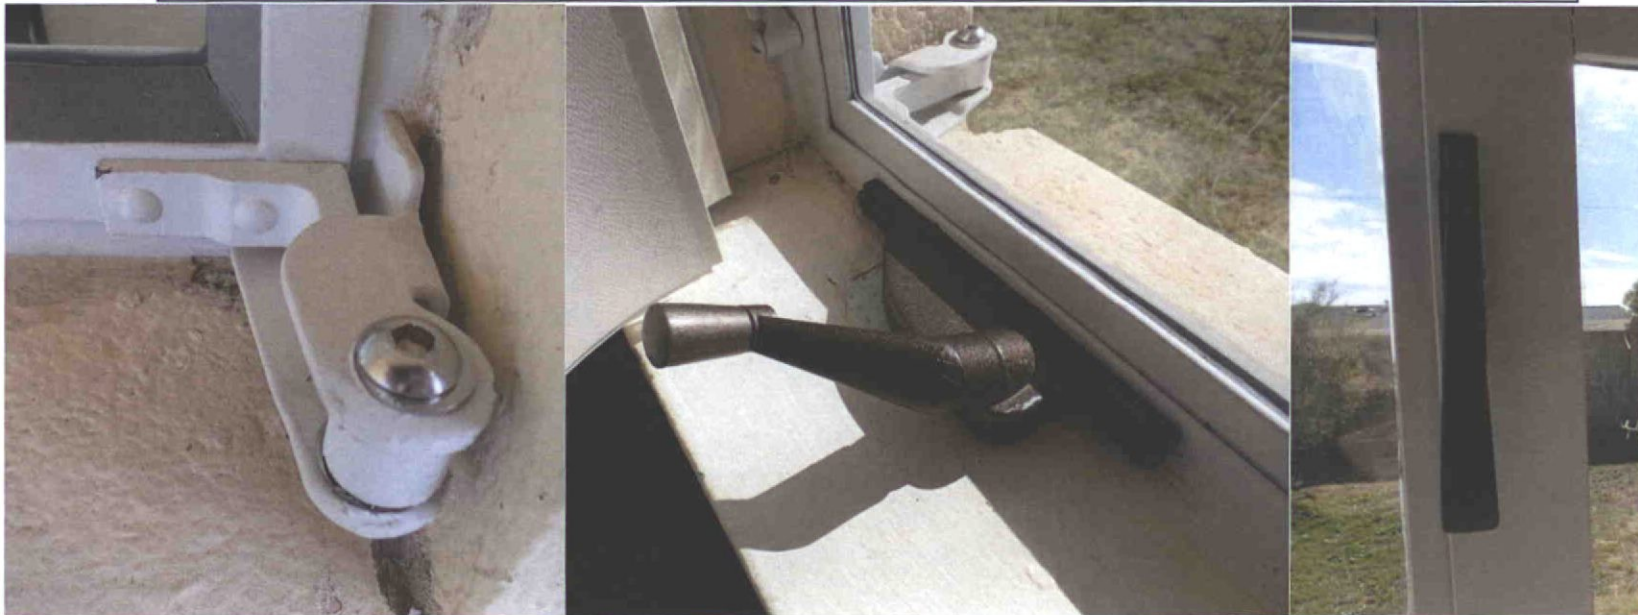
Left: window hinge hardware. Center: window operator crank. Right: window lock handle.

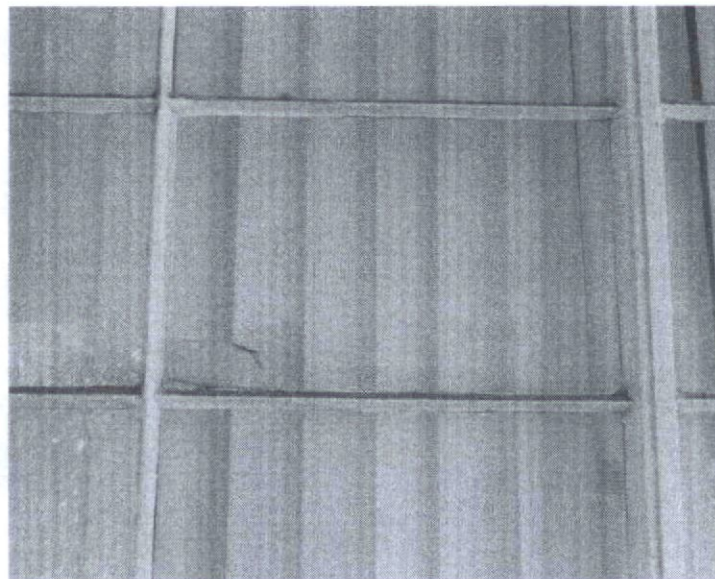
Window 7 cracks in panes facing South

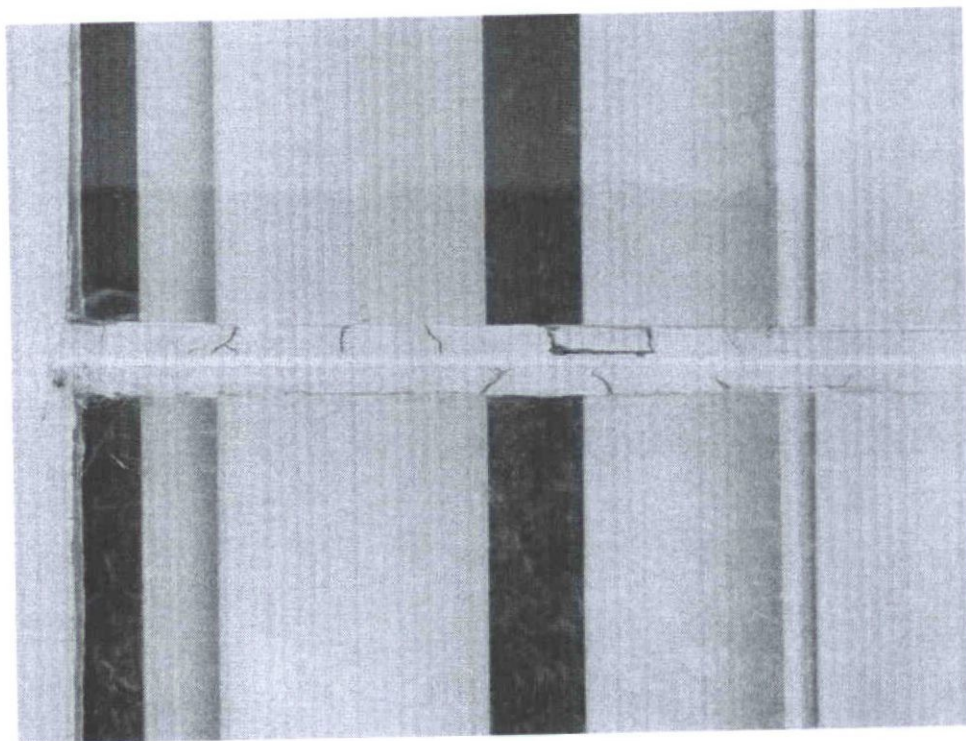
Window 10 cracked caulking facing South
