**Simulations**  
**Photos**  
**All Graphics (no plans)**

11-HP-2016  
6/28/2016

7615 E. Meadowbrook Ave  
 Scottsdale, AZ. 85251  
 Villa Monterey

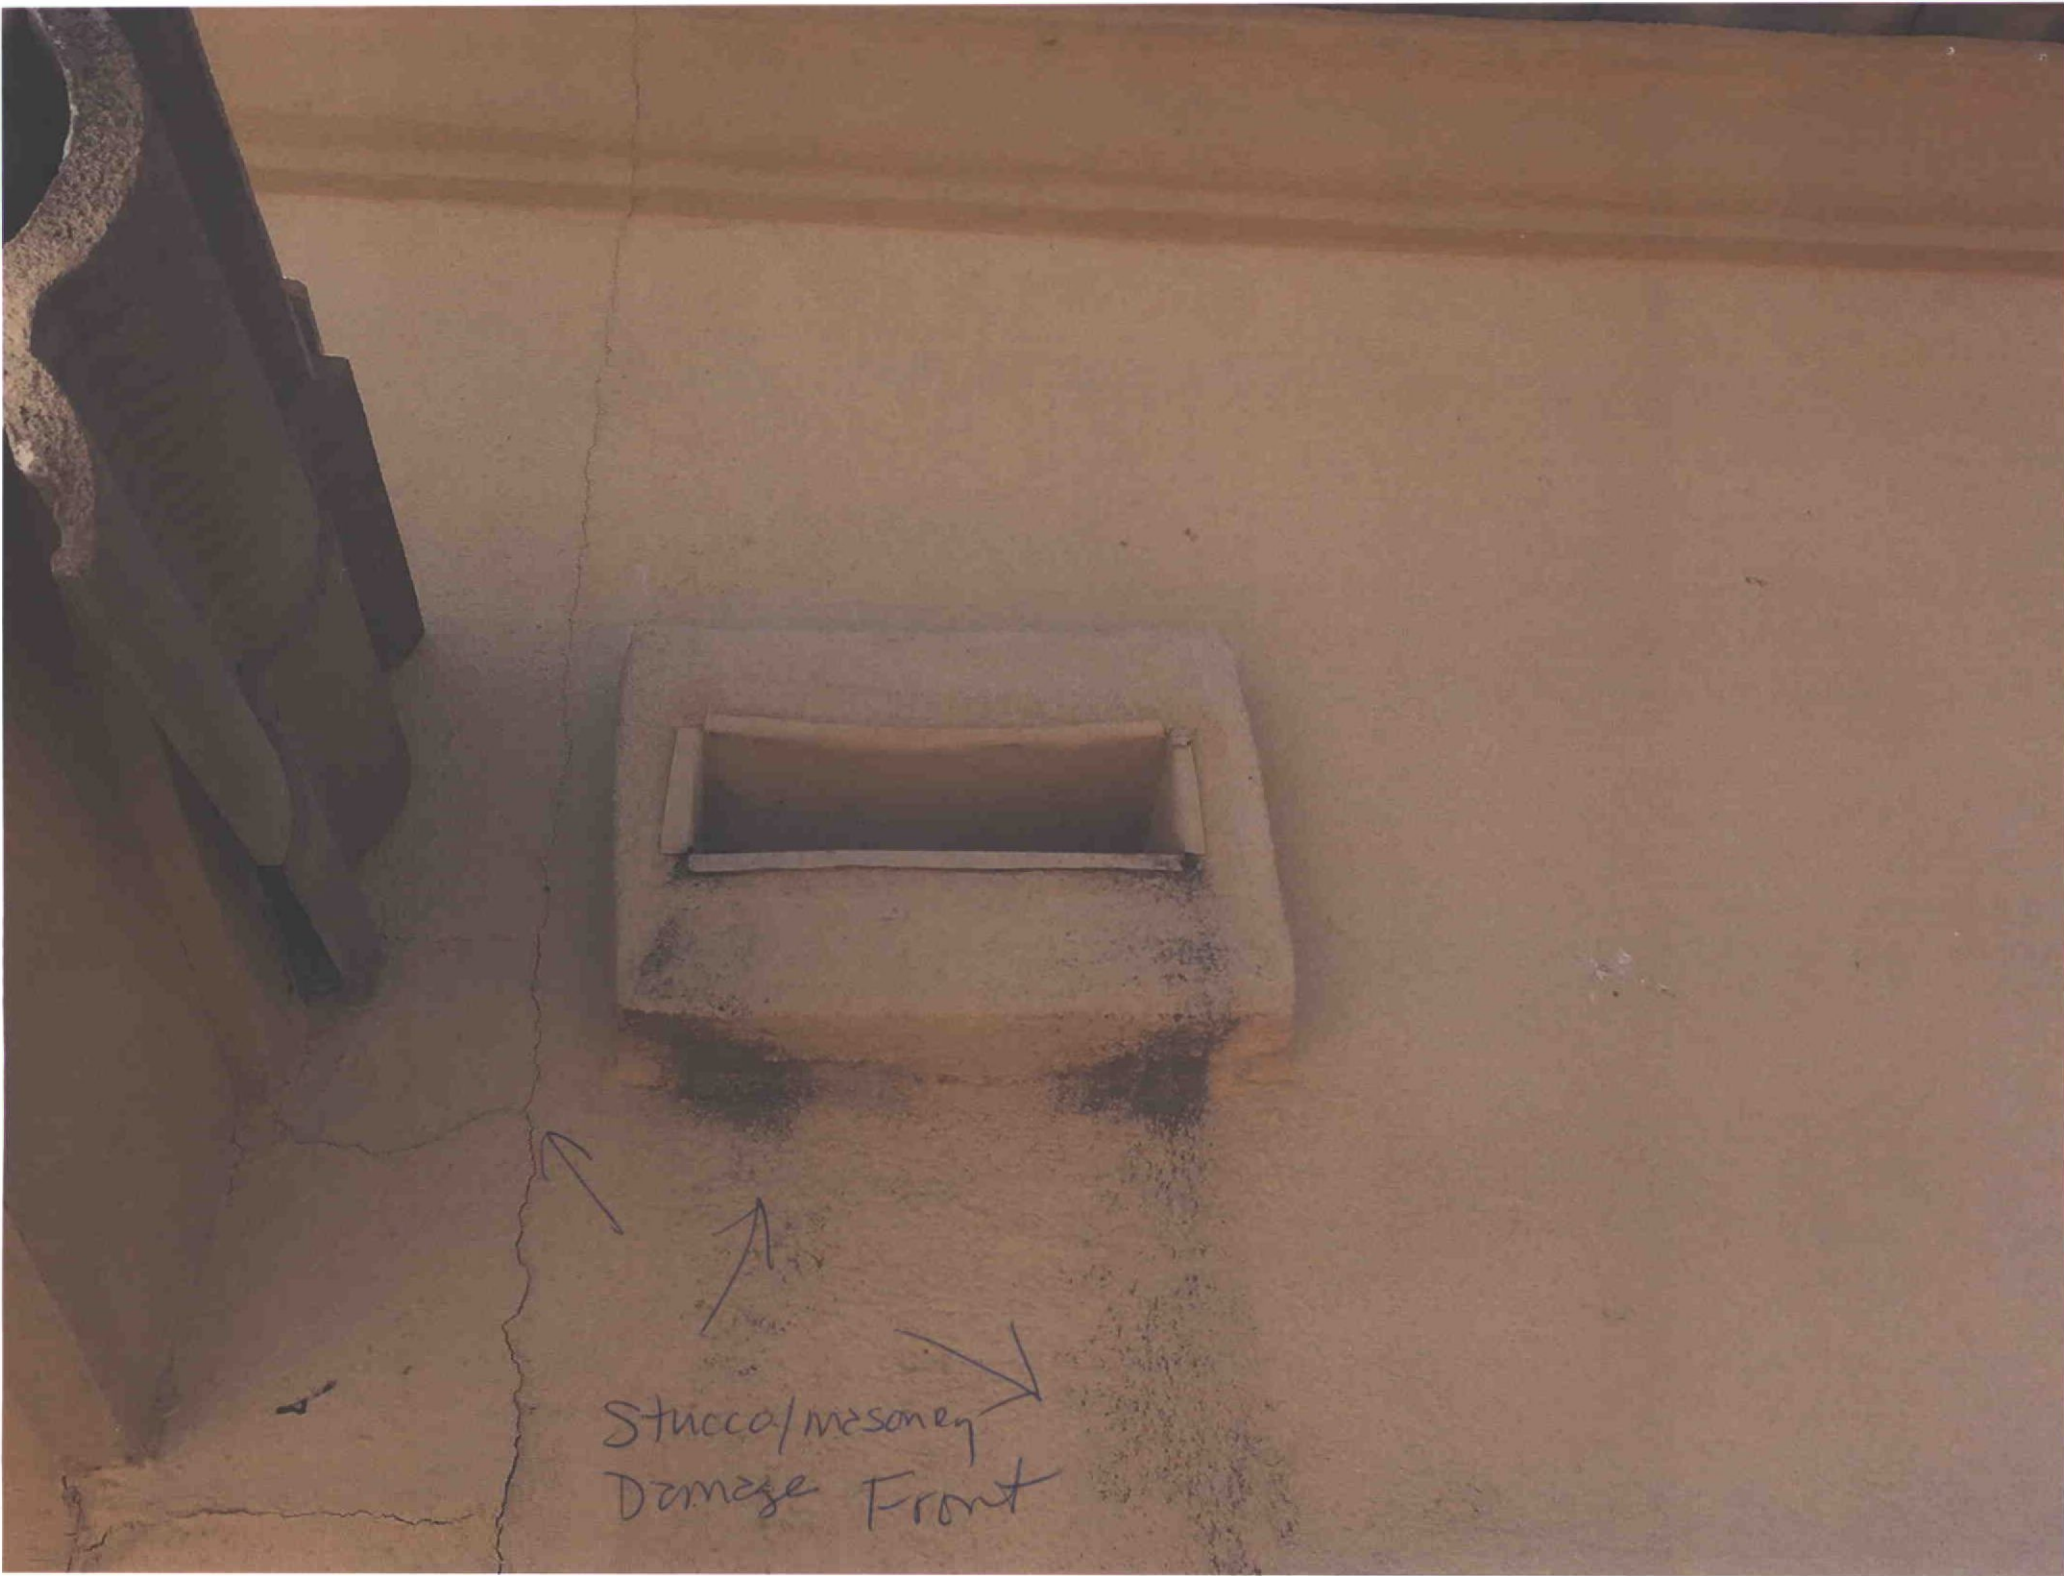
Stucco/masonry  
Damage  
Water intrusion  
FRONT

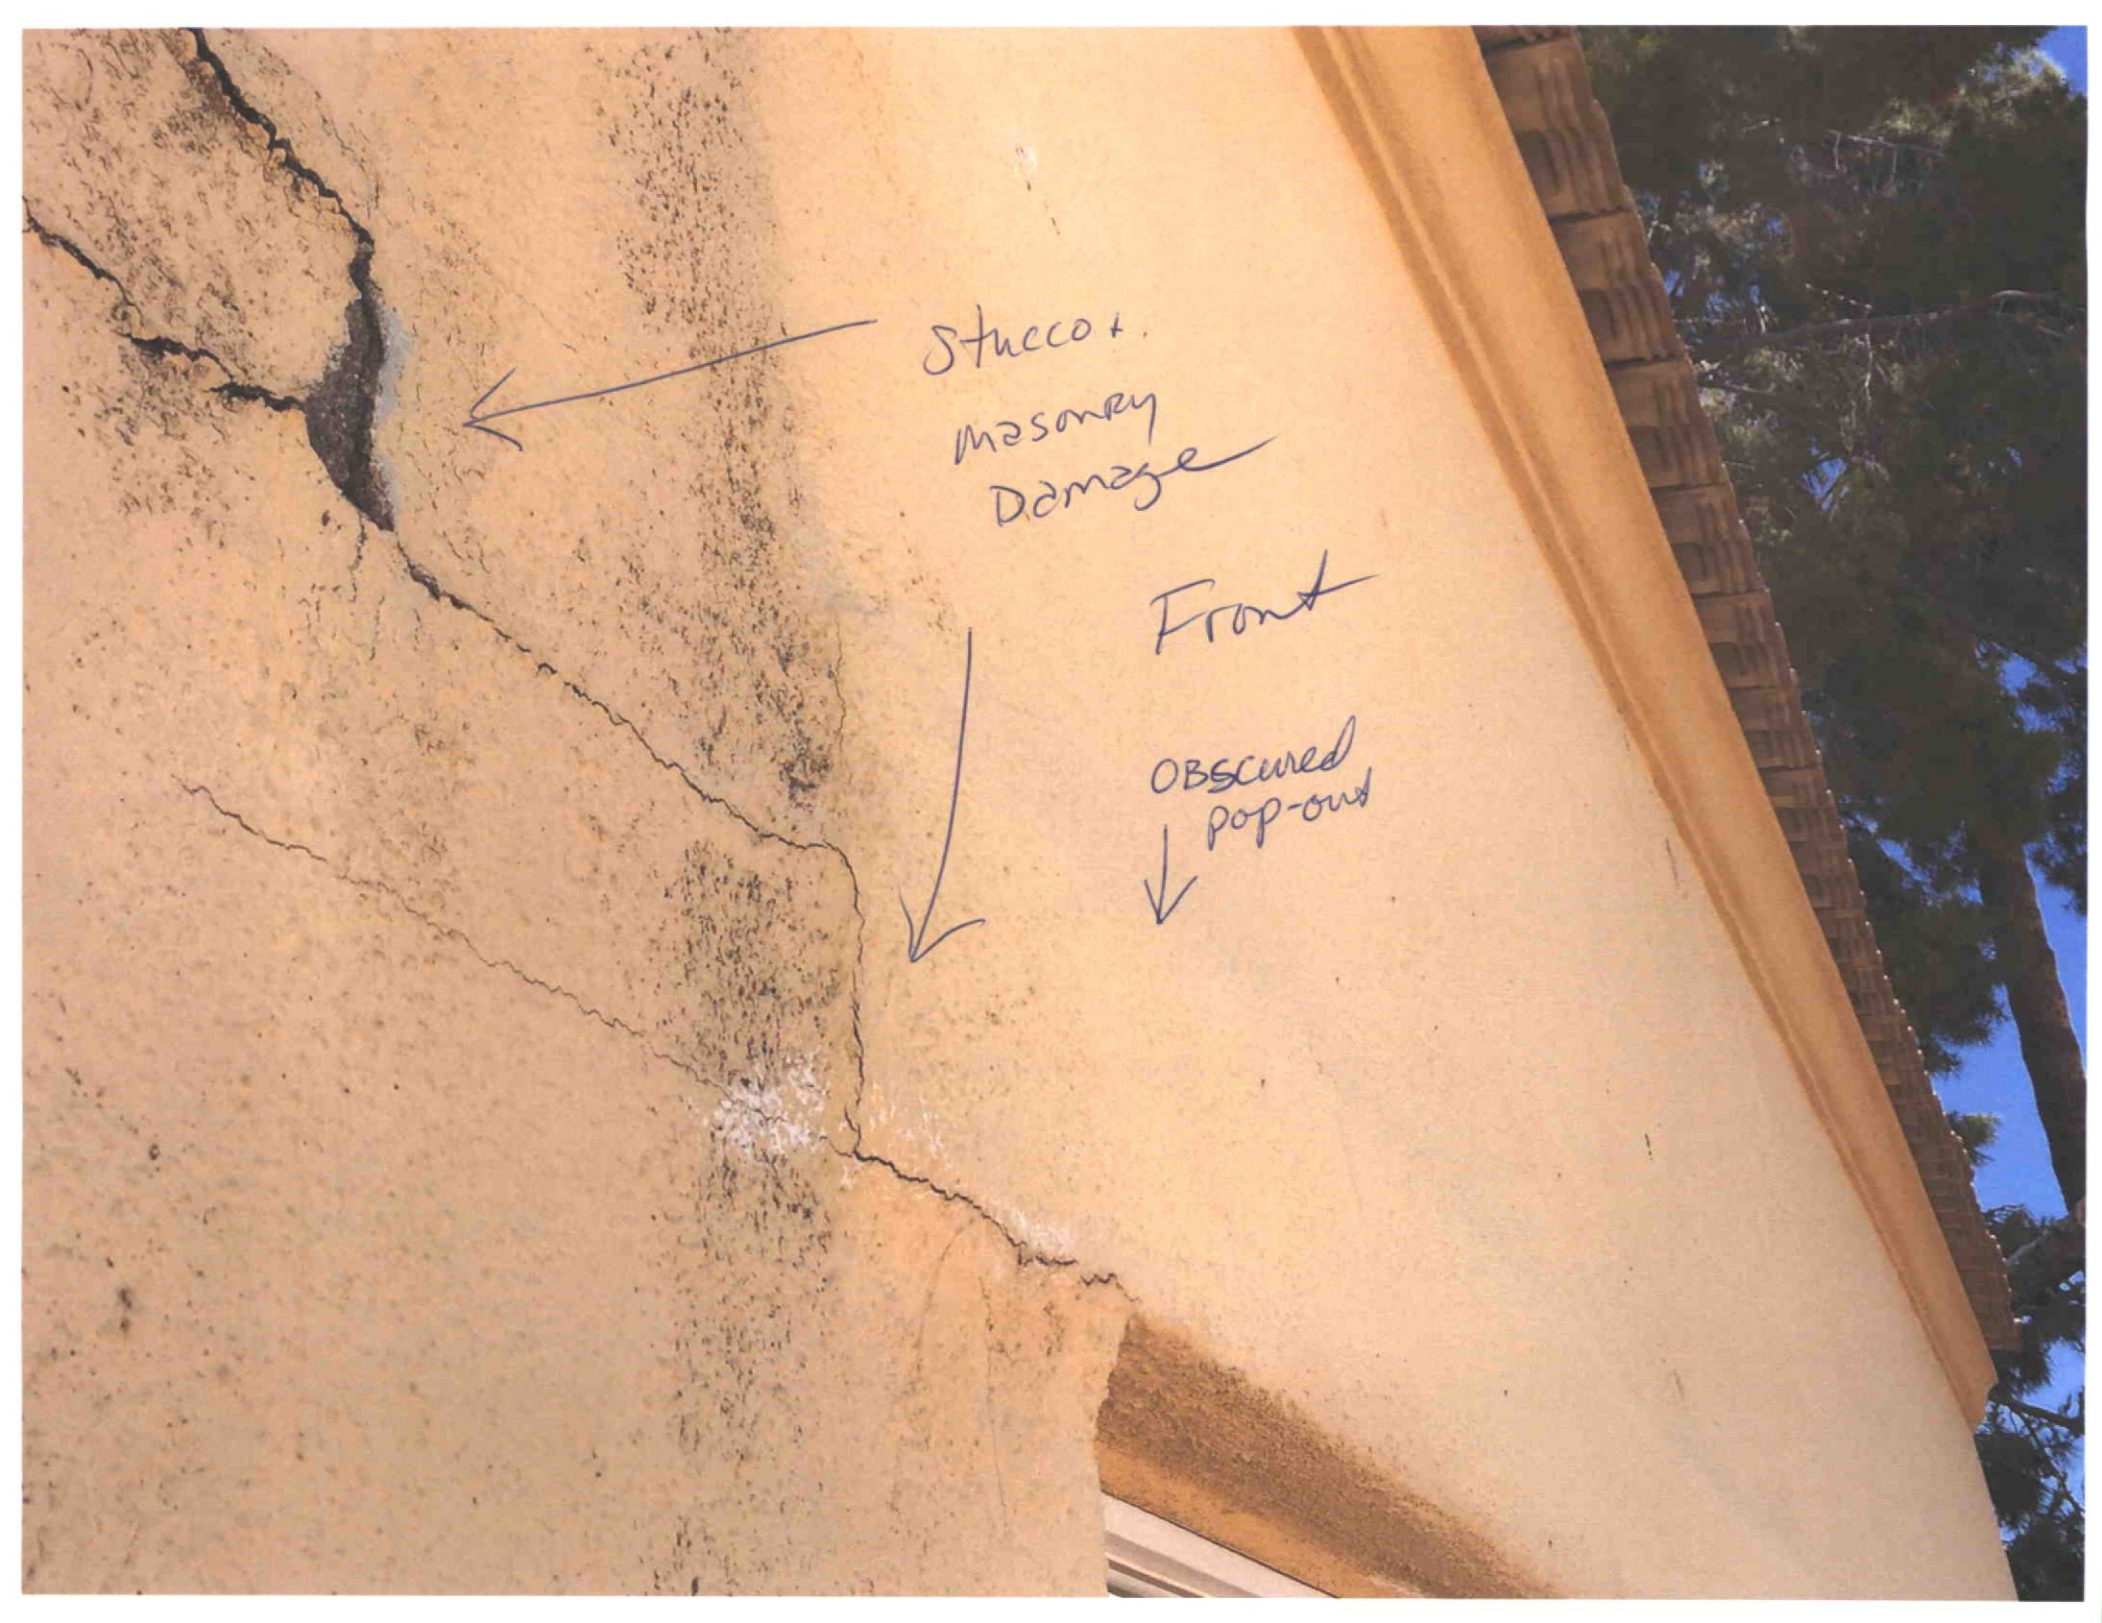
Stucco/masonry  
Damage Front

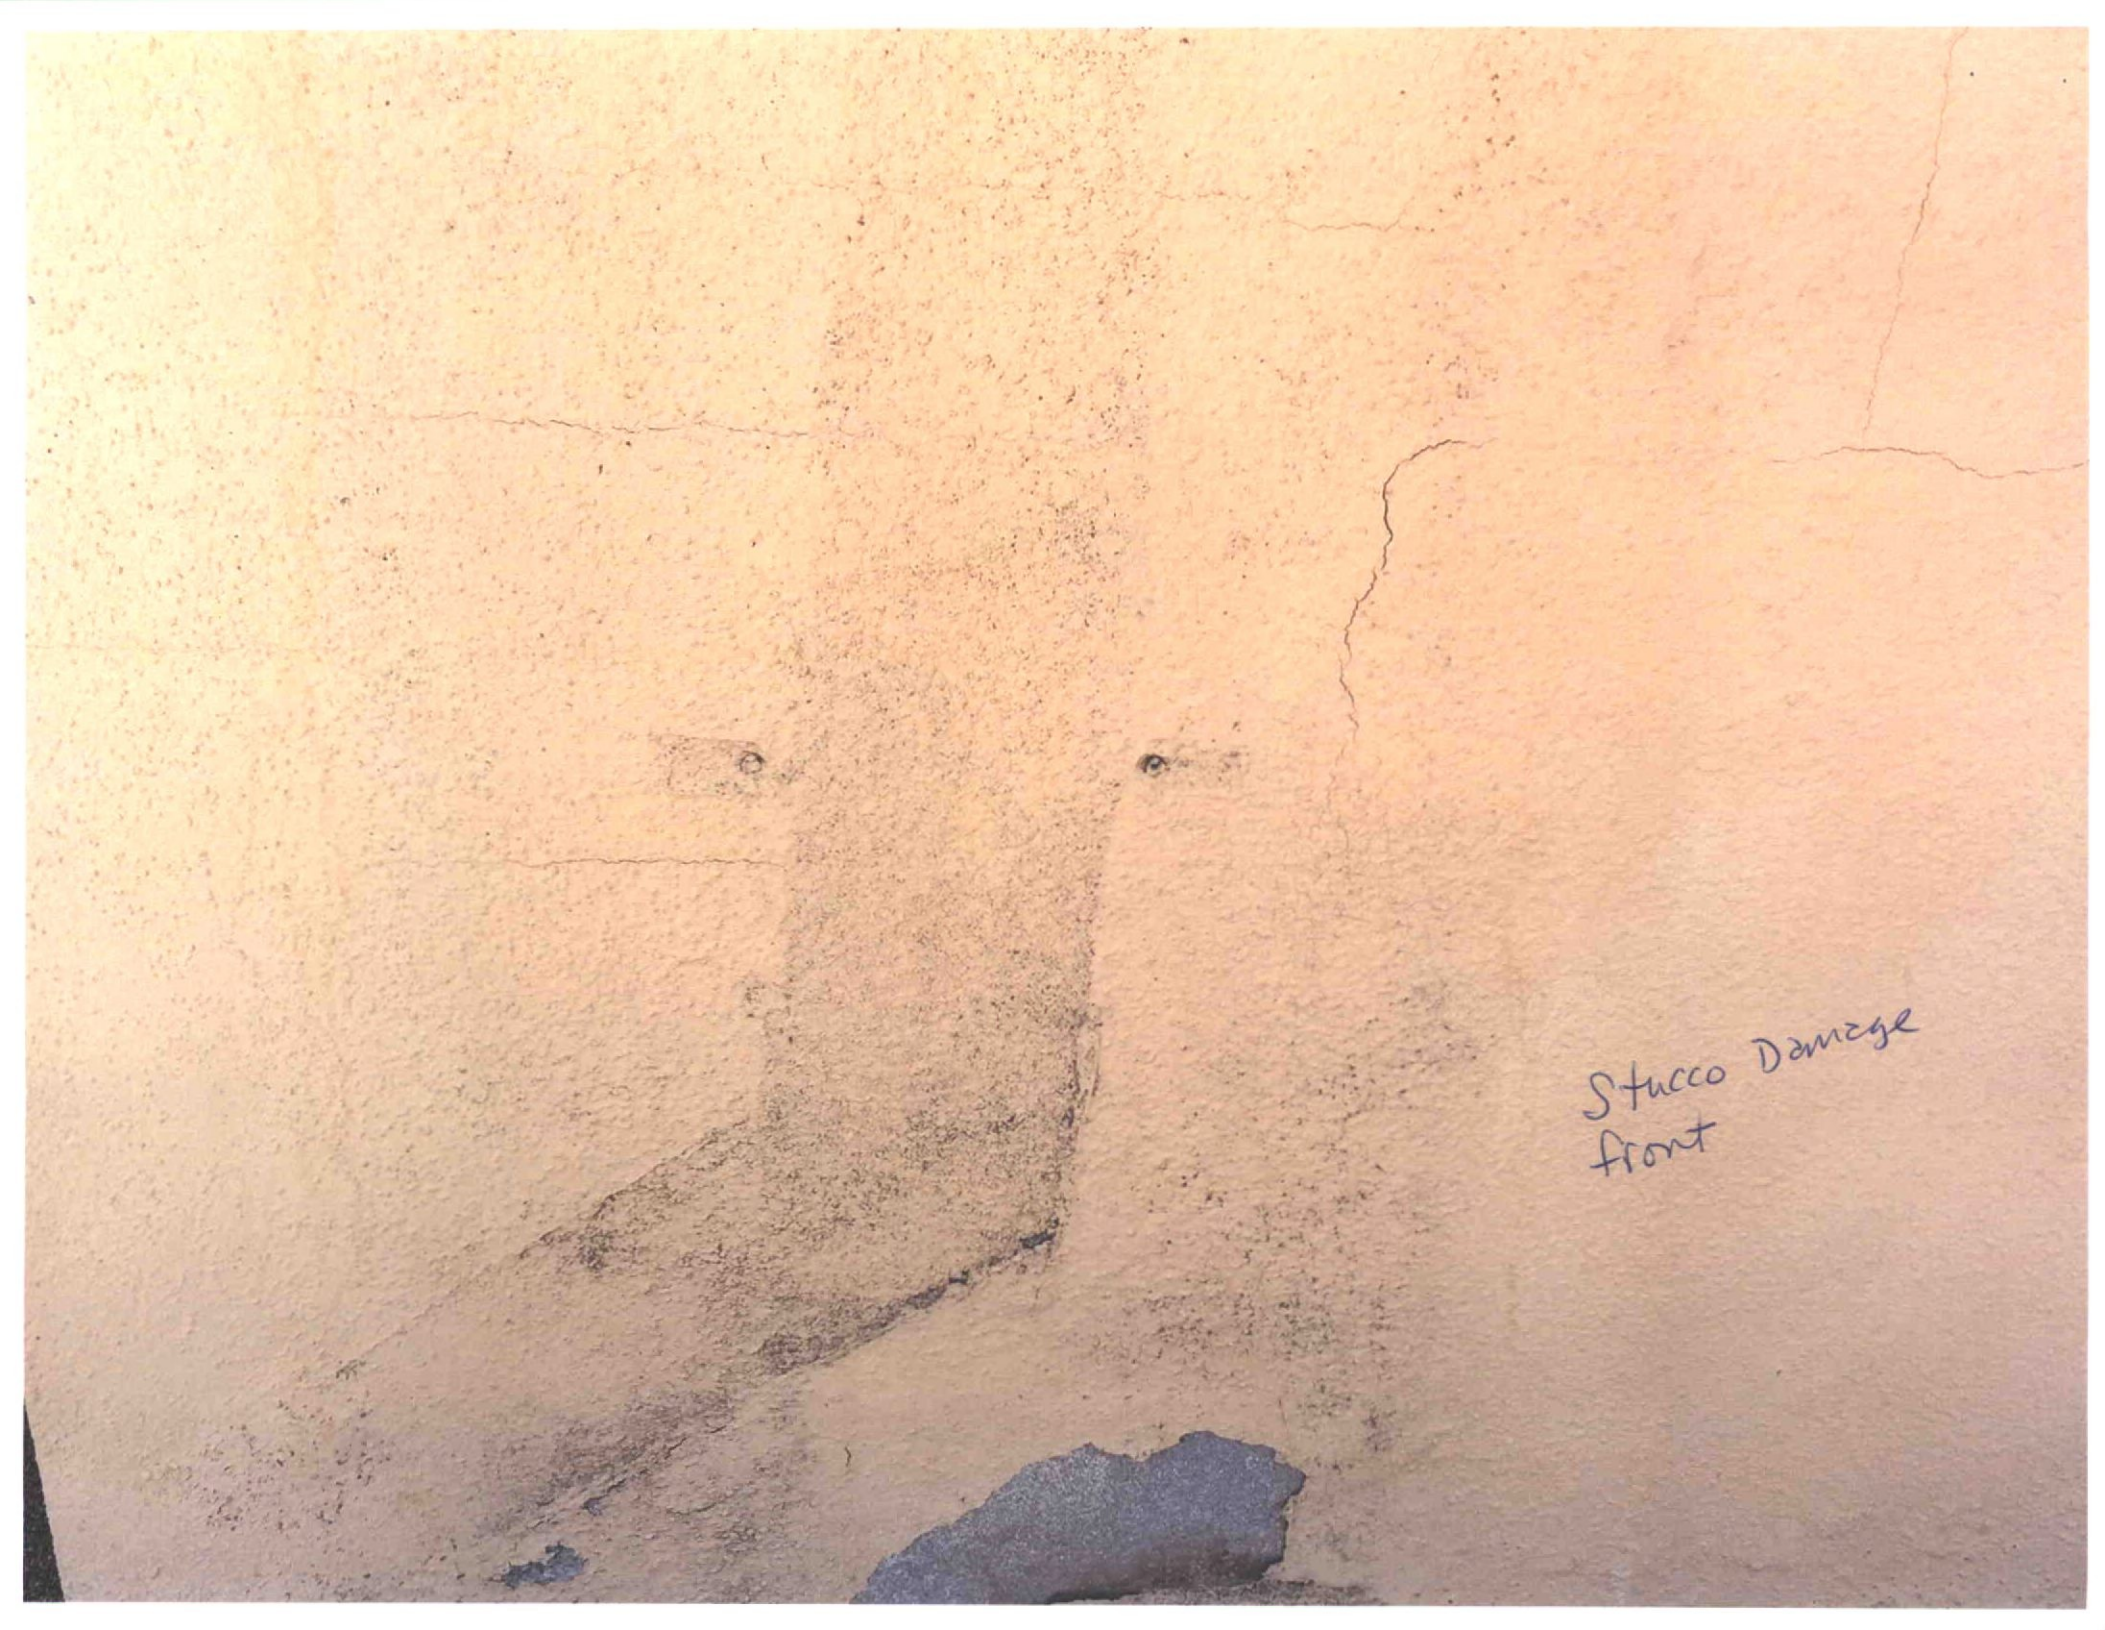
Stucco  
Damage  
(H<sub>2</sub>O intrusion)

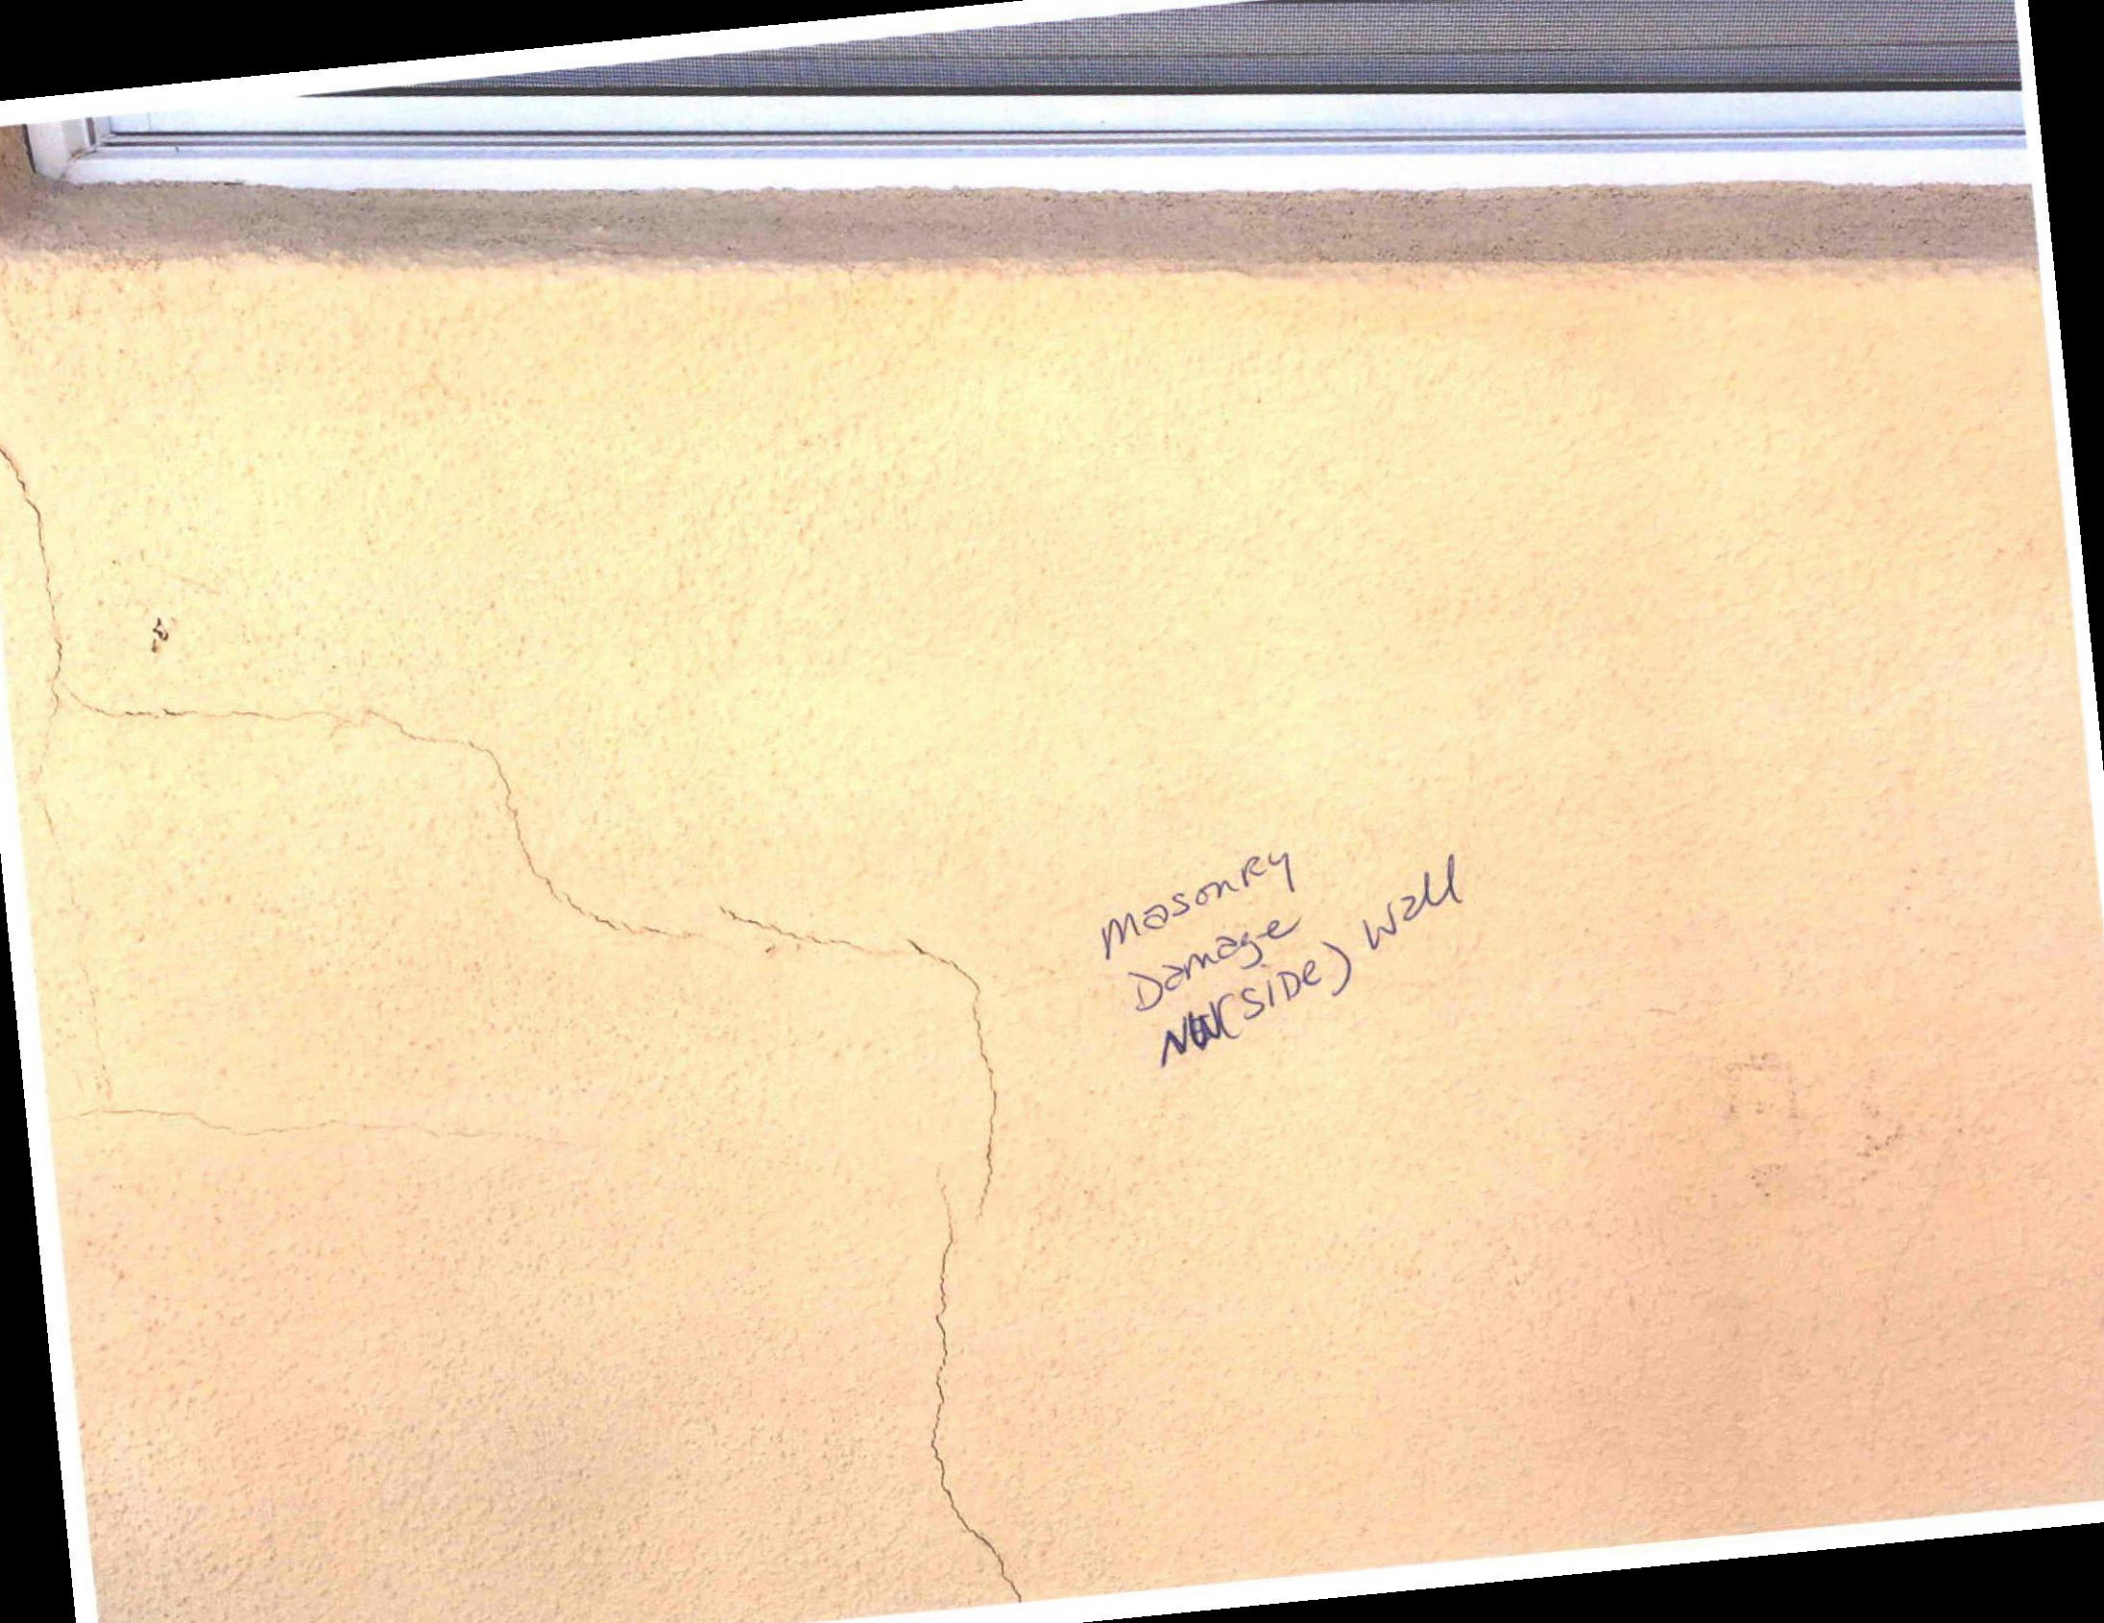
masonry  
Damage  
NW (side) wall

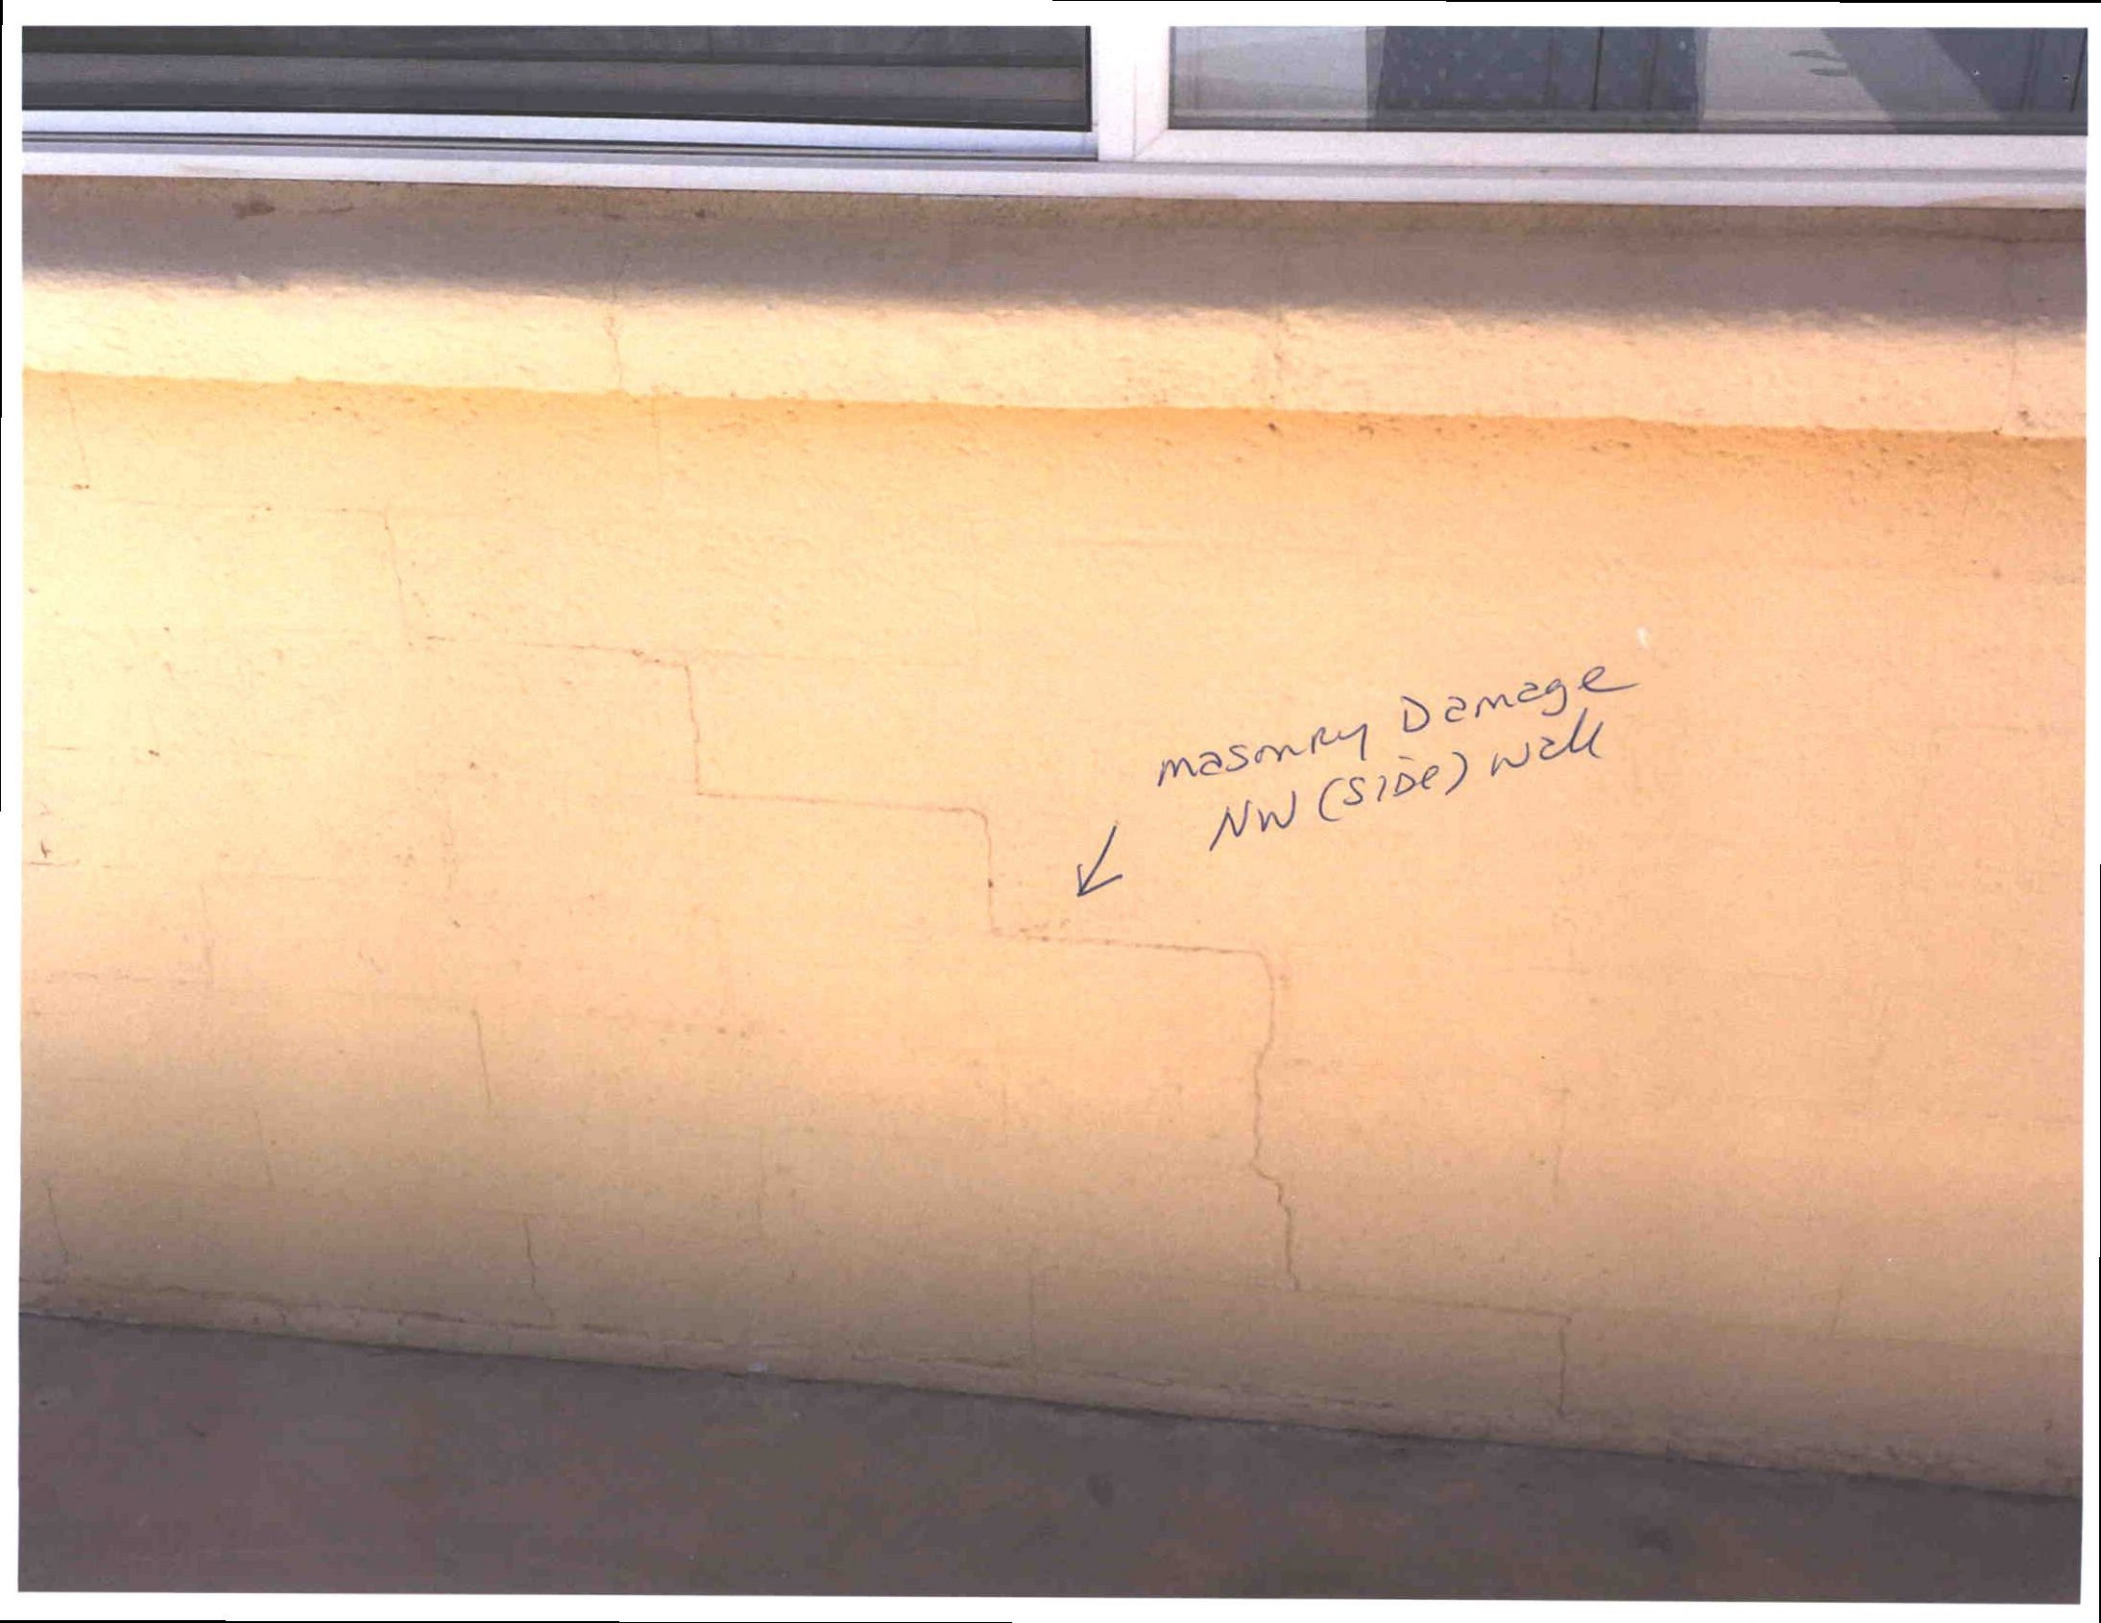
Masonry  
Damage  
floor wall

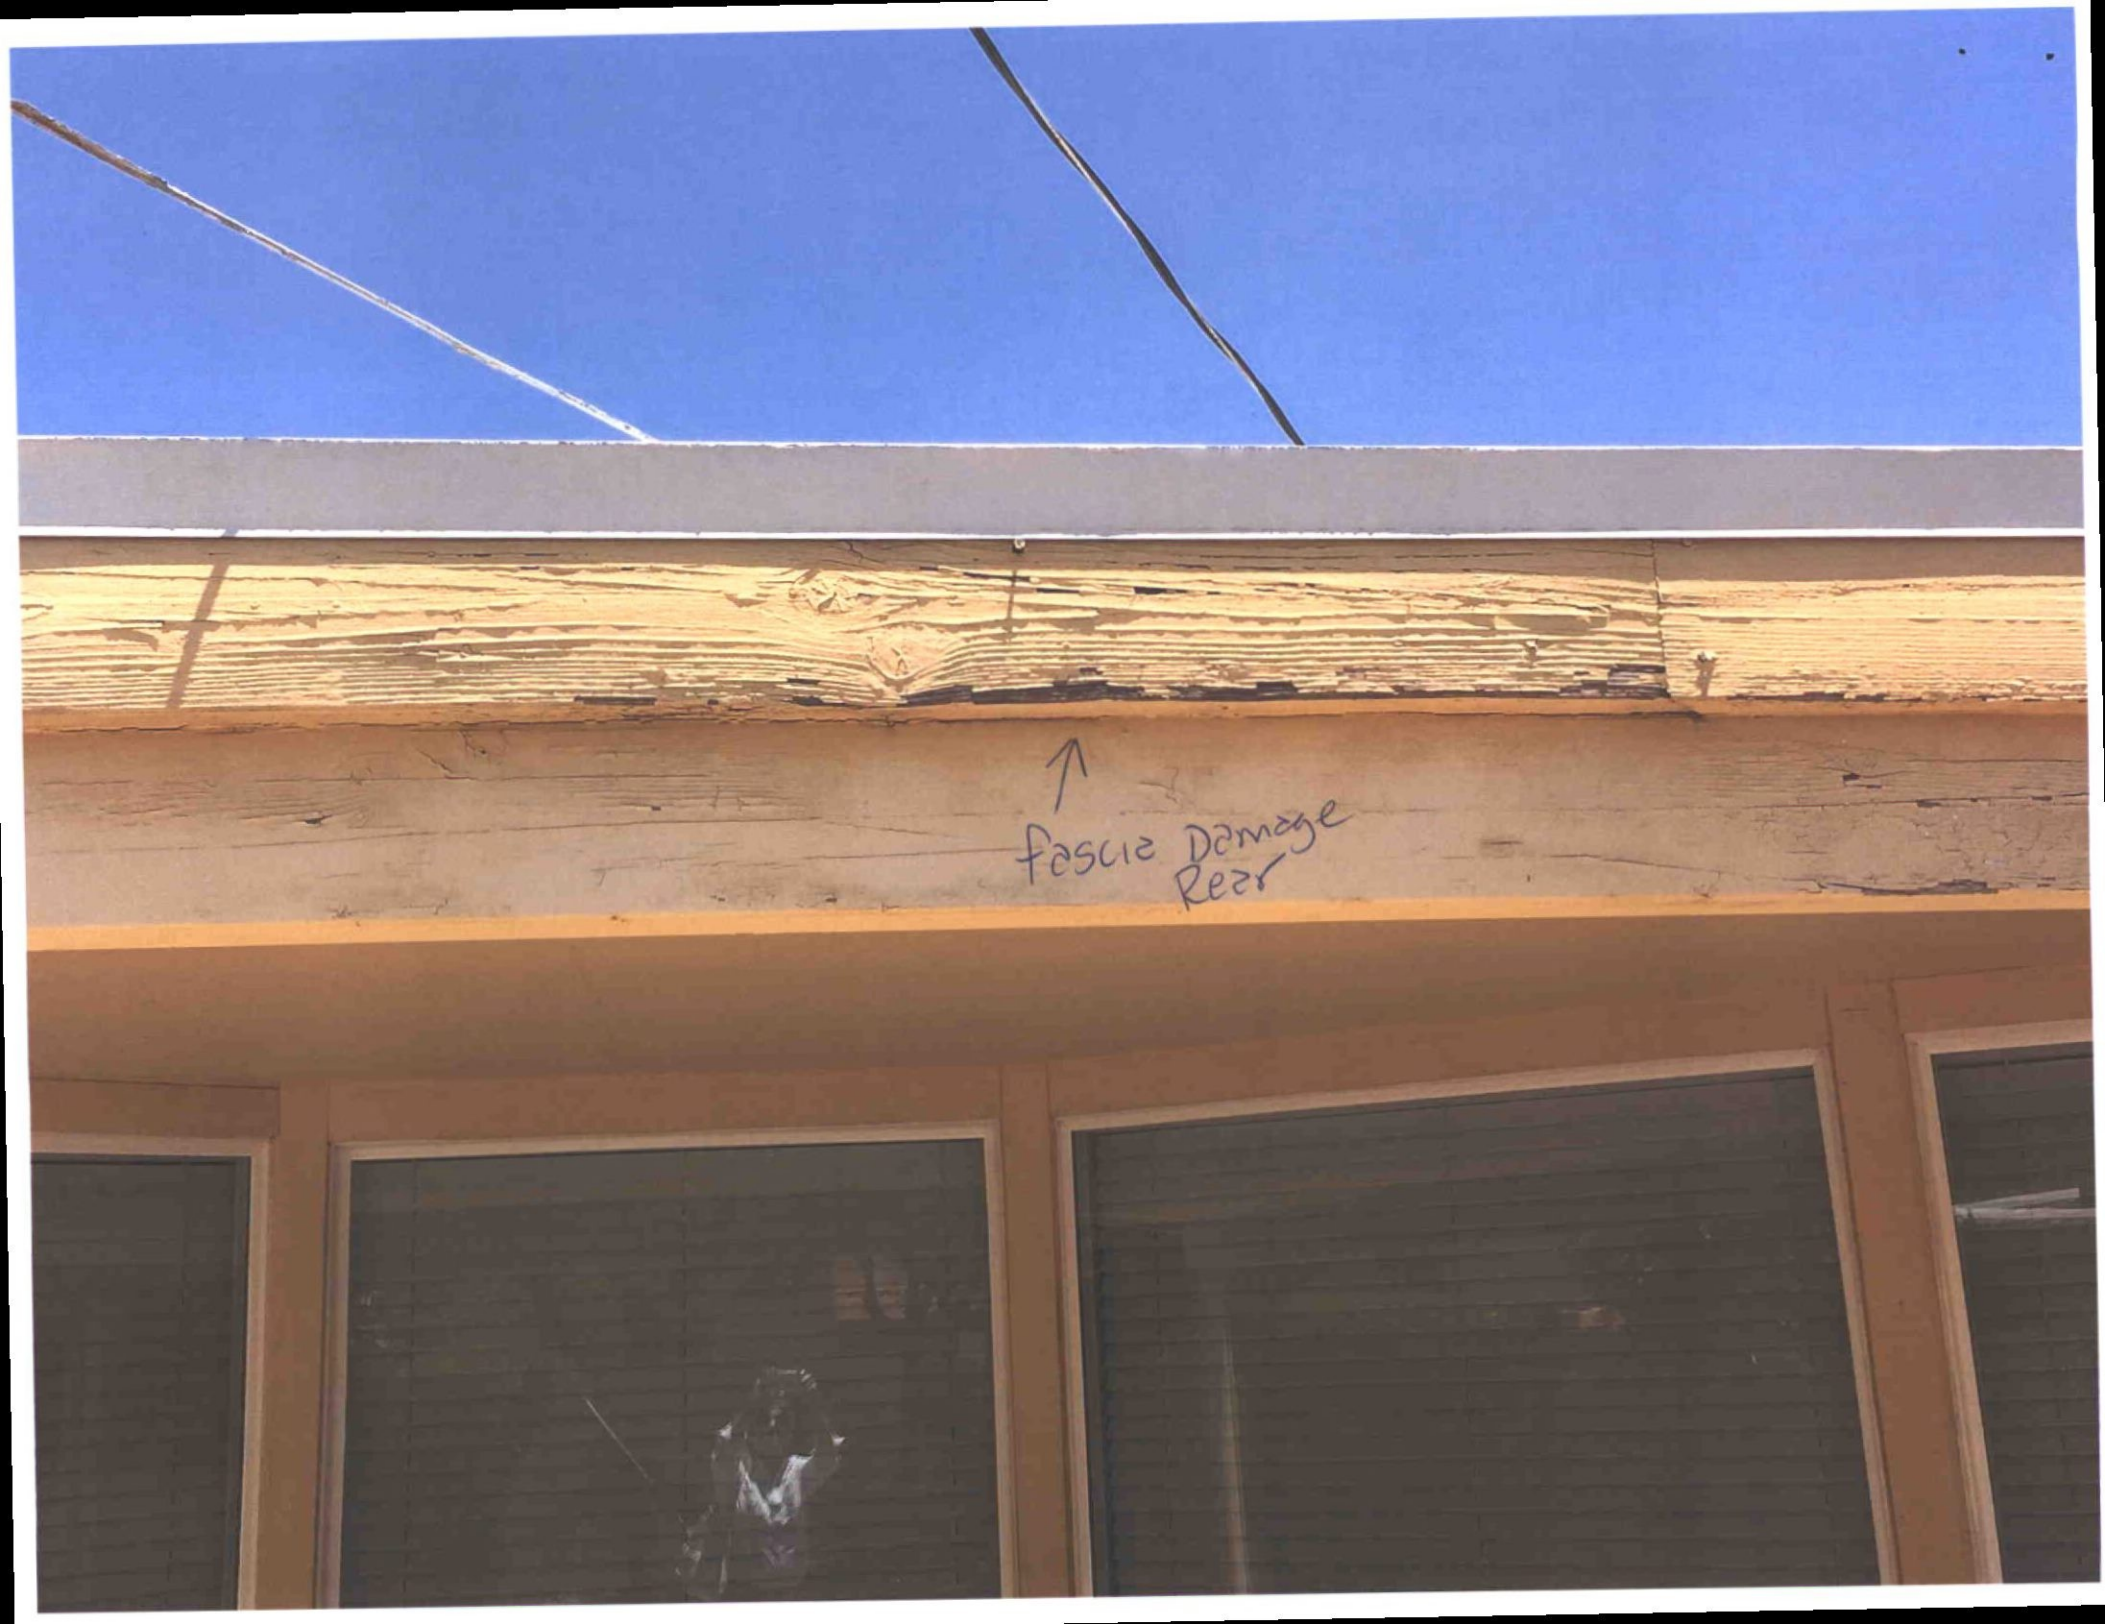
↑  
fascia Damage  
Rear
