**Simulations**  
**Photos**  
**All Graphics (no plans)**

11-HP-2016  
6/28/2016

7615 E. Meadowbrook Ave  
 Scottsdale, AZ. 85251  
 Villa Monterey

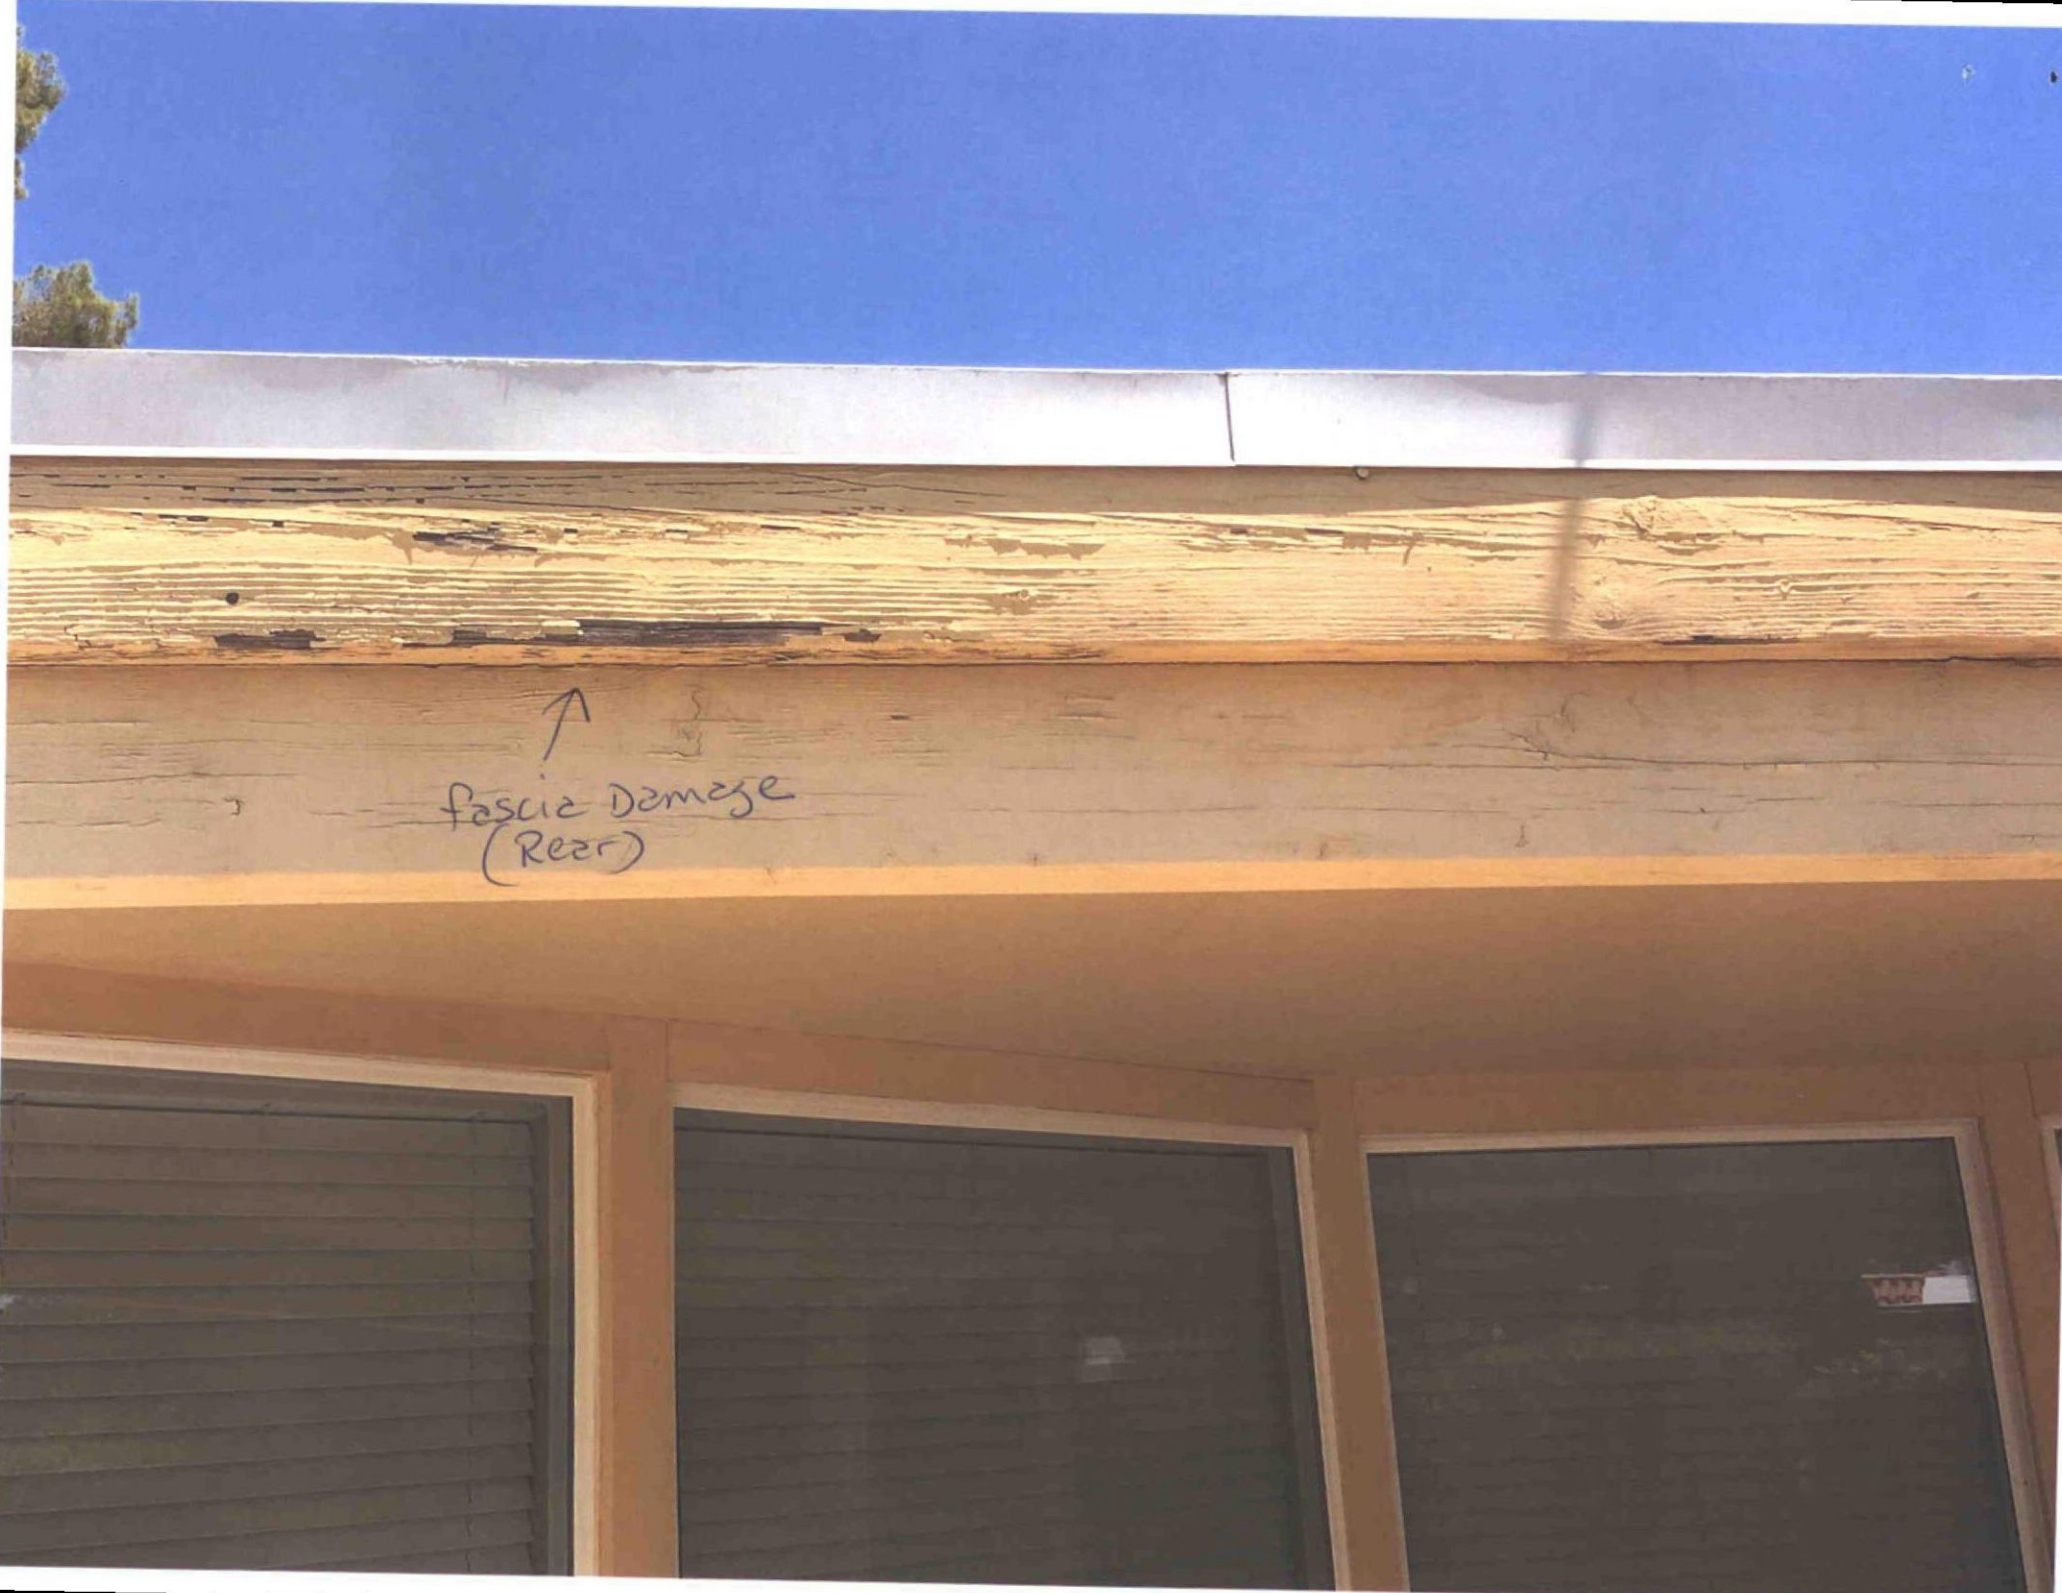
↑  
Fascia Damage  
Rear
