ACCESSIBILITY COMPLIANCE CONSULTATION

ADA "Design and Construction" Accessibility Compliance at Parking Lot

Troon Country Club
25000 North Windy Walk Drive
Scottsdale, AZ

Survey Date: *September 25, 2015*

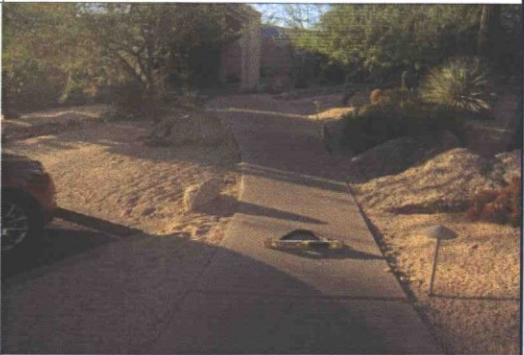
<u>Technical Note:</u> Most of this central walkway will be part of the required accessible route between new accessible parking spaces and the clubhouse building entrance.]

<u>Photo above:</u> Location of proposed new minimum 60" long x minimum 60" long level (maximum 2.0%) landing at the turn in direction that connects to the lower lot accessible parking spaces.

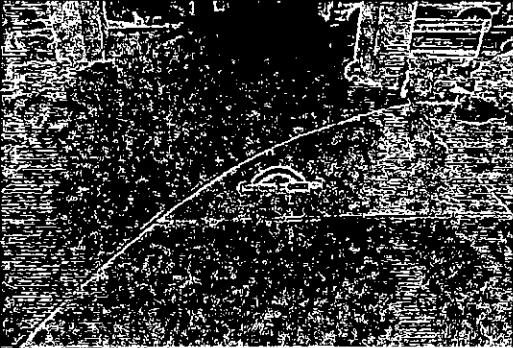
<p>Photo above: The concrete walkway (1 square) exceeds maximum 2.0% cross slope at 2.8%.</p>

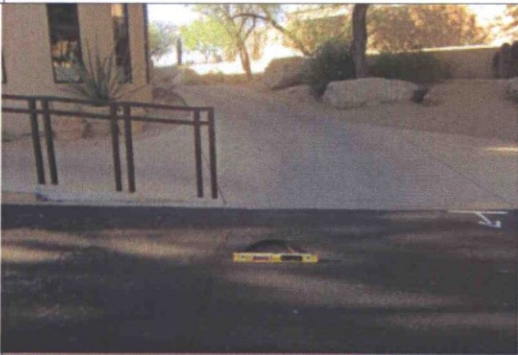
<p><u>Photo above:</u> The accessible route along the asphalt surface to the Fitness entrance walkway has cross slopes that exceed maximum 2.0% (measures at 2.2%).</p>

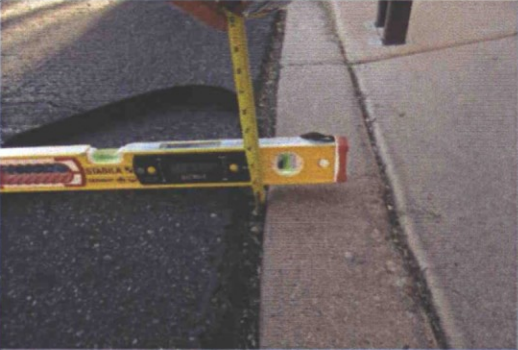
<p><u>Photo above:</u> The transition between the asphalt and concrete surfaces and the walkway exceeds maximum 1/4" high vertical with significant erosion.</p>

Item No.	Location	Observed Barrier (ADA non-compliant item/feature)	Technical Reference	Proposed Solutions and Recommendations per 2010 ADA Standards
9	Accessible Route to Fitness entry, Transition	The transition between the asphalt and concrete surfaces exceeds maximum 1/4" high vertical (measures up to 1-3/4" high), and the transition has a "opening" more than 1/2" wide (measures between 1-1/2" - 3" wide at asphalt erosion).	ADA 302.3, ADA 303.2	Modify transition between asphalt and concrete surfaces (ensure 1/4" vertical or maximum 1/2" high with a 1:2 bevel transition, and no more than 1/2" wide). Coordinate work with asphalt contractor.

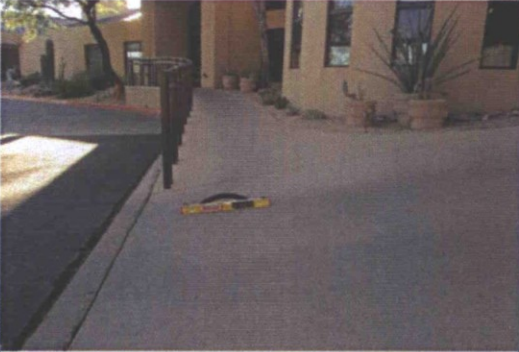
<p><u>Photo above:</u> Existing Fitness entry ramps lacks a level bottom landing (measures at 8.2% cross slopes at bottom of ramp).</p>

Item No.	Location	Observed Barrier (ADA non-compliant item/feature)	Technical Reference	Proposed Solutions and Recommendations per 2010 ADA Standards
10	Ramp, to Fitness entrance	<p>The Fitness center entrance ramp has several non-compliant features, including the ramp lacks a minimum 60" long level bottom landing (measures 8.2% - 9.6% cross slopes), lacks a minimum 60" long top landing due to the "angled" configuration at the building, a portion of the ramp has cross slopes that exceed maximum 2.0% (measures between 3.7% - 7.8% cross slopes at approximately 8'-0" long near bottom of ramp), and ramp lacks handrails on each side.</p>	ADA 405	<p>Replace with new compliant ramp. Work requires: Provide minimum 60" x 60" long level (maximum 2.0% slopes in all directions) turning space at bottom, provide new ramp run with maximum 8.33% slopes, provide minimum 60" long level top landing (ensure full 60" length in front of building edge), and add handrails on each side. Handrails to extend minimum 12" long horizontal beyond the ramp run.</p>

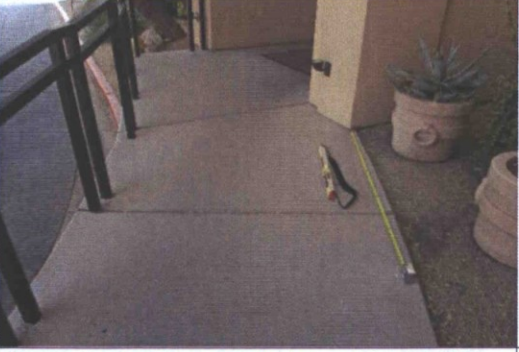
<p><u>Photo above:</u> The ramp lacks a minimum 60" long level top landing in the direction of the ramp run (ramp is sloped into the building corner which reduces the landing width).</p>

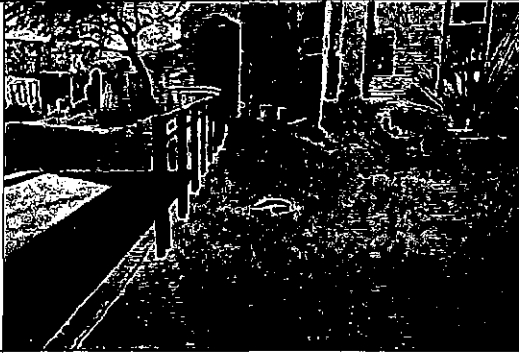
<p>Photo above: Approximately 8'-0" length of ramp has cross slopes that exceed maximum 2.0% (measures between 7.8% - 3.7%), and the ramp lacks handrails on each side.</p>
