**From:** Tim Little <tlittleco@gmail.com>  
**Sent:** Friday, February 28, 2025 2:55 PM  
**To:** Moriarity, Ben  
**Cc:** Tim Little; Marcia Little  
**Subject:** 7635 E. Pasadena Avenue  
**Attachments:** IMG\_5881.JPG; IMG\_0146.jpg; IMG\_1880 (2) (1).JPG

Thank you for talking on the phone a few days ago. We wanted to follow up with a note detailing our concerns about the balcony condition at 7635 E. Pasadena Avenue here in Villa Monterey Unit 7.

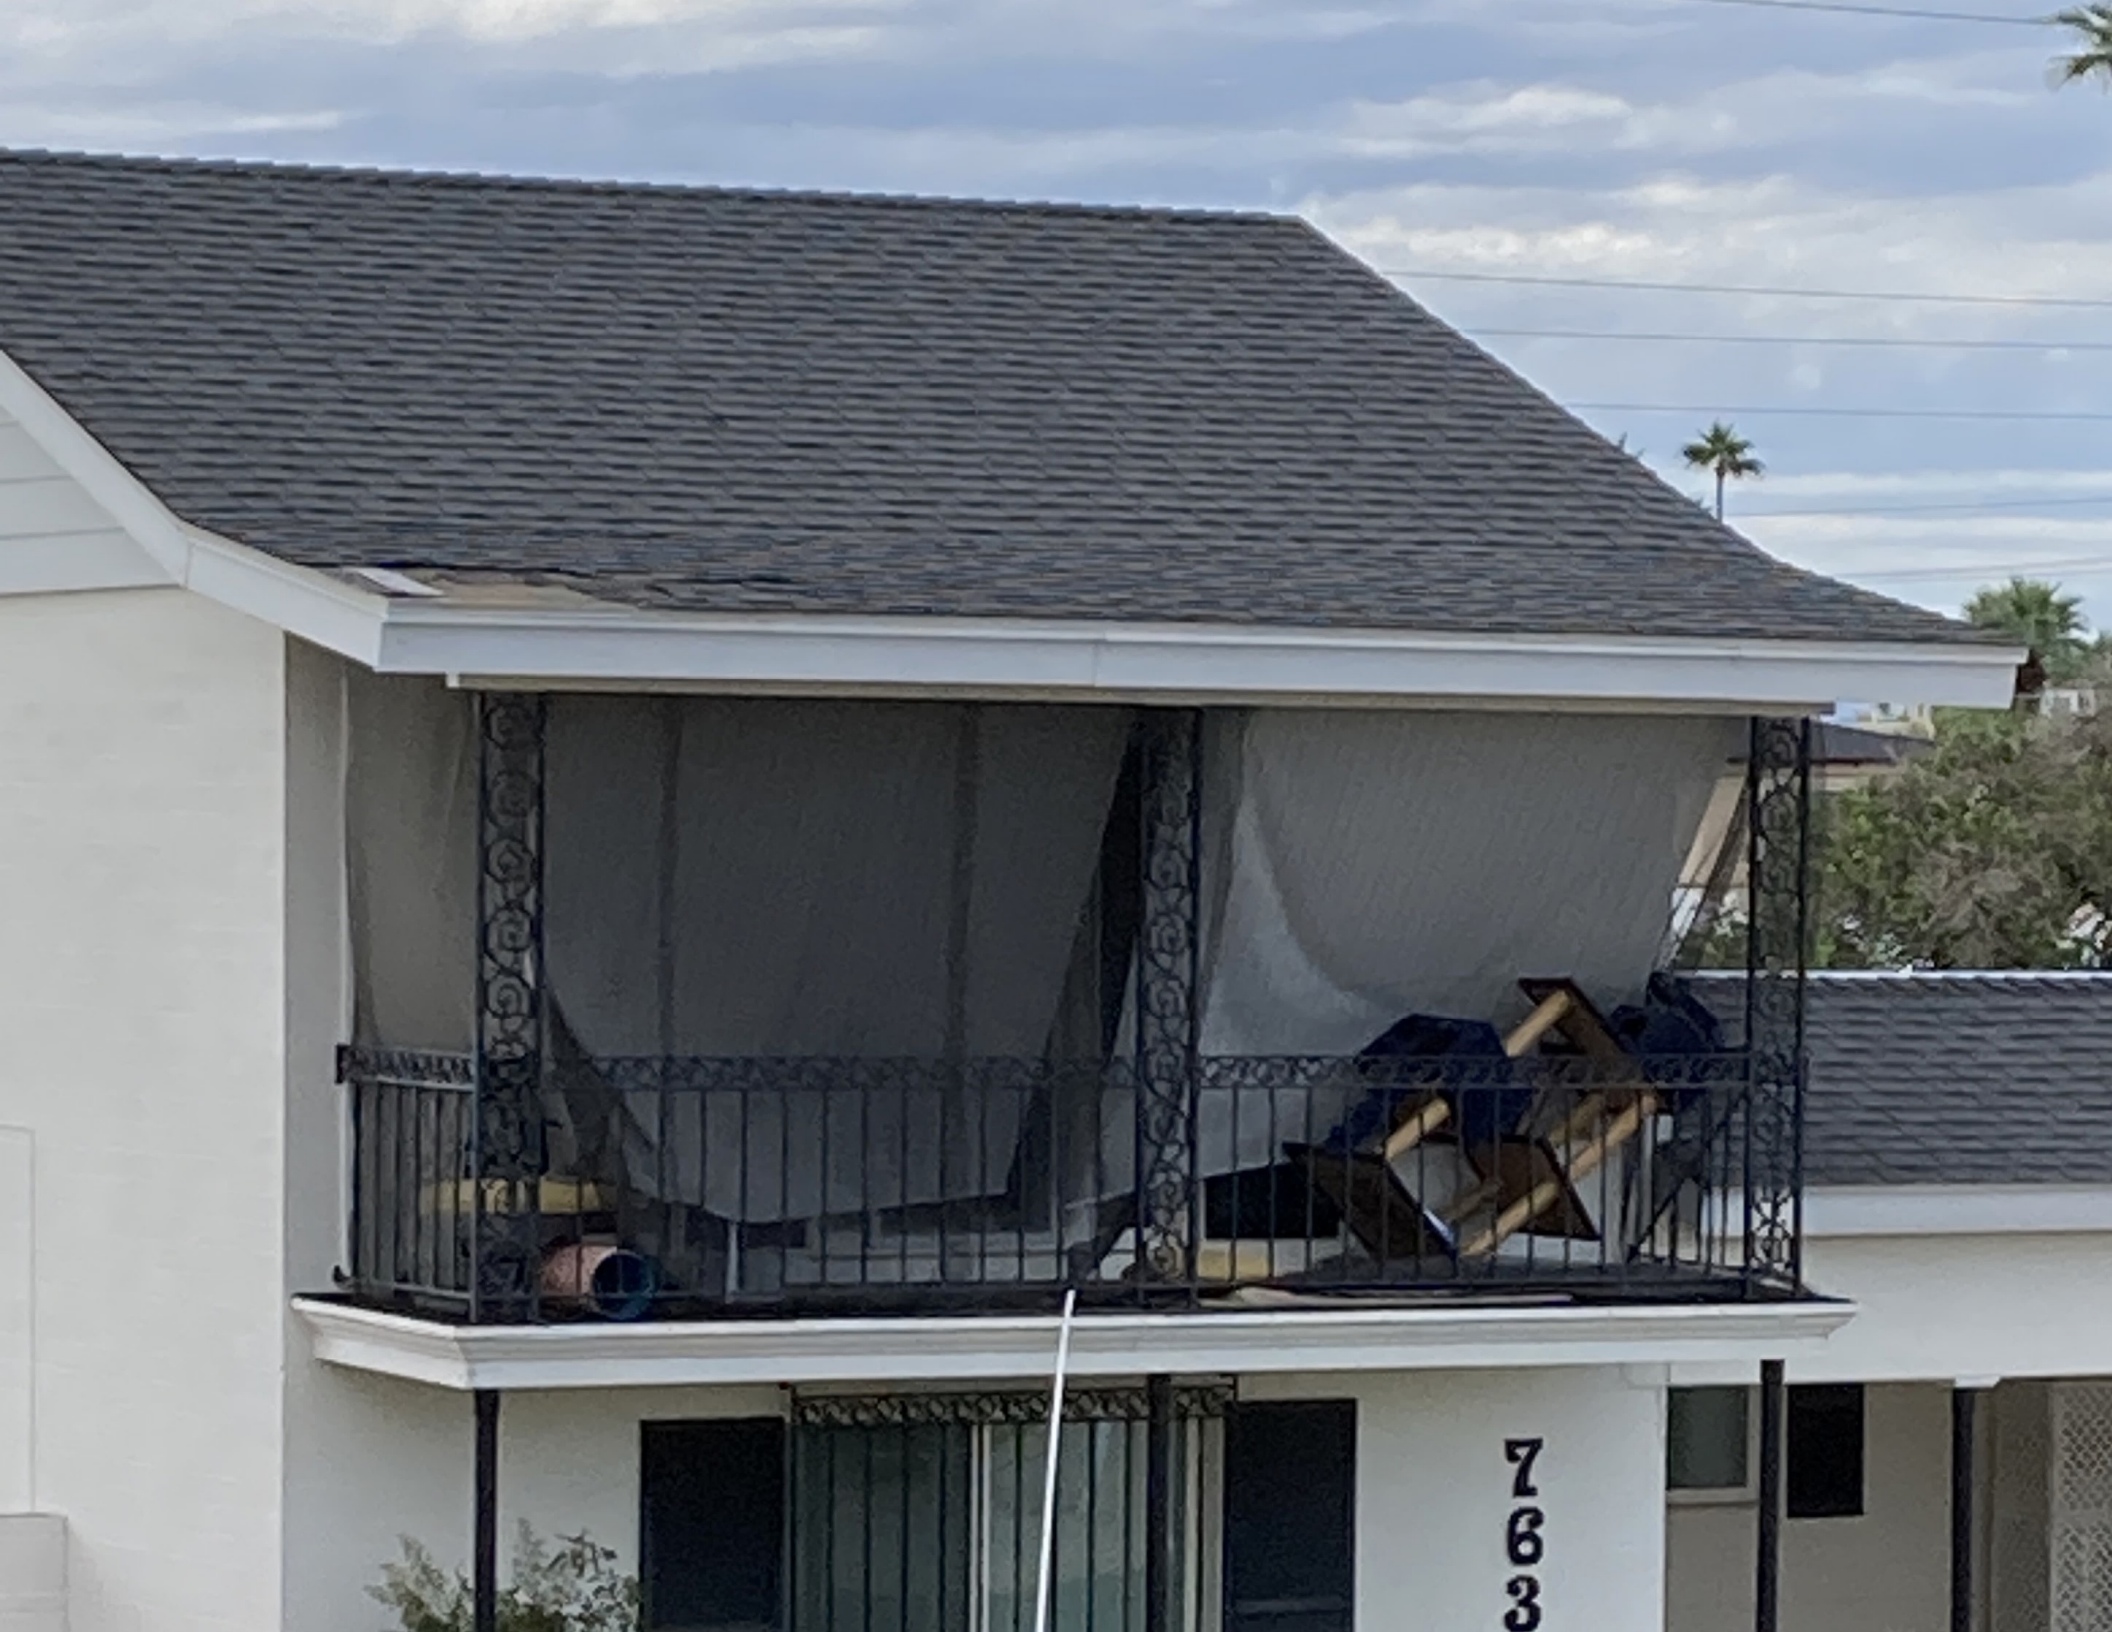
763

As we discussed, this balcony has been completely enclosed with window screening material and a pet door has been installed within the sliding glass door on the balcony. Most likely not under the jurisdiction of the HPC, the balcony has no furniture; rather it is furnished with a cat box and cat toys. The balcony has been converted into an unsightly cat cage. These changes do not contribute to the historical character of the house and are no good for anyone. We have not seen this anywhere else in Villa Monterey.

For so many reasons this condition should be removed and the balcony needs to be returned to its historical appearance.
