STAFF APPROVAL LETTER

Mercedes Benz of Scottsdale

Request: Approval of reconfiguration of entry drive and front visitor parking areas.

**Memo: Scottsdale Mercedes - Benz
Traffic Circulation Analysis – FIRST
REVISION**

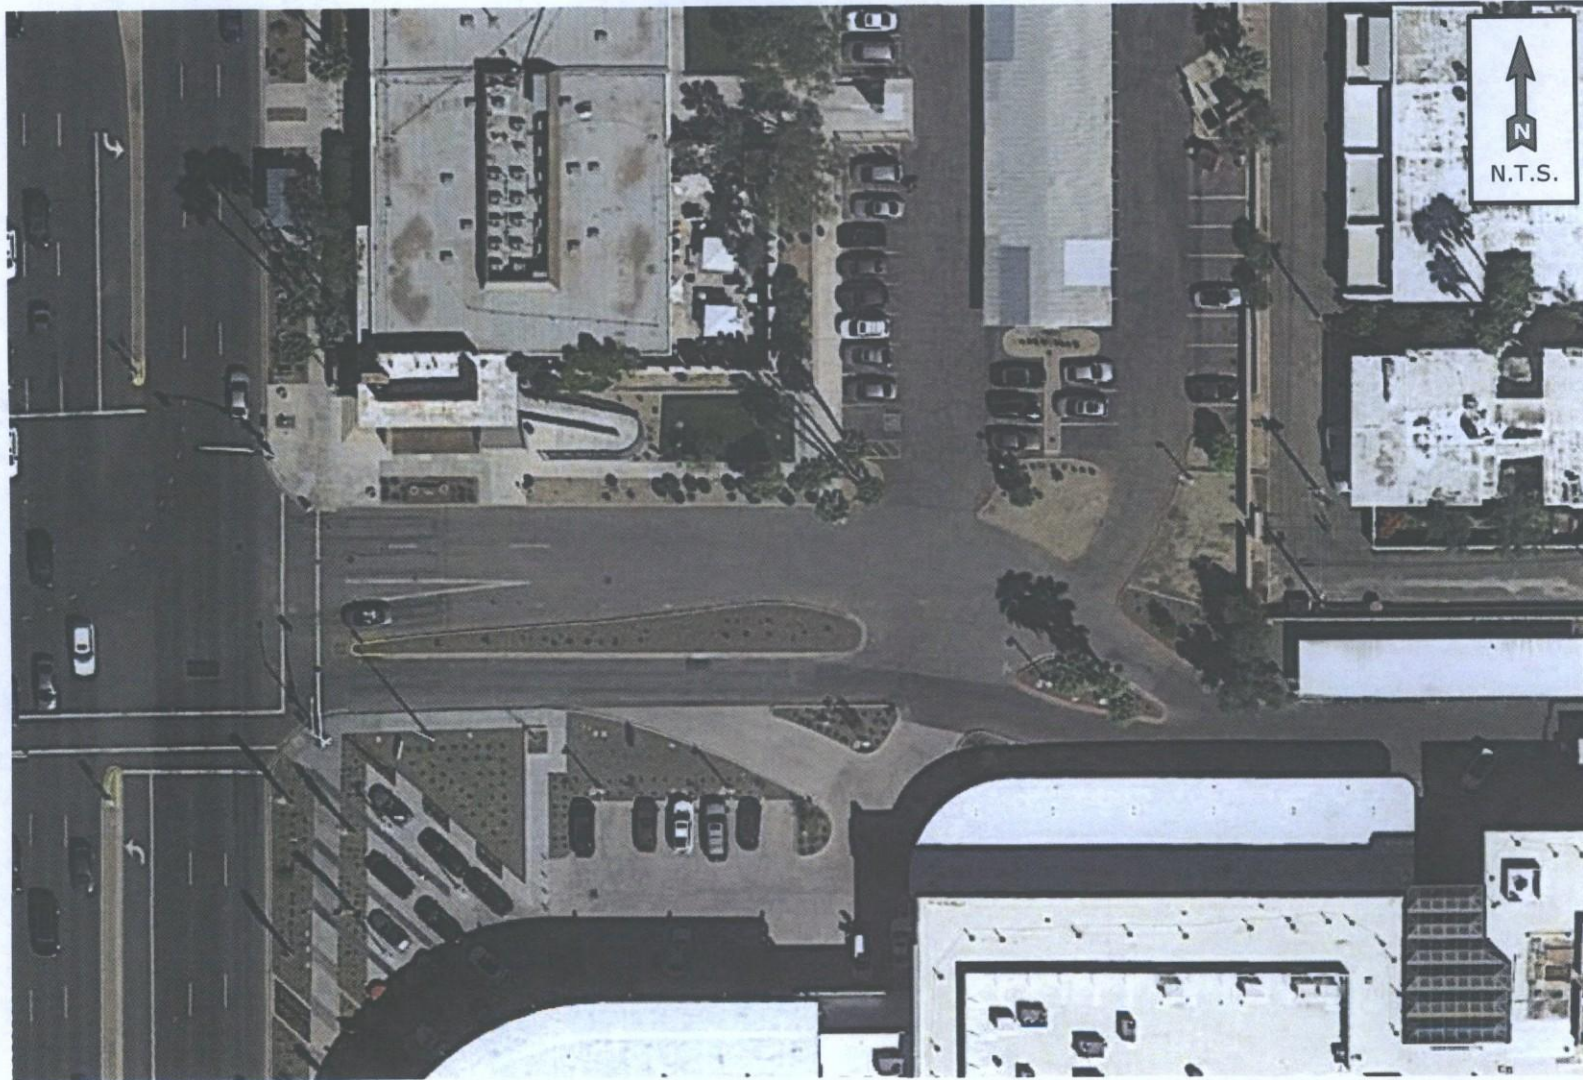
Figure 2 provides a detailed "close-up" aerial view of the existing site access on Highland Avenue.

Figure 2: Existing Site Access

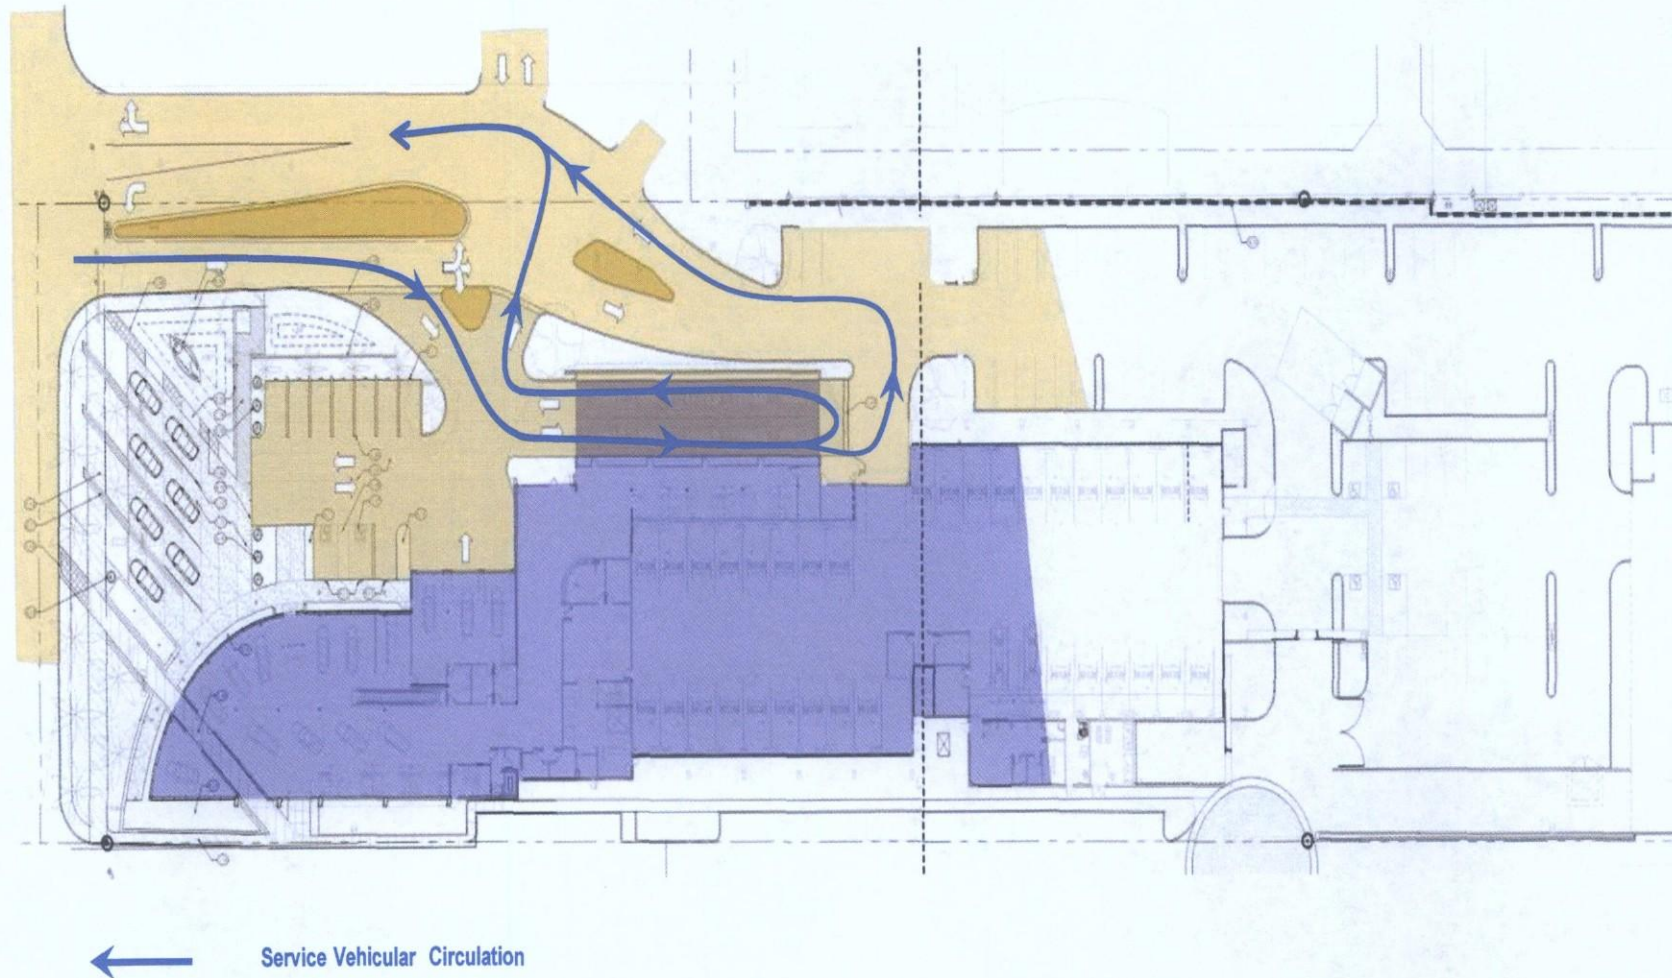
Figure 4: Existing Vehicle Service Customer Traffic Circulation

The impacts of employee related traffic was omitted since this type of user does not typically coincide with the peak customer and delivery traffic. **Figure 3** through **Figure 5** provide schematic diagrams of the existing circulation routes for each traffic component, respectively. **Figure 7** provides a schematic diagram of the circulation routes for all three (3) traffic components combined.

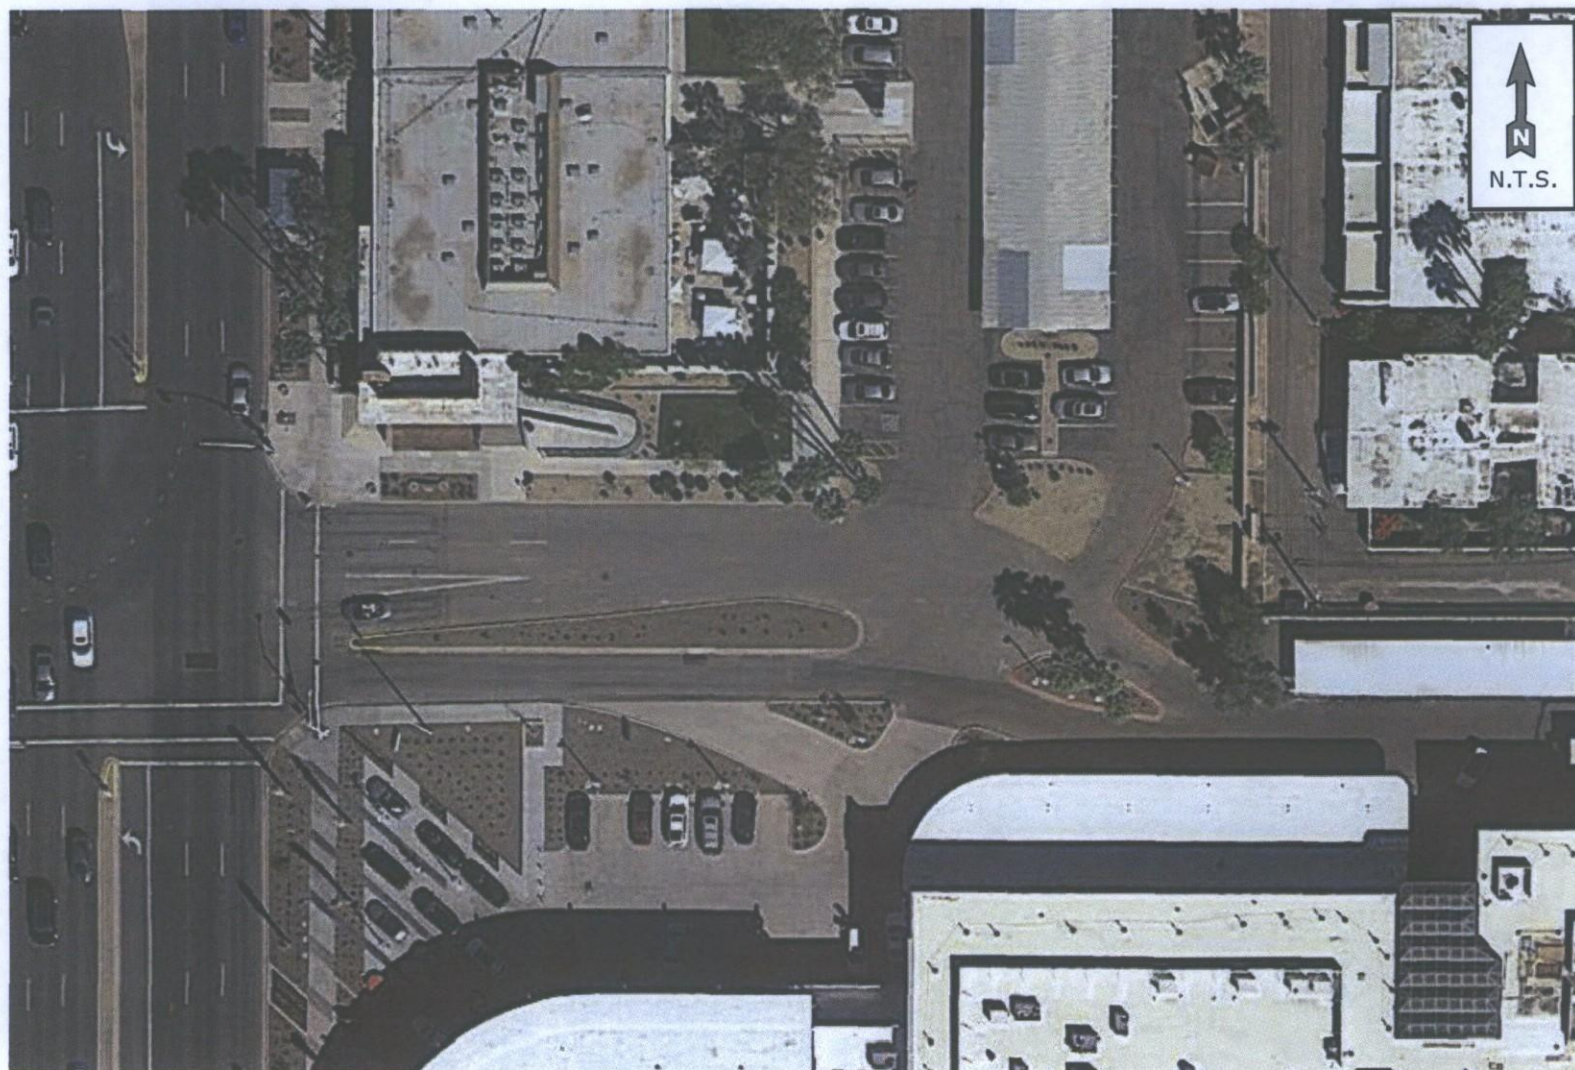
Figure 2 provides a detailed “close-up” aerial view of the existing site access on Highland Avenue.

Figure 2: Existing Site Access
