Desert Mountain Parcel 19
Scottsdale, Arizona

Traffic Impact Mitigation Analysis

June 15, 2016

Prepared by:
Stanley Consultants, Inc.

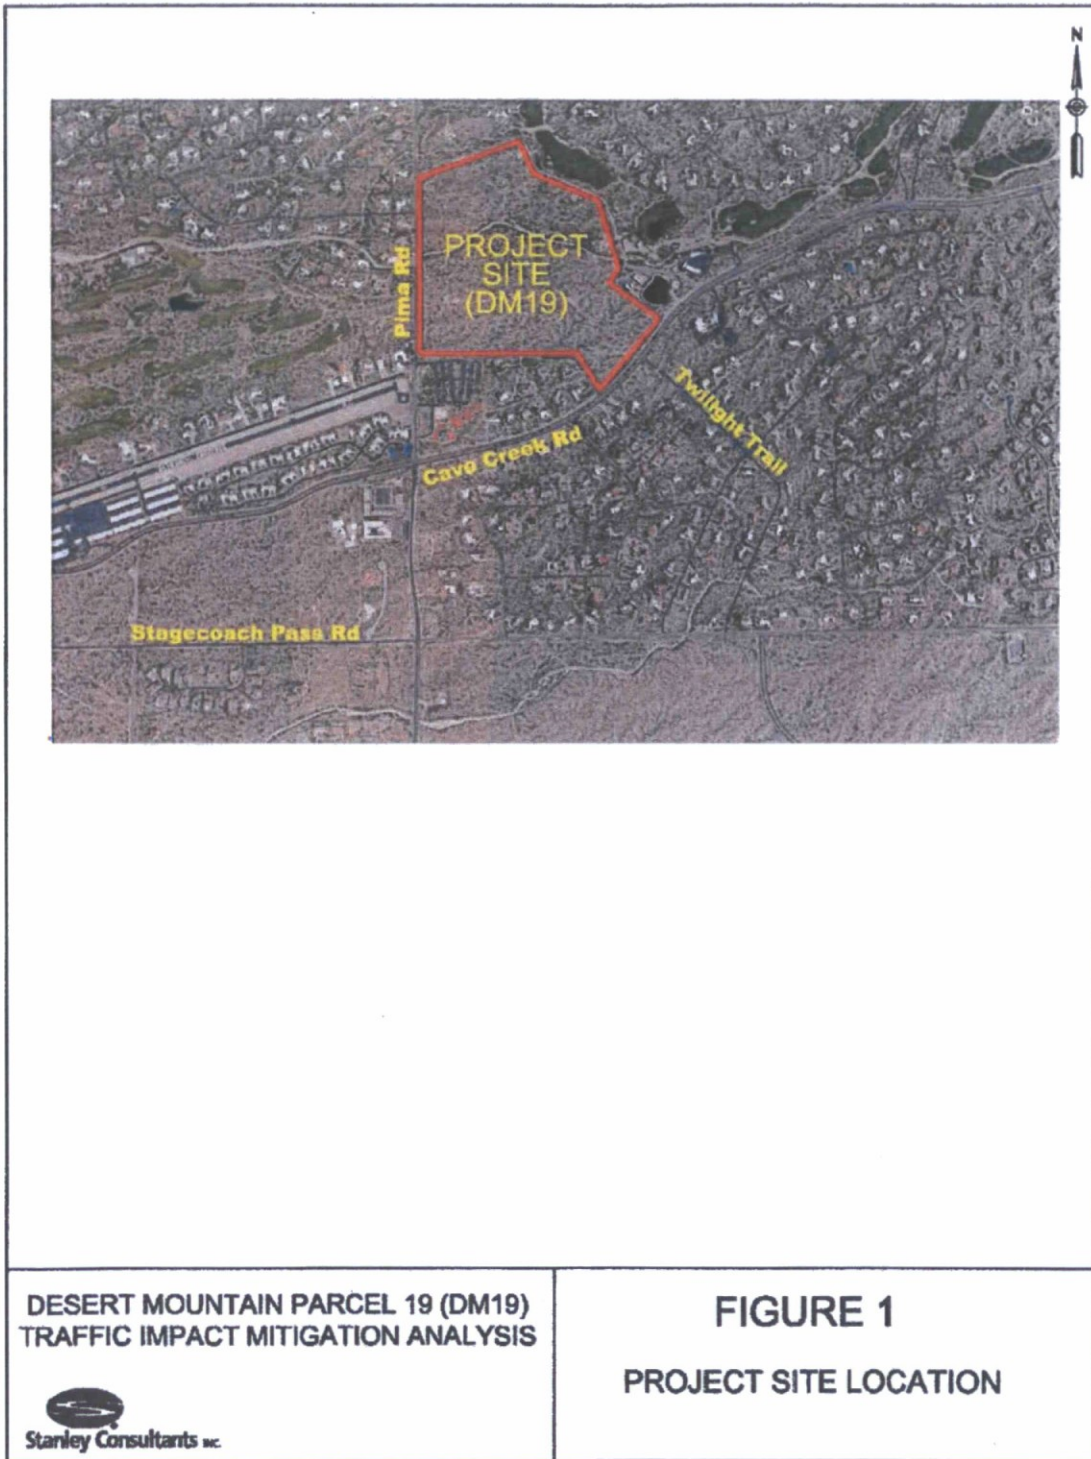
Figure 1 – Project Site Location

Stanley Consultants, Inc. was retained by DM 19, LLC to complete a Traffic Impact Mitigation Analysis (TIMA) for the proposed Desert Mountain Parcel 19 (DM 19), located in the northeast quadrant of the Cave Creek Road/Pima Road intersection in Scottsdale, Arizona. The site is currently vacant and is located approximately three miles northeast of the Carefree Highway and Scottsdale Road intersection. The project site location is shown in Figure 1.
