HISTORIC PRESERVATION COMMISSION

Case Name: Burtnett Residence – Exterior Rehabilitation

Case Number: 42-HP-2017

Location: 6713 East Granada Road

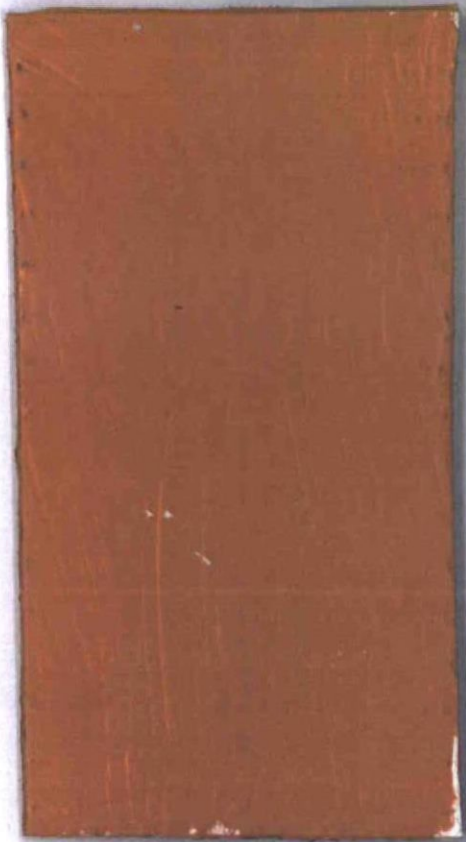
Dunn Edwards
5187
Weathered Saddle
FRONT &
CARPORT
DOORS

Benjamin Moore
1066
Barely Beige
Window Trim
+
Screen door

Benjamin Moore
1067
Blond Wood
House, back door
+ utility room
door

3. Paint colors shall be consistent with the following:
 - a. Backdoor and utility room door limited to: Benjamin Moore 1067 – Blond Wood
 - b. Window trim and screen door limited to: Benjamin Moore 1066 – Barely Beige

- c. Front door and door located in carport area limited to: Benjamin Moore 1066 – Weathered Saddle
- 4. HRER Program reimbursement funding shall be for rehabilitation of ten windows, and the one replacement door, Door #2.
