Historic Preservation Plan
and Guidelines for

Sands North Townhouses

Historic District

Scottsdale, Arizona

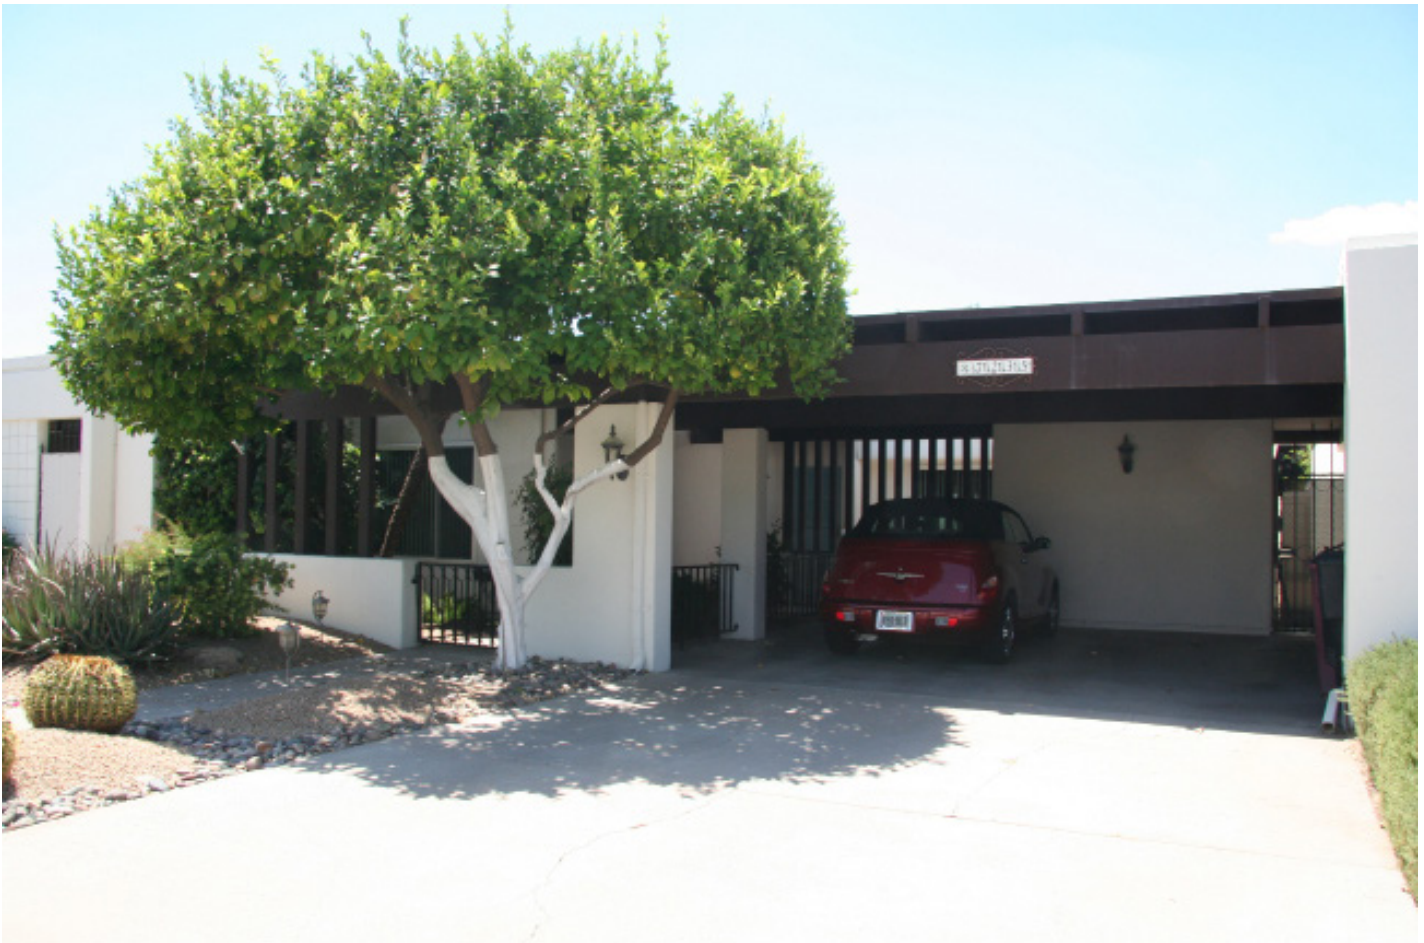
Lot 23, Type A1 - Wood post screen on stucco wall and wrought iron gate

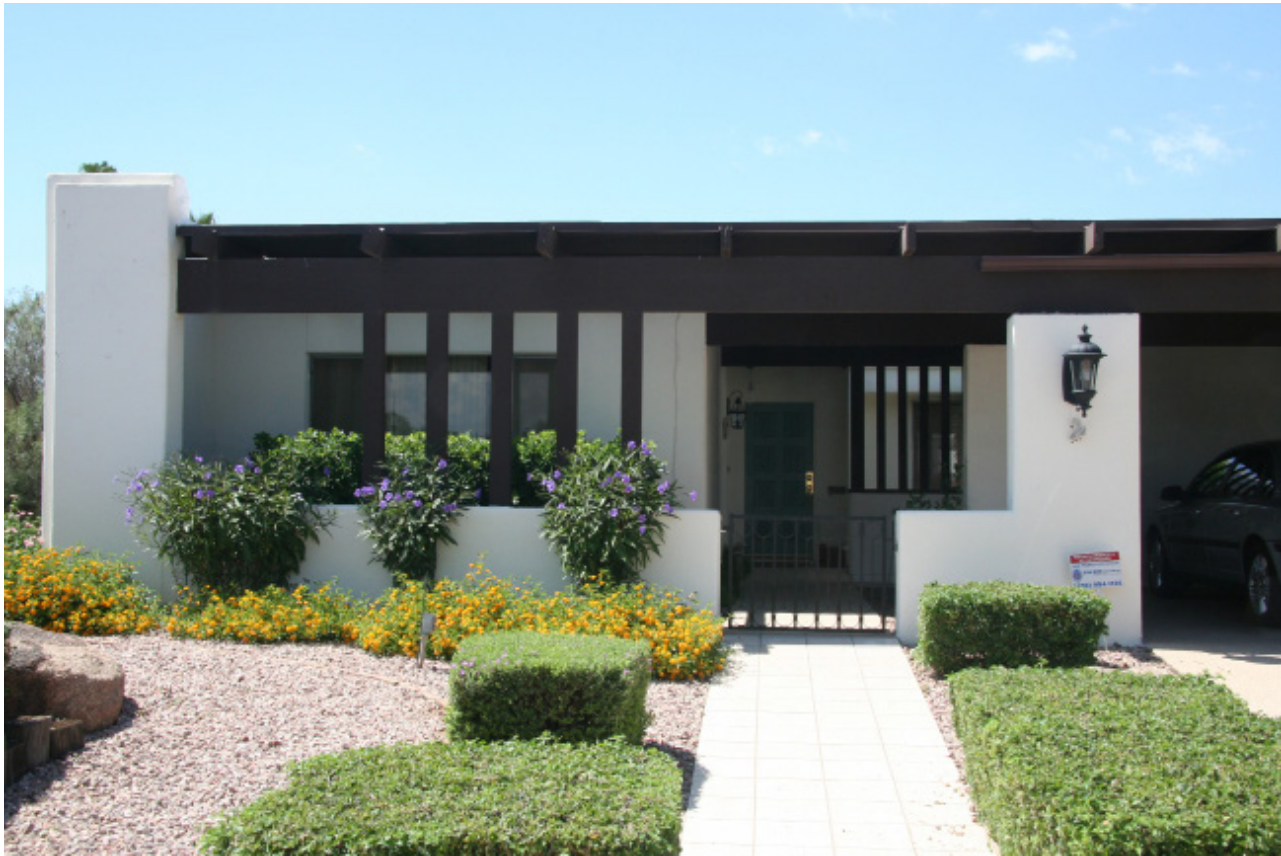
Lot 30, Type A - Low wall with wood post screening and wrought iron gate

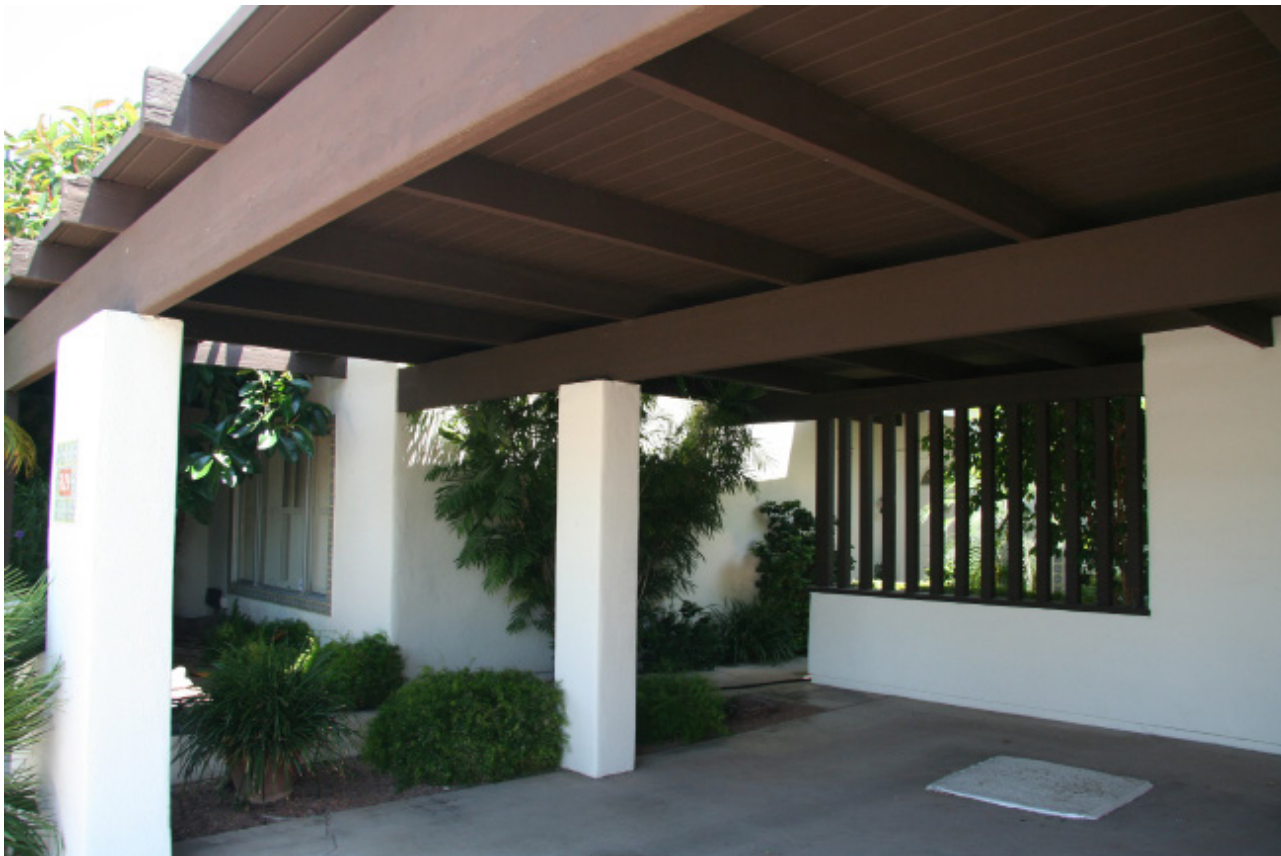
Lot 51, Type A1 - Wood beams and exposed rafters

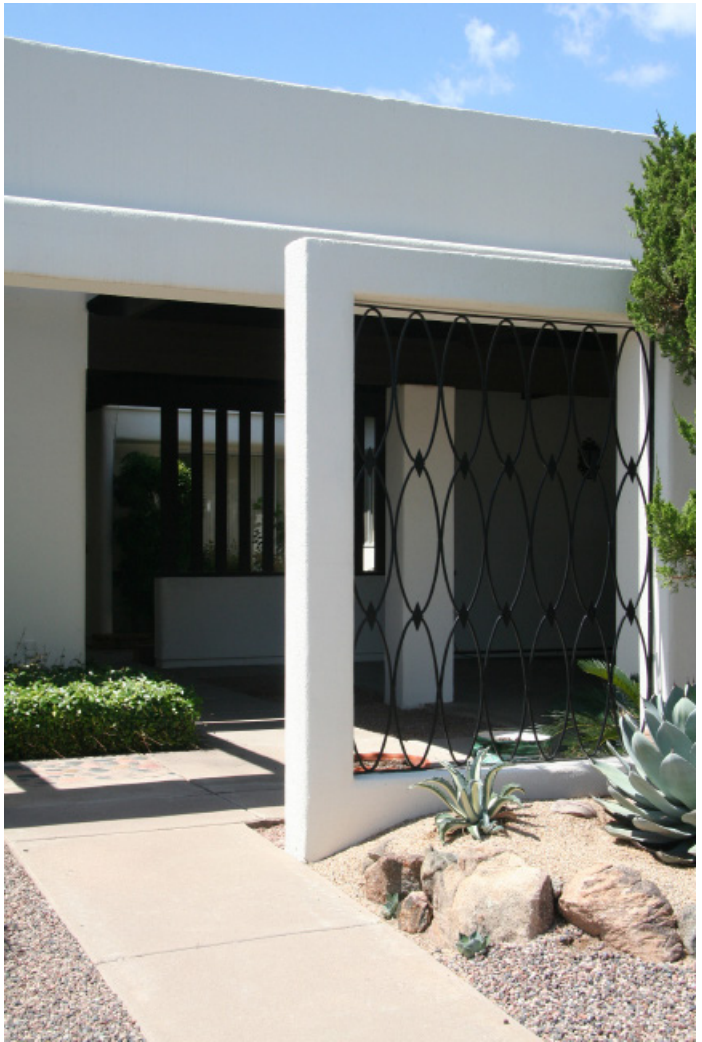
Lot 28, Type A3 - Screens at entry
