HISTORIC PRESERVATION PLAN & DESIGN GUIDELINES
for the rehabilitation of

THE KIMSEY BUILDING

15 January 2021

SCOTTSDALE, ARIZONA

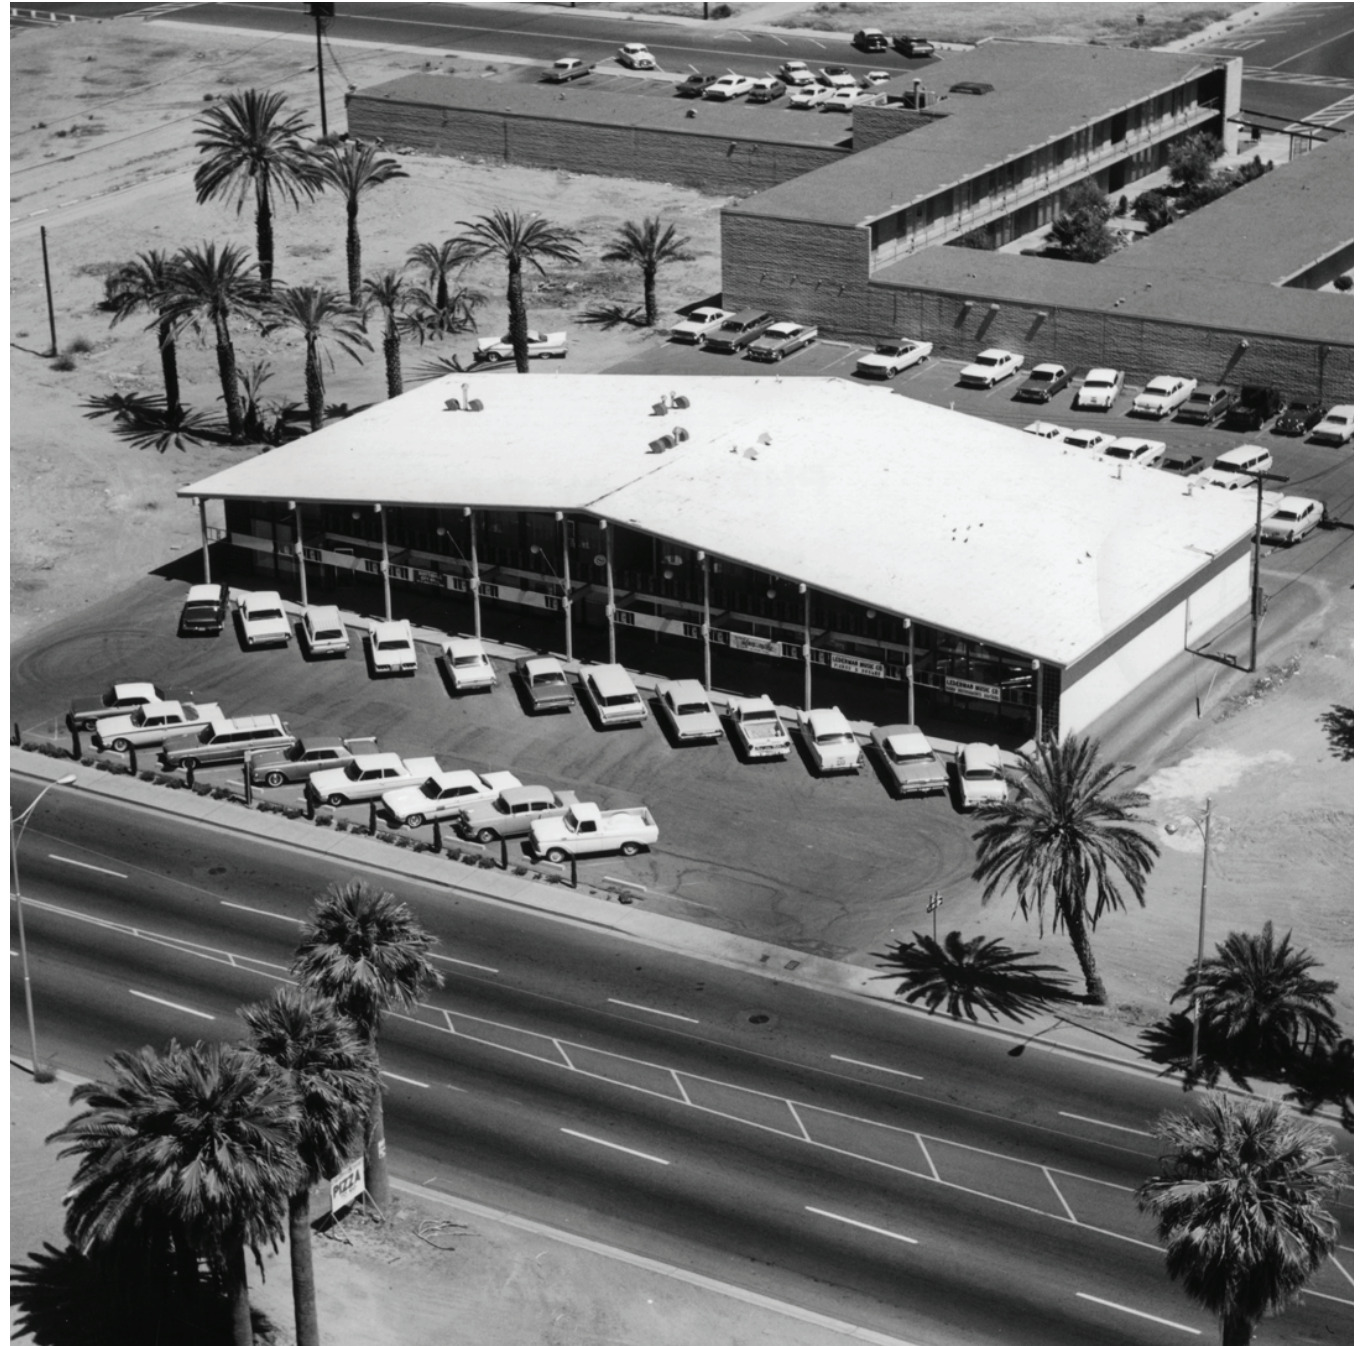
Oblique aerial view of the Kimsey Building in about 1963 when occupied by Scottsdale City Hall, Lederman Music, and Olan Mill Photography.

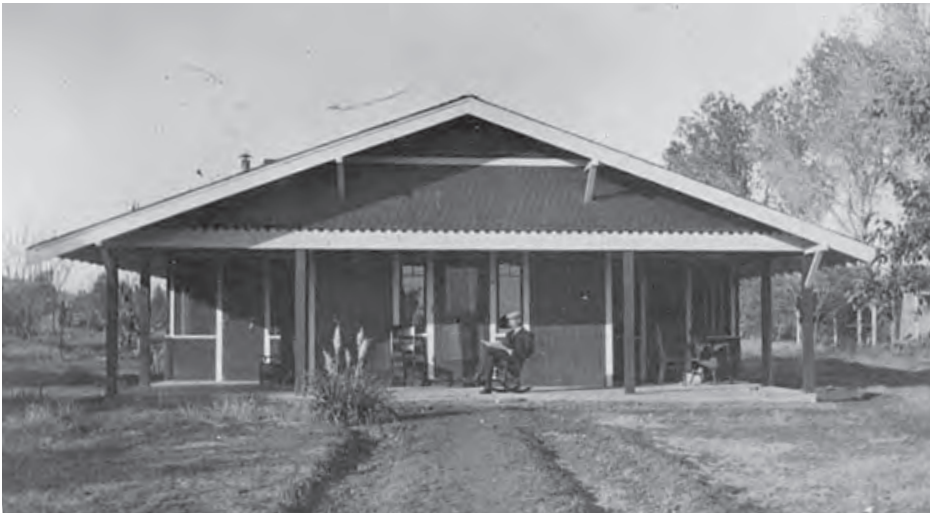
Elizabeth & William E. Kimsey farmhouse, circa 1916, was demolished in 1961 for construction of the Kimsey Building. (Scottsdale Heritage Collection at the Scottsdale Public Library; SCOT-SHS-2012-0156A)

Amazingly, the front façade of the little Kimsey cottage possessed character-defining patterns that can still be seen in the front façade of the Kimsey Building. The now missing cottage was comprised of:

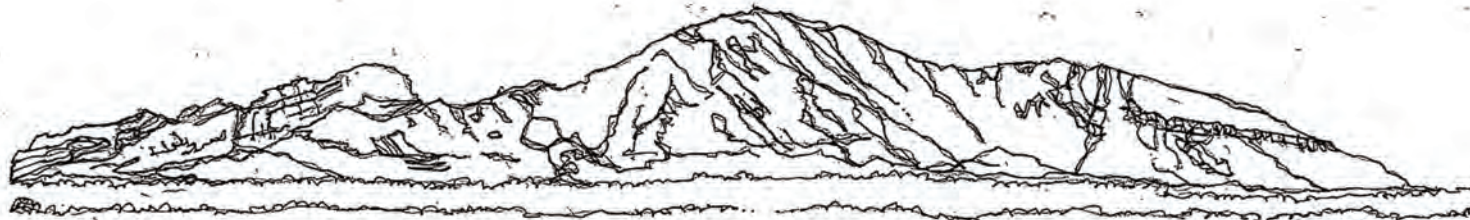
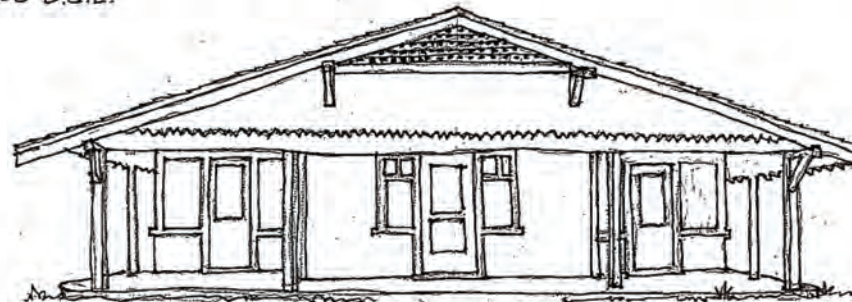
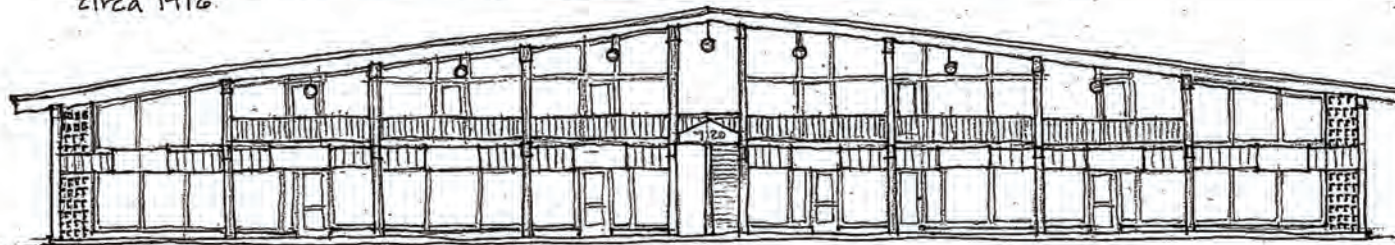
CAMELBACK MOUNTAIN
formed 12,000,000 B.C.E.

MR. & MRS. WILLIAM E. KIMSEY FARMHOUSE
circa 1916

KIMSEY BUILDING
built 1963 - Scottsdale, AZ

And taking the observations one more step into the past, could it have been that the unknown designer of the Kimsey cottage intuitively captured the triangular symmetry, ridge slope, and three parts of nearby Camelback Mountain?

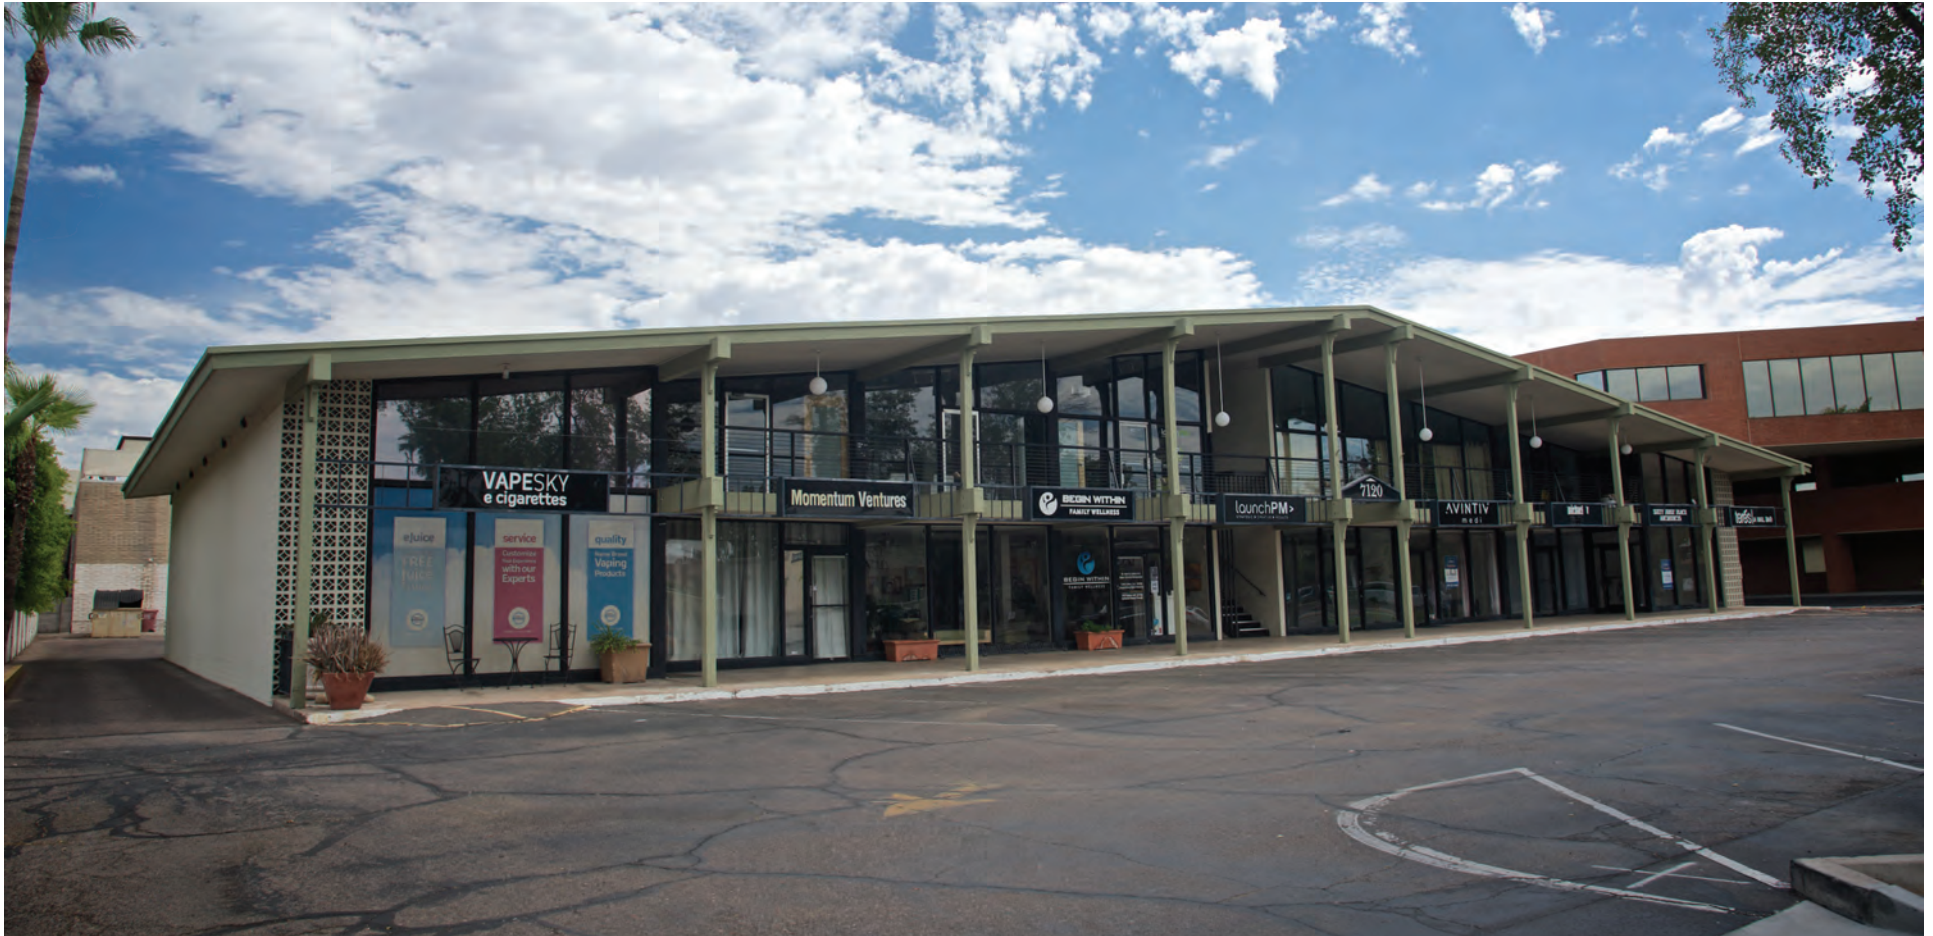
Kimsey Building front façade and parking. (August 2020)

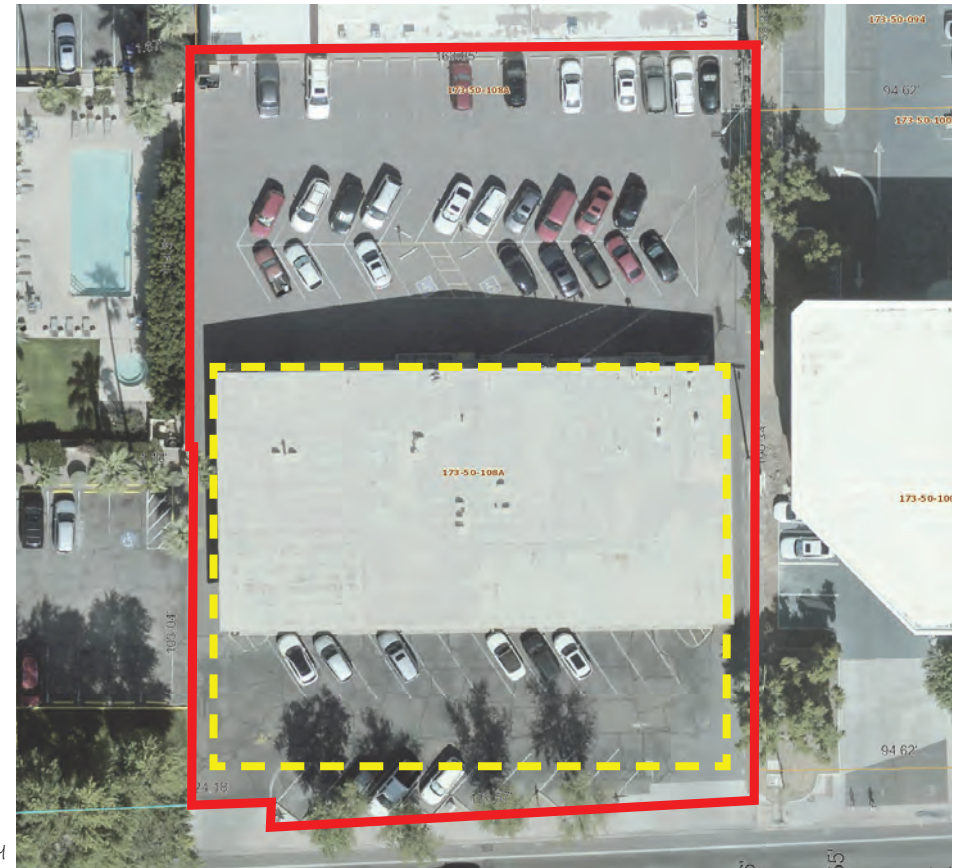
2020 Aerial

- Repair or replace damaged concrete curbs in kind at landscape planter. Consider retaining the post-historic period “sawtooth” shape of the landscape strip as it relates to the diagonal parking pattern and triangular aspect of the building façade.

- Consider replacing the few existing sissou trees and shrubs in the landscape strip with the missing rhythmic pattern of original Italian cypress trees and three shrubs to reflect the pattern of the porch bays and storefronts as shown in 1962 oblique aerial photo. Coordinate with City ROW and streetscape design guidelines.

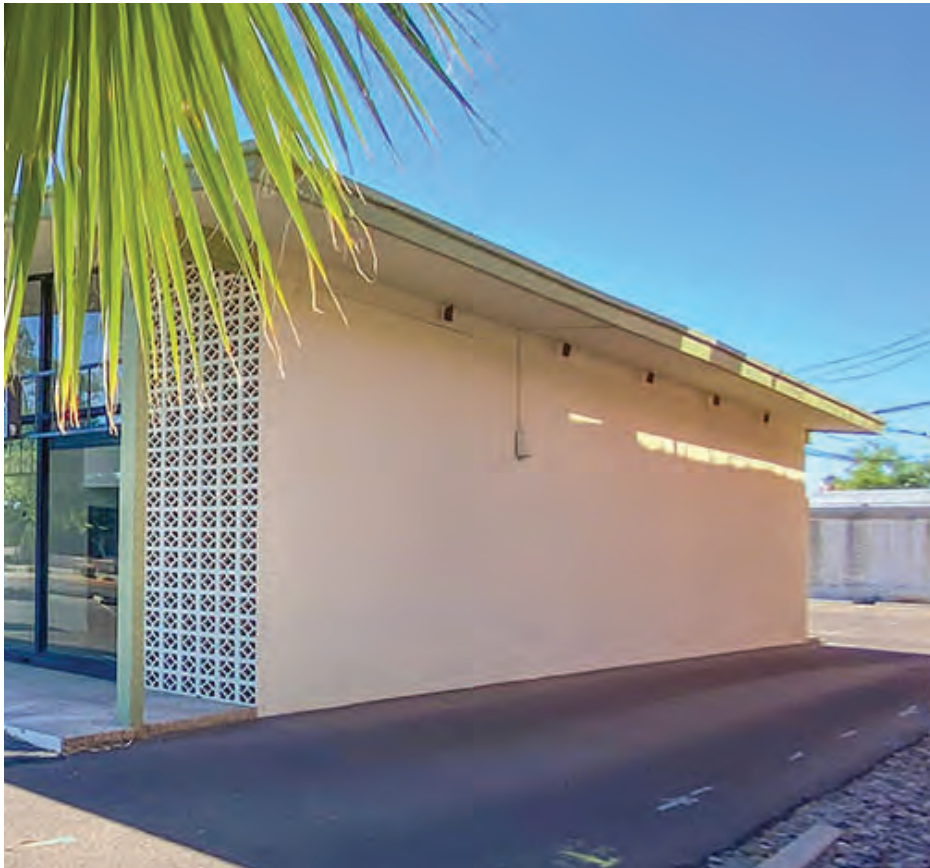
East facade having no openings or architectural features.

Structural masonry joint revealing horizontal steel reinforcing "ladders".

- When rehabilitating the interiors for adaptive uses, avoid changes to the solid side façades (e.g., introducing windows, doors, louvers) if possible. If changes are necessary, restrain the design and respect the historic stylistic concept and patterns.

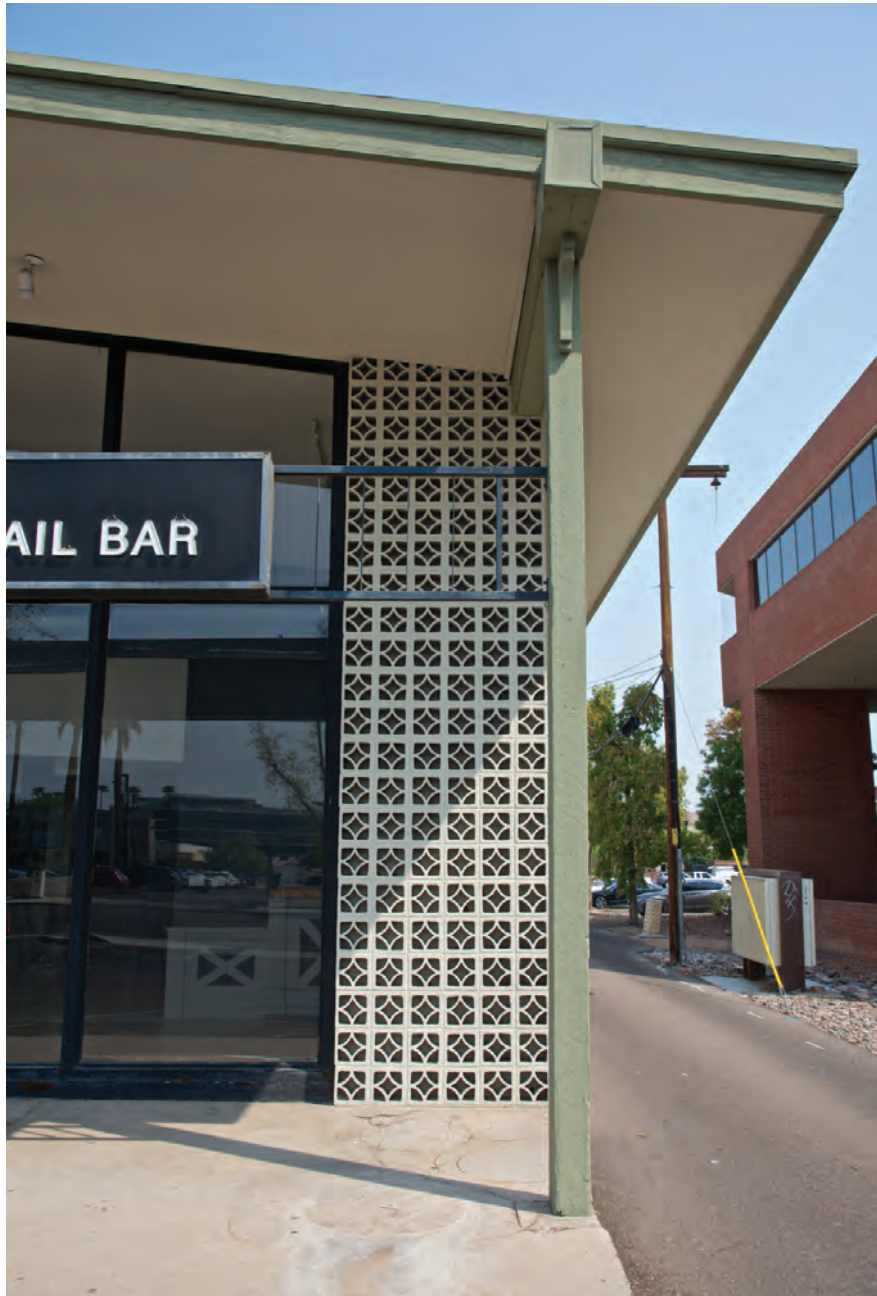
Decades of relocated doors and added pipes, conduits, vents, and equipment cover north façade.

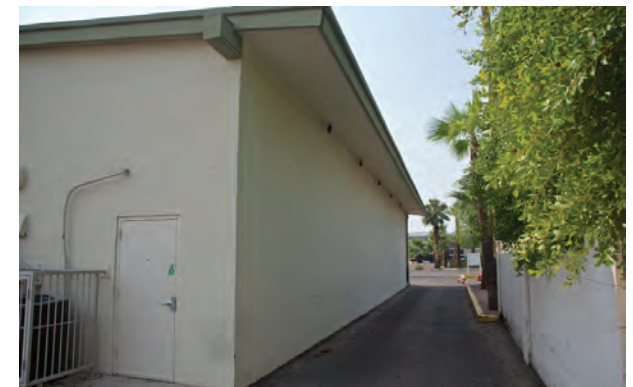
Standard concrete block walls enclose the side and rear elevations.

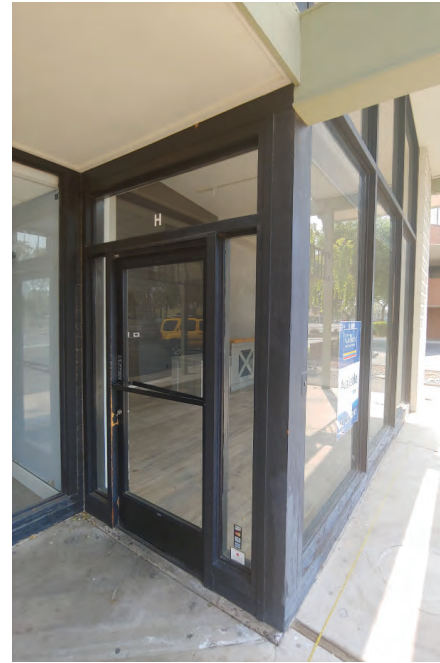
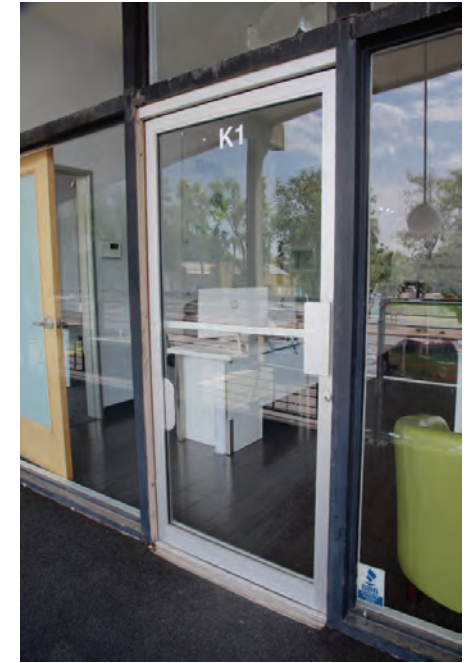
Compare loss of integrity where dark doors replace original mill-finished aluminum doors.

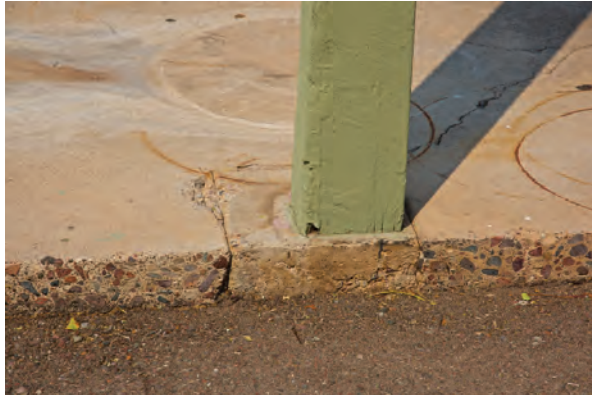
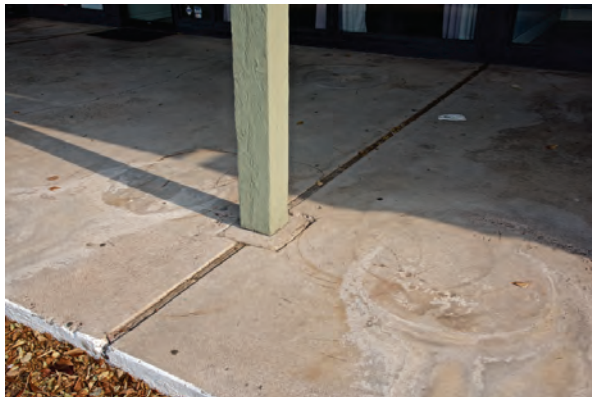
The character-defining concrete slab and redwood headers of the porch terrace have sustained staining, deterioration, and modification that affect their integrity of materials.

- Repair the wood porch structure by reinforcing the materials and by limited replacement in kind—or with compatible substitute material—of those extensively deteriorated or missing parts of repeated features where there are surviving prototypes such as railings, balustrades, and stairs.

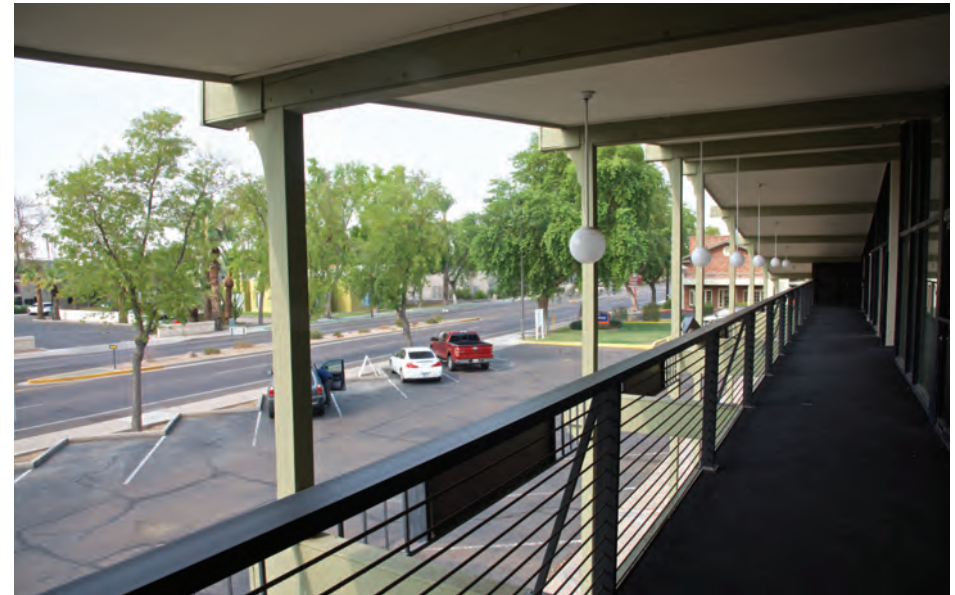
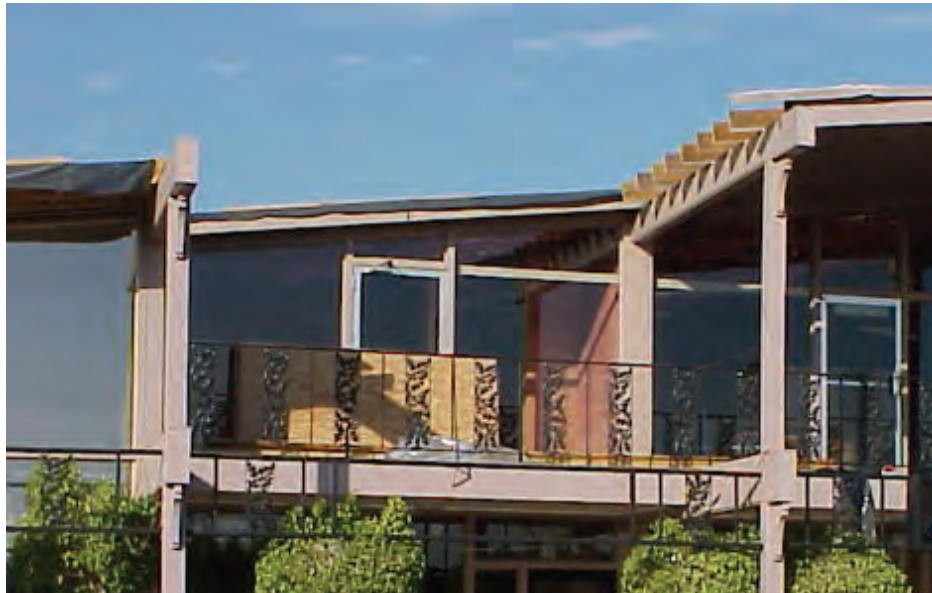
The storm damage of 2000 resulted in the replacement of the original cast iron balcony guardrails with a new aircraft cable system.

- Consider retaining the code-compliant aircraft cable guard and steel handrail that replaced the cast iron balustrade damaged by the 2000 windstorm. Minimize the visual impact to the south façade and storefront of any new features introduced to the existing balcony.
- If the rehabilitation plans retain the small wood balcony (not character-defining) at the north façade, repair its structure and finishes in kind. Retain the remnant original cast iron railing but modify the installation to comply with building code.
- If the rehabilitation plans do not retain the small wood balcony at the north façade, consider reinstalling the surviving original cast iron railing in an appropriate adaptive location to preserve the remnant as record of the original materials of the front balcony.

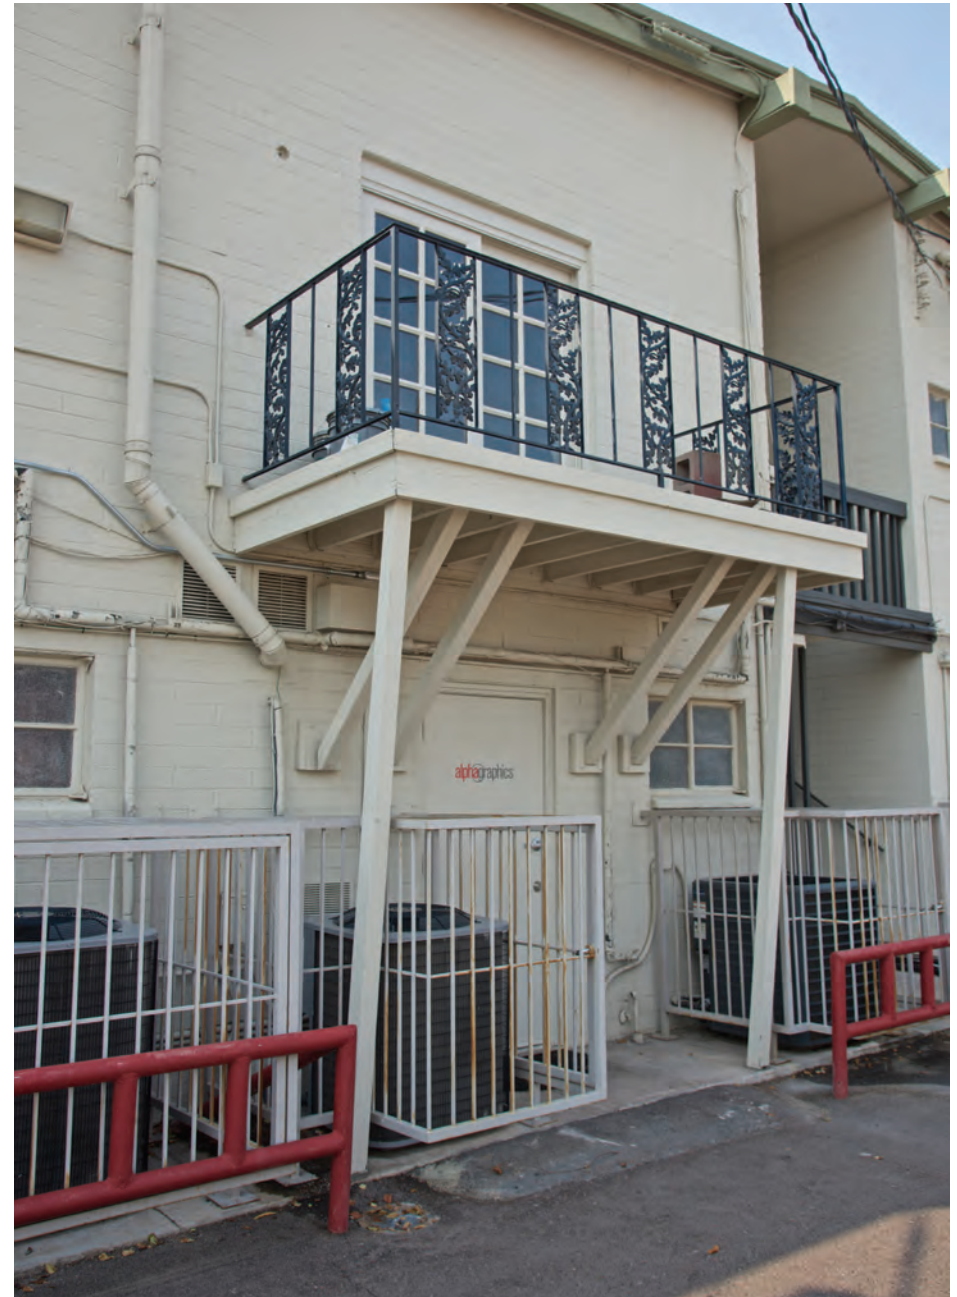
A remnant of the original cast iron balcony guardrails survives at the rear balcony.

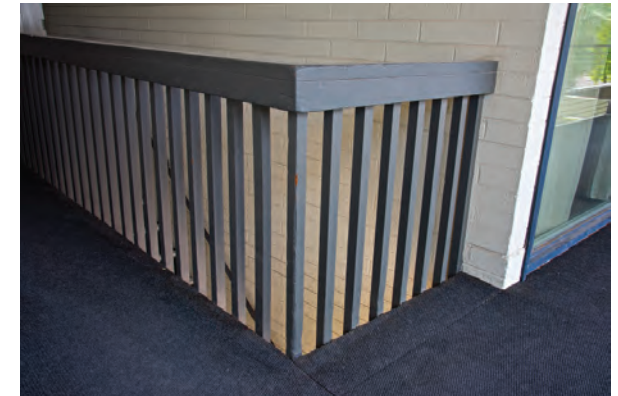
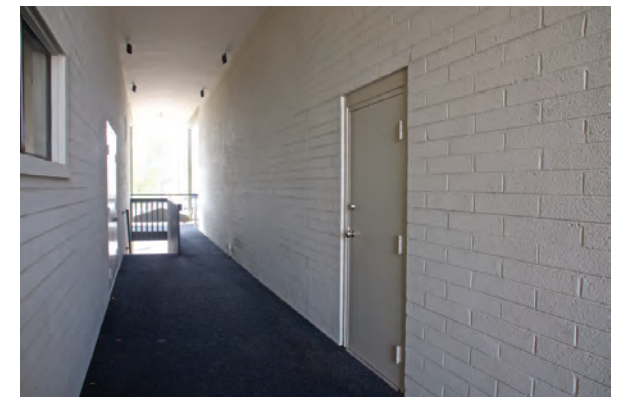
The original wood stairways in the breezeway have been unclosed for mechanical equipment leaving the wood spindles to convey the Modern character.

- Retain the two-story volume of the open breezeway and repair features and finishes by reinforcing the historic materials or by limited replacement of materials in kind. Consider using a compatible substitute material for extensively deteriorated or missing parts that convey the visual appearance of the surviving parts of the breezeway.
- At the breezeway, remove mechanical equipment beneath the two wood stairways. Replace deteriorated wood stair treads, risers, and stringers with new materials and proportions to meet building code compliance. Reuse the decorative wood balusters (square spindles) that appear to suspend the stringers or replicate them with compatible new materials for a new design compatible with the historic character of the building.

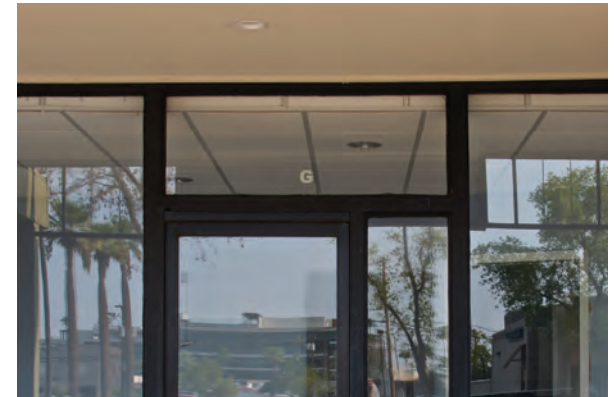
An interior structural masonry wall has been partially removed from between the two easternmost bays to install base cabinets and countertops.

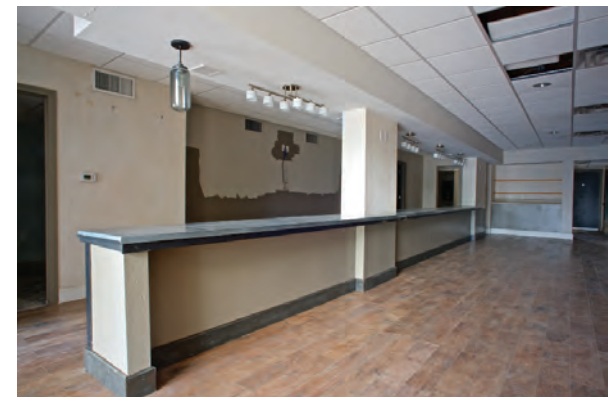
The end bays have a high ceiling at their entrances and a hidden loft above the original low ceiling.

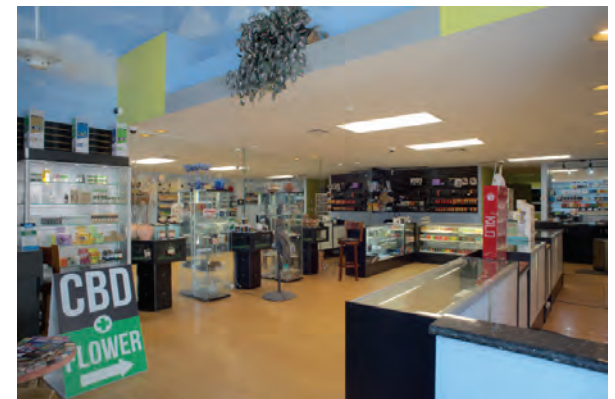
Ghosts of missing paired stairs seen on the concrete floor suggest an infilled atrium in the west half of the building.

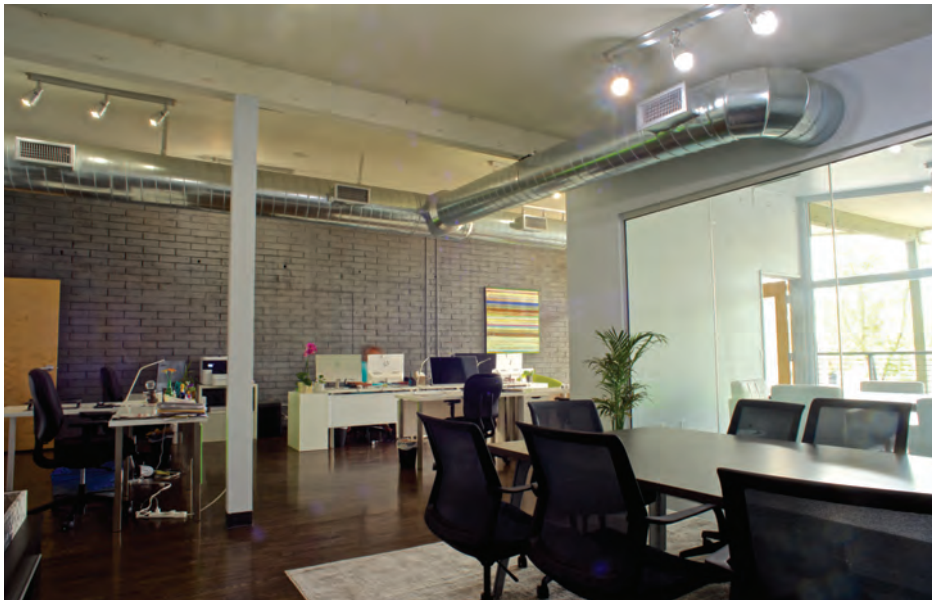
Tenant improvements in several leased spaces (2020) appropriately interpret the open plan and daylighting feeling characteristic of the Modern period.

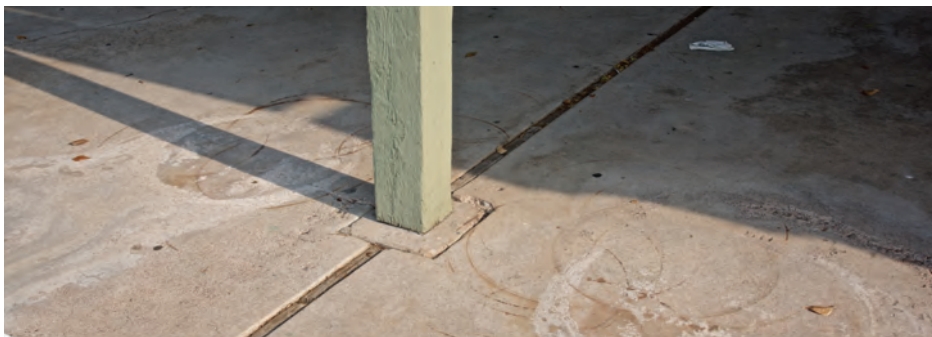
The simple post-and-beam structural system characteristic of Contemporary-style homes and commercial buildings by architect Ralph Haver allow flexibility for tenant improvements without affecting design integrity.

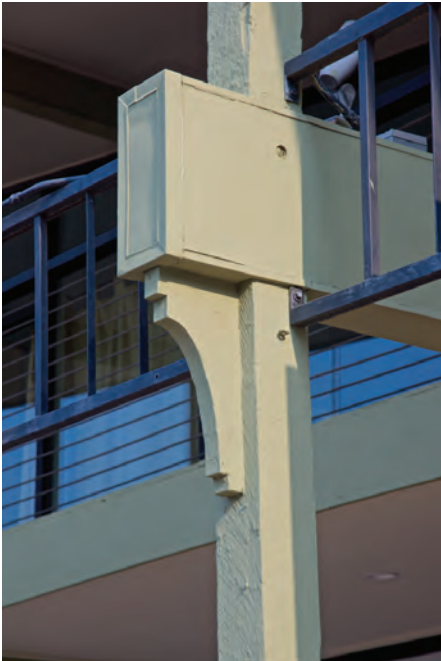
The original curved corbel design is an unusual detail for Contemporary-style beams that may be an architectural salute to the gable brackets of the earlier Kimsey farmhouse.

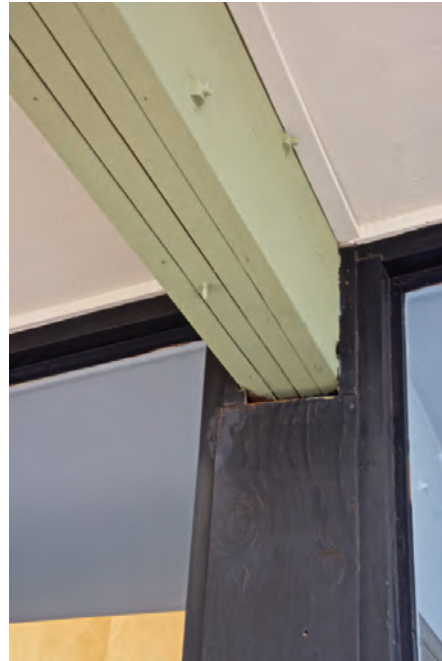
The economical laminated beams supporting the roof and second floor have been sheathed to protect from weather and to enhance their appearance.

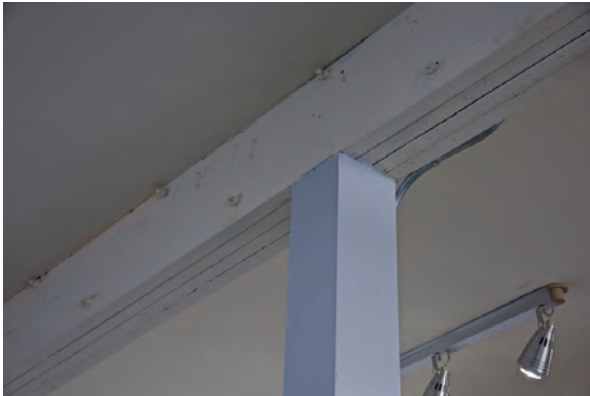
Surprisingly, the beam connections at posts and walls have no visible metal connectors.

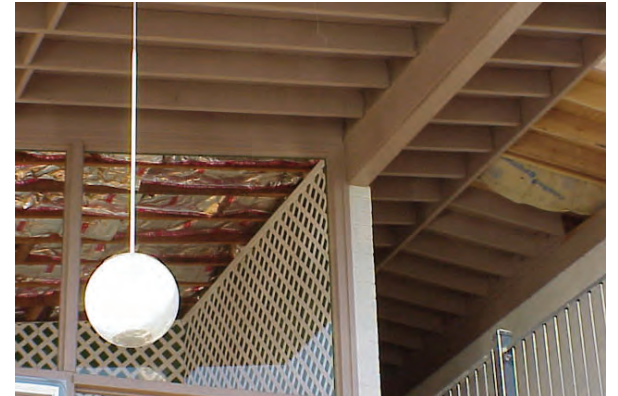
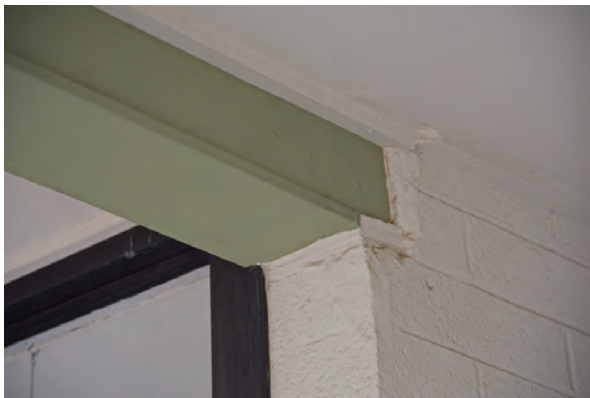
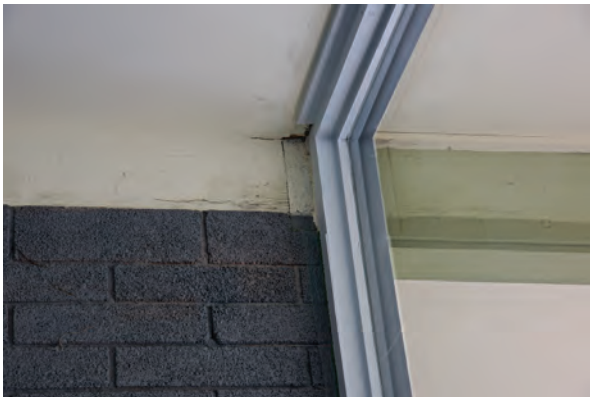
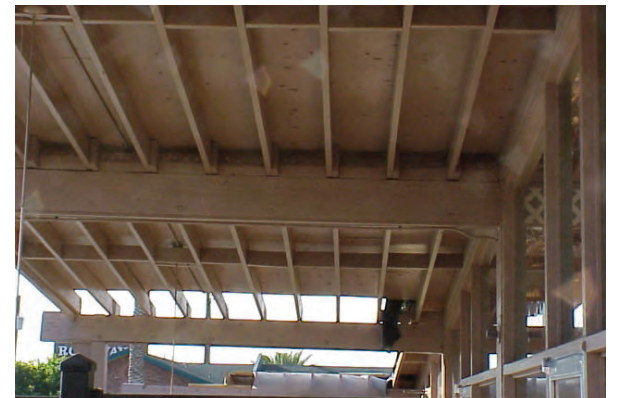
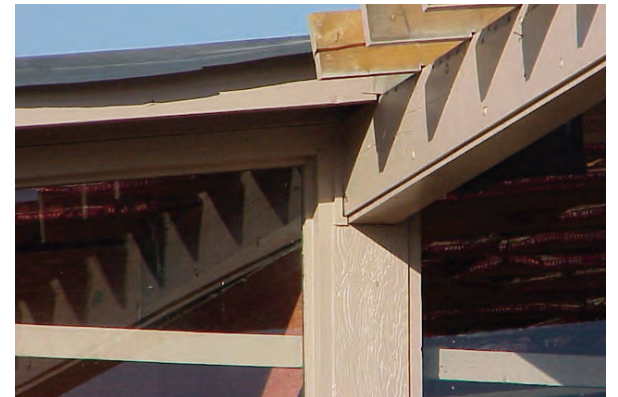
Construction photos from the roof and balcony repairs of 2000 disclose no clues of connectors.

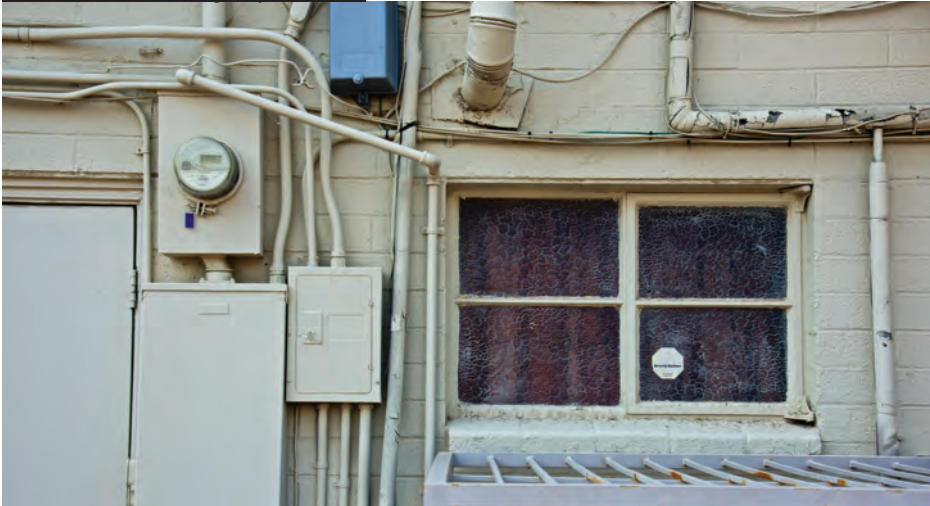
many generations of electrical system modifications are evident on the rear elevation

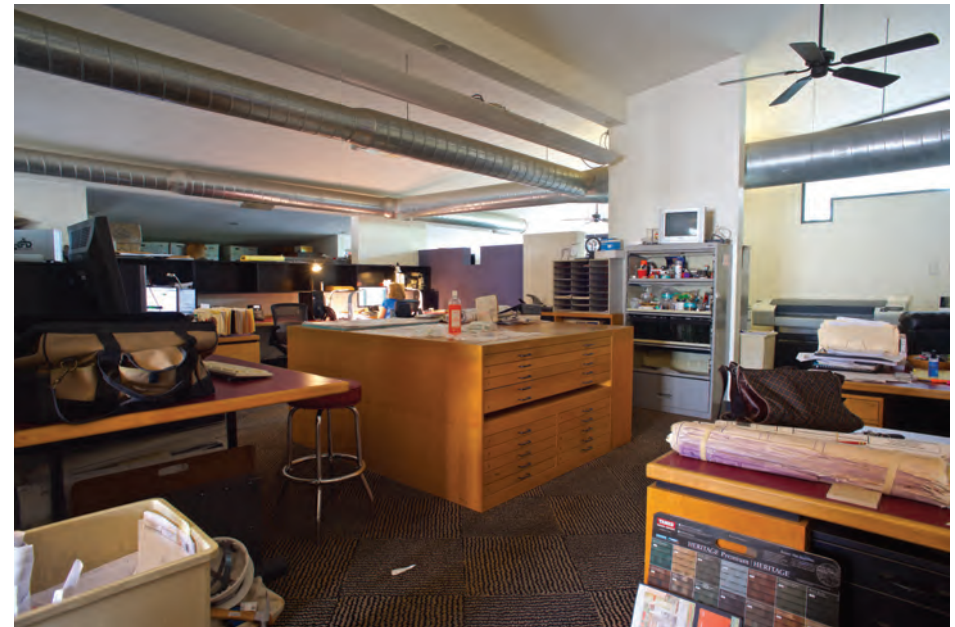
Round air ducts suspended in plain sight within the vaulted ceilings retain the Modern spatial characteristics and systems honesty of Contemporary-style interiors.
