## *DC Ranch – Arcadia at Silver Leaf*

This report is to provide actionable advice regarding the Sissoo trees currently located in Arcadia at Silver Leaf. Of particular concern are the issues that these trees can and will create. These issues include long-term damage to existing roads, hardscapes, walkways, sewer lines, foundations, and nearby landscaping.

**Purpose of Site Assessment-** On May 31, 2021, we had the opportunity to spend several hours walking and driving through the streets of Arcadia. Our goals in doing this assessment were to:

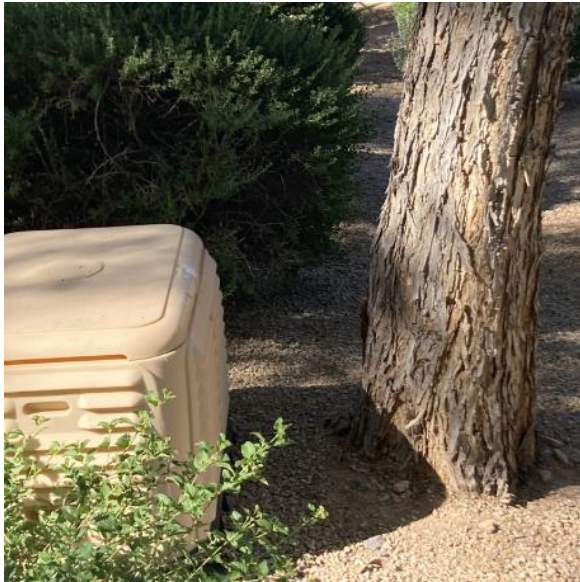
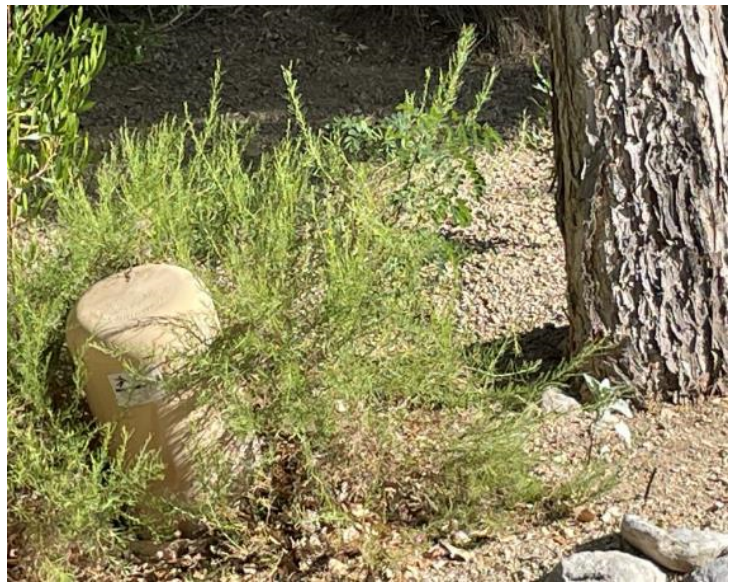
Current damage to infrastructure due to the Roots of Dalbergia Sissoos- It appears there has already been extensive damage to the streets. We found many asphalt patches in the streets where roots swelling underneath have caused cracking and uneven surfaces. Private driveways and walkways also showed cracks and were lifted due to Sissoo roots. These roots have caused uneven surfaces, which could very easily cause a trip hazard and a liability for the HOA. Many residences in the development have retaining walls in their front yards. We observed in several cases that the roots of Sissoos, some planted only 2' from the base of the retaining wall, have begun to create cracks in these walls. The most alarming problem that we observed was the proximity of Sissoo trees to utility boxes, many within a foot or two of a Sissoo. A few utility boxes were lifted on one side already. One resident had recently had the utility lines marked in their yard and in that case the Sissoo trees were growing very near or almost directly next to electrical, cable, and gas lines. Our concern is that the invasive tree roots may damage these critical service lines.

The roots have tilted the service boxes in the pictures below.

**Avoid Future Usage of Sissoos:** We would recommend immediately restricting the use of Sissoos in all new development. We would recommend replacing all the Sissoo trees that are in front of residential homes.

**Summary of our recommendations-** We would recommend removing the Dalbergia Sissoo from the street scapes in Arcadia for the reasons that we have previously stated. The mitigation of root damage by cutting or root barriers, if even possible, will be costly, indefinite and not guarantee success. The cost of removal at this point will be high but less than waiting later as the trees will continue to grow and become more expensive to remove and the damage more extensive to repair.

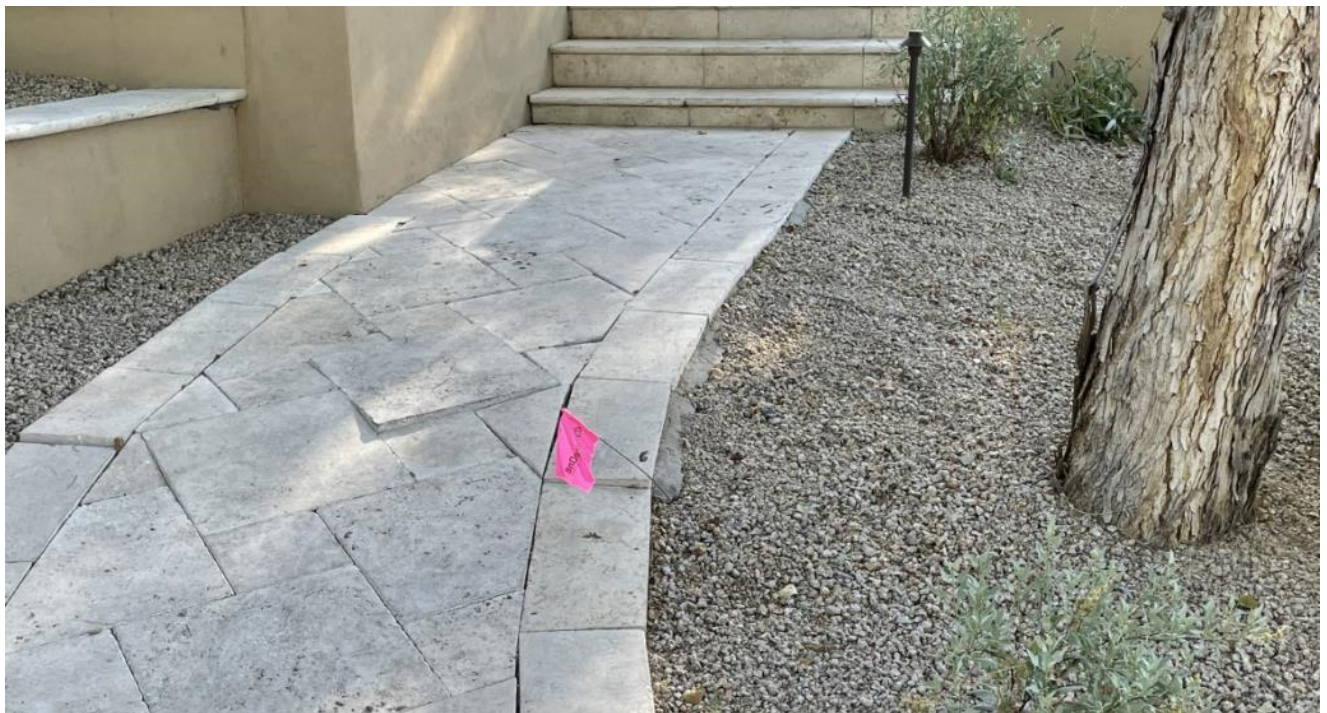
The pavers have been lifted by the tree roots.

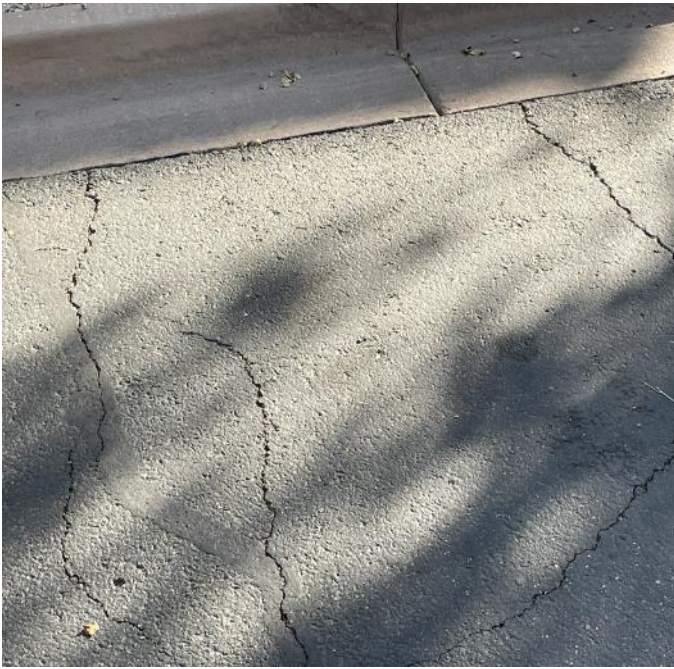
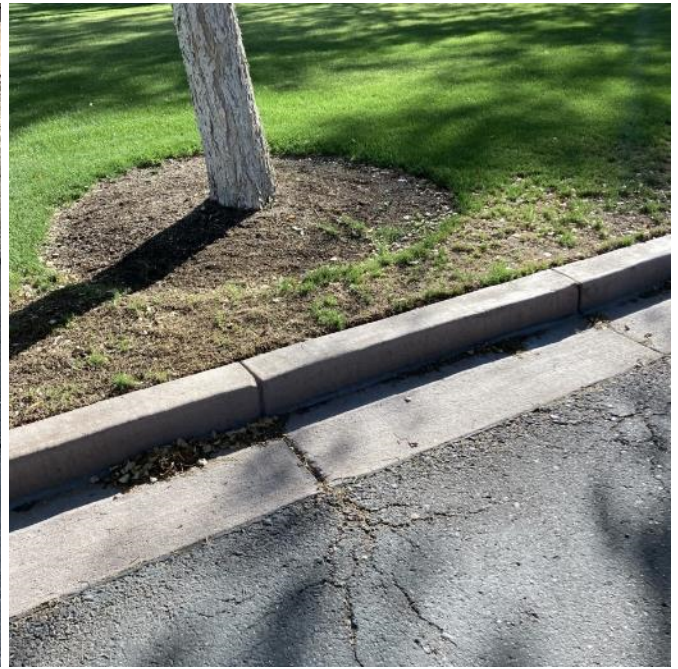
The street damage is caused by the roots of the Sissoo tree seeking moisture.

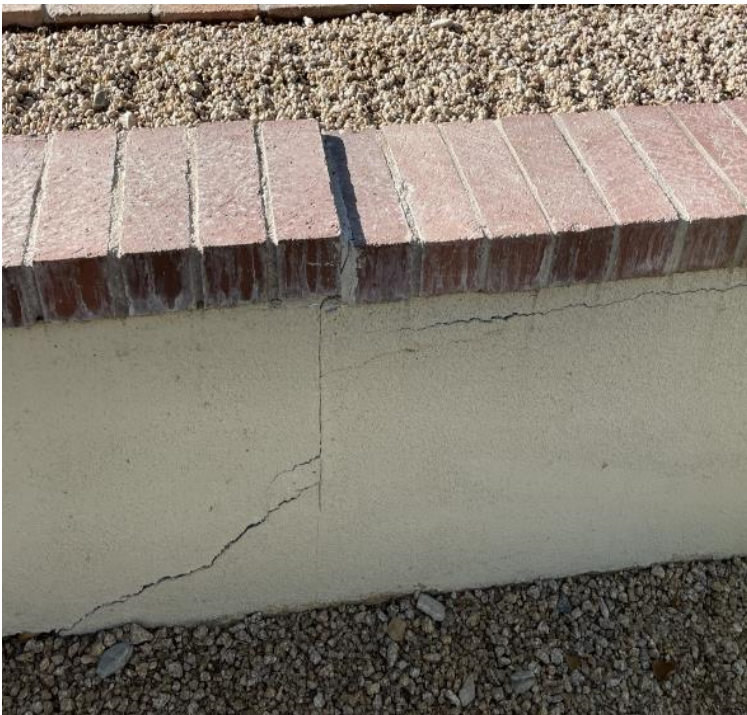
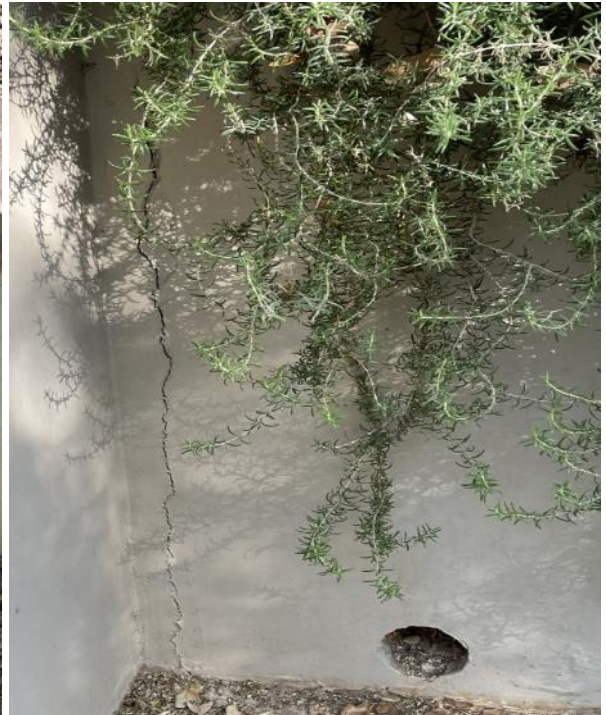
The retaining walls have been damaged by the roots of the Sissoo trees.

The first is that trimming exceptionally large diameter roots one foot from the trunk, as would be needed in the case of the retaining walls and the utility boxes that we mentioned, would be so detrimental to the tree that we suspect the survival rate would be exceptionally low.

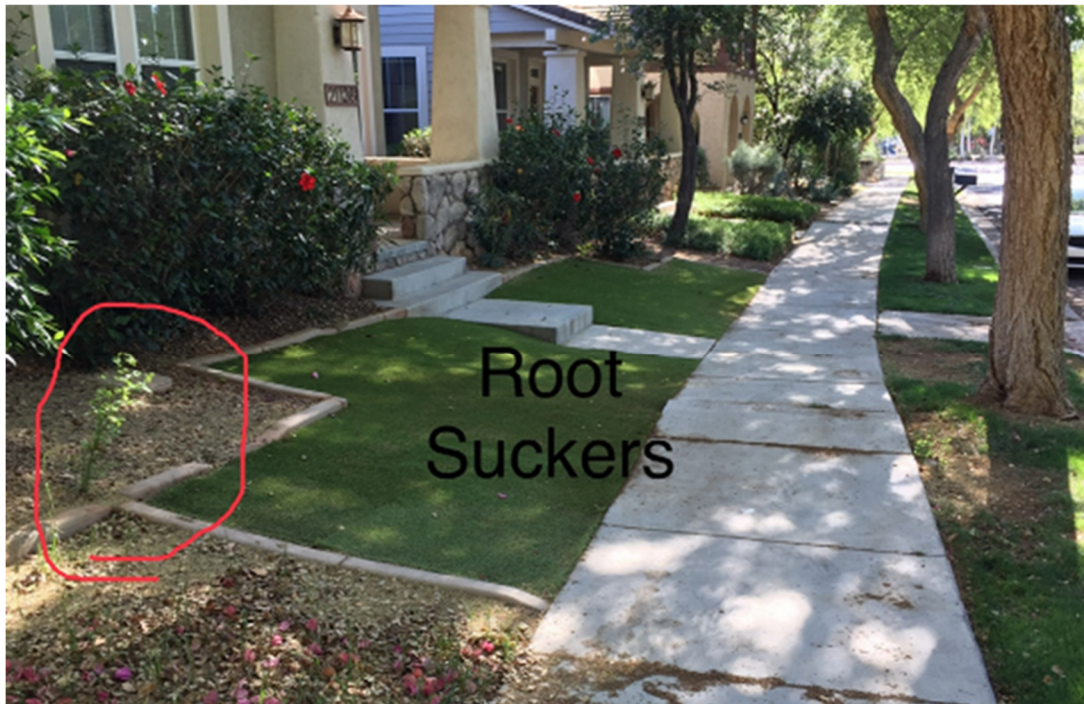
Thirdly, if the root mitigation plan is like what has happened at Verrado (another DMB property), then we have seen that it is not solving the problem of infrastructure and other damage there. Root pruning there has only produced swelling of roots on BOTH sides of the sidewalk and the production of many more root suckers along the entire extensive root system of the tree that has been root pruned. Many suckers pop up in lawns and in the landscapes of private residents where they are creating other maintenance problems.

Below is a picture taken at Verrado where root mitigation was evident. The cutting of the root caused suckers to grow up in the resident's front yard.

**Root Mitigation:** This process does not work and will cause suckers to grow and spread quicker. It has not worked at Verrado or anywhere else with Sissoos.

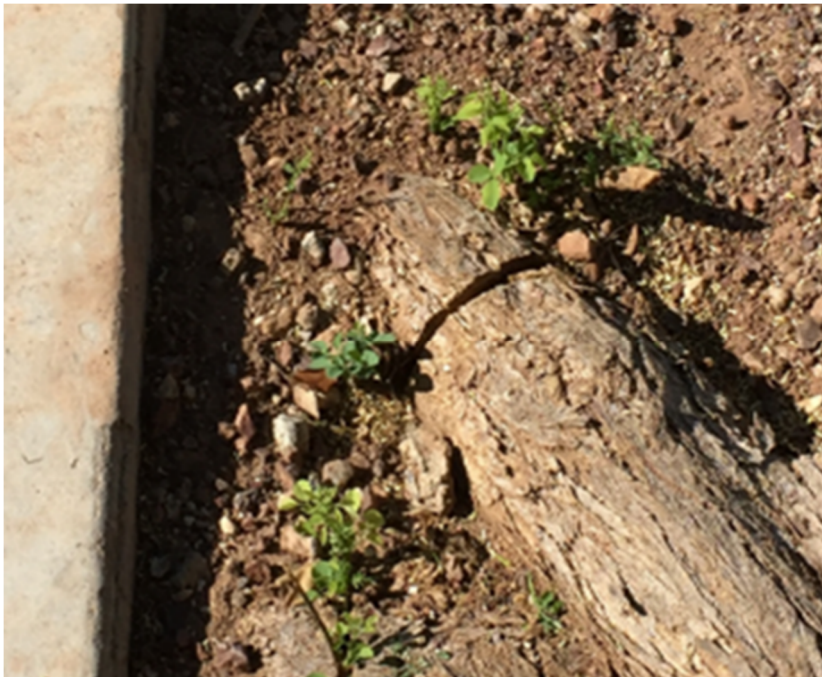
The picture below shows the suckers growing up after the root was cut. Suckers are now growing up on both sides of the cut.
