**INVITATION FOR BID #13PB031**  
**SOUTHWEST WATERLINE UPGRADES**  
**ADDENDUM #2**  
**FEBRUARY 25, 2013**

**The following are the Questions and Answers and additional information that were brought up as a result of the Pre-Bid meeting on 02/14/2013.**

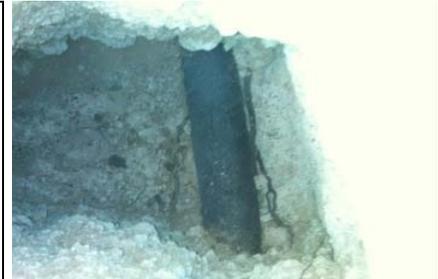
COORDINATES: NORTHING 901407.41 EASTING 686716.40  
 STATIONING: STATION None OFFSET None  
 PAVING THICKNESS 5" PAVING TYPE Asphalt SOIL CONDITION Dirt  
 SIZE 2" TYPE Steel FACILITY OWNER Southwest Gas

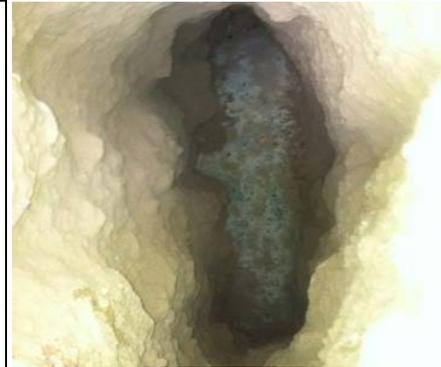
COORDINATES: NORTHING 901403.95 EASTING 686707.67  
 STATIONING: STATION None OFFSET None  
 PAVING THICKNESS 4" PAVING TYPE Asphalt SOIL CONDITION Dirt  
 SIZE 54" TYPE RCP FACILITY OWNER City of Scottsdale Water

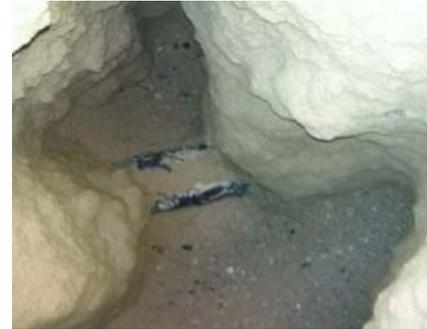
<p><b>SITE BENCHMARK</b>                  BM#2 = BCHH @ 56th St and Thomas Rd                  Elev = 1256.68</p>		<p><b>CROSS SECTION - NOT TO SCALE</b>                  FACING <u>Northeast</u></p>	
<p>SURFACE ELEVATION <u>1276.84</u></p>	<p>← WIDTH/O.D. →  <u>2.38"</u></p>	<p>TOP ELEVATION <u>1274.08</u></p>	<p><u>2.76</u> TOP DEPTH (FEET)</p>
<p>BOTTOM ELEVATION <u>1273.88</u></p>	<p>○</p>	<p><u>2.96</u> BOTTOM (FEET)</p>	
<p>RIBBON COLOR <u>Yellow</u></p>

COORDINATES: NORTHING 901083.76 EASTING 687594.23  
 STATIONING: STATION None OFFSET None  
 PAVING THICKNESS None PAVING TYPE None SOIL CONDITION Dirt  
 SIZE 2" TYPE Steel FACILITY OWNER Southwest Gas

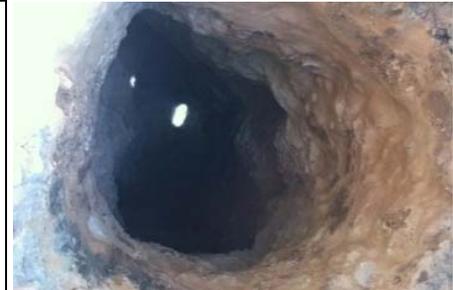
COORDINATES: NORTHING 901415.64 EASTING 687666.75  
 STATIONING: STATION None OFFSET None  
 PAVING THICKNESS 4" PAVING TYPE Asphalt SOIL CONDITION Dirt  
 SIZE See Comments TYPE See Comments FACILITY OWNER City of Scottsdale Water

Found poured concrete on elbow of water line. Unable to find edges or bottom of concrete.

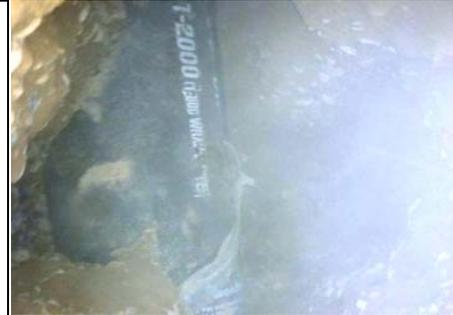
COORDINATES: NORTHING 942590.57 EASTING 702167.15  
 STATIONING: STATION None OFFSET None  
 PAVING THICKNESS 3" PAVING TYPE Asphalt SOIL CONDITION Dirt  
 SIZE 8" TYPE DIP FACILITY OWNER City of Scottsdale Water

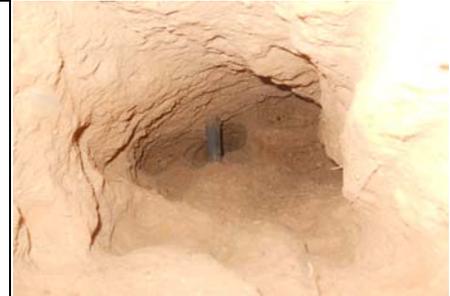
<p style="text-align: center;"><b>SITE BENCHMARK</b></p> <p>BM#1 = BCFL @ Miller Rd and Shea Blvd                  Elev = 1354.84</p>	<p style="text-align: center;"><b>CROSS SECTION - NOT TO SCALE</b></p> <p style="text-align: center;">FACING <u>North</u></p>

COORDINATES: NORTHING 942393.03 EASTING 701125.92  
 STATIONING: STATION None OFFSET None  
 PAVING THICKNESS None PAVING TYPE None SOIL CONDITION Dirt  
 SIZE 3/4" TYPE PE FACILITY OWNER Century Link Communications

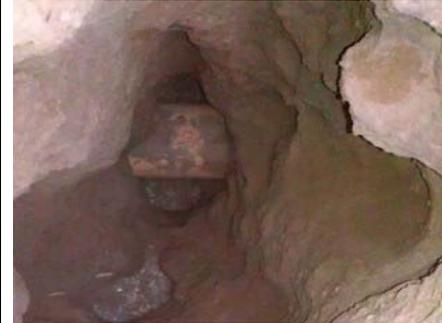
<p style="text-align: center;"><b>SITE BENCHMARK</b></p> <p>BM#1 = BCFL @ Miller Rd and Shea Blvd                  Elev = 1354.84</p>	<p style="text-align: center;"><b>CROSS SECTION - NOT TO SCALE</b></p> <p style="text-align: center;">FACING <u>East</u></p>

COORDINATES: NORTHING 943826.83 EASTING 701400.40  
 STATIONING: STATION None OFFSET None  
 PAVING THICKNESS 3" PAVING TYPE Asphalt SOIL CONDITION Dirt  
 SIZE 2" TYPE Steel FACILITY OWNER Southwest Gas

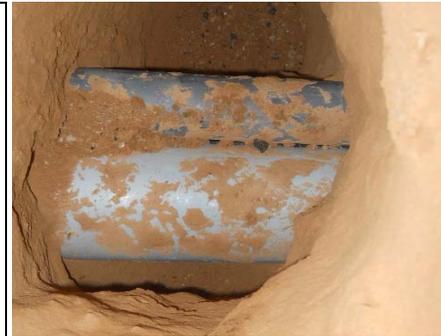
COORDINATES: NORTHING 944544.90 EASTING 701383.69  
 STATIONING: STATION None OFFSET None  
 PAVING THICKNESS 5" PAVING TYPE Asphalt SOIL CONDITION Dirt  
 SIZE See Comments TYPE PVC FACILITY OWNER APS/COX

COMMENTS:  
 Found one 4" and one 2" PVC in a bundle. Blue Stake marks for both APS and COX, joint trench.

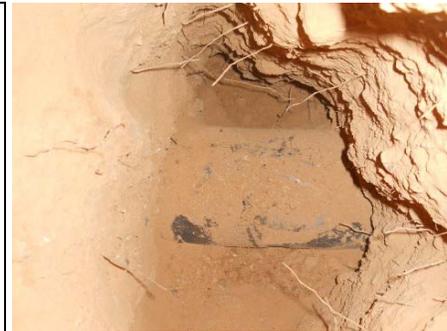
COORDINATES: NORTHING 944552.25 EASTING 701383.72  
 STATIONING: STATION None OFFSET None  
 PAVING THICKNESS 5" PAVING TYPE Asphalt SOIL CONDITION Dirt  
 SIZE 4" TYPE Steel FACILITY OWNER Southwest Gas

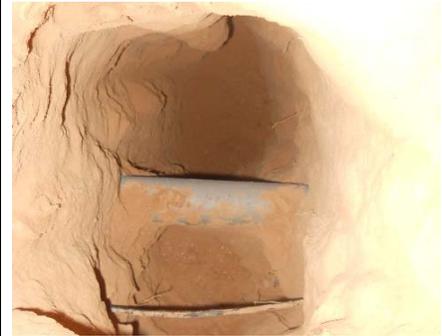
COORDINATES: NORTHING 944553.84 EASTING 701383.69  
 STATIONING: STATION None OFFSET None  
 PAVING THICKNESS 5" PAVING TYPE Asphalt SOIL CONDITION Dirt  
 SIZE 2" TYPE PVC FACILITY OWNER Unknown

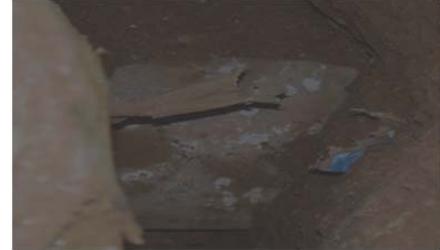
<p style="text-align: center;"><b>SITE BENCHMARK</b></p> <p>BM#1 = BCFL @ Miller Rd and Shea Blvd                  Elev = 1354.84</p>	<p style="text-align: center;"><b>CROSS SECTION - NOT TO SCALE</b></p> <p style="text-align: center;">FACING <u>East</u></p>

COORDINATES: NORTHING 939578.04 EASTING 700438.16  
 STATIONING: STATION None OFFSET None  
 PAVING THICKNESS None PAVING TYPE None SOIL CONDITION Dirt  
 SIZE 4" TYPE ACP FACILITY OWNER City of Scottsdale Water

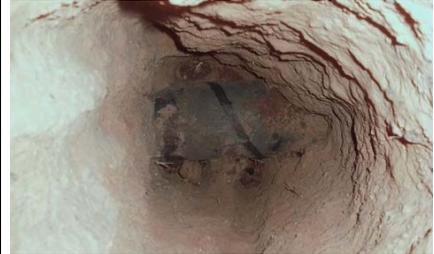
<p><b>SITE BENCHMARK</b>                  BM#1 = BCFL @ Miller Rd and Shea Blvd                  Elev = 1354.84</p>		<p><b>CROSS SECTION - NOT TO SCALE</b></p> <p>FACING <u>East</u></p> <p>SURFACE ELEVATION <u>1357.56</u></p> <p>TOP ELEVATION <u>1352.64</u></p> <p>BOTTOM ELEVATION <u>1357.56</u></p> <p>WIDTH/O.D. <u>4.5"</u></p> <p>TOP DEPTH (FEET) <u>4.92</u></p> <p>BOTTOM (FEET)</p>	
<p>RIBBON COLOR <u>Yellow</u></p>

COORDINATES: NORTHING 939270.52 EASTING 701921.85  
 STATIONING: STATION None OFFSET None  
 PAVING THICKNESS 5" PAVING TYPE Asphalt SOIL CONDITION Dirt  
 SIZE 4" TYPE Steel FACILITY OWNER Southwest Gas

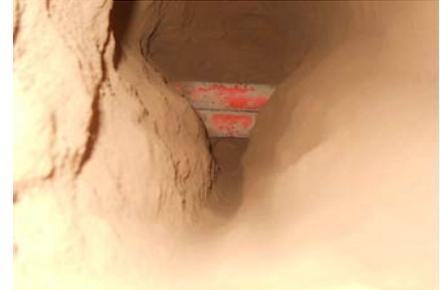
<p><b>SITE BENCHMARK</b>                  BM#1 = BCFL @ Miller Rd and Shea Blvd                  Elev = 1354.84</p>		<p><b>CROSS SECTION - NOT TO SCALE</b></p> <p>FACING <u>East</u></p>	
<p>RIBBON COLOR <u>Orange</u></p>		<p>SURFACE ELEVATION <u>1354.98</u></p>	<p>WIDTH/O.D. <u>4"</u></p>
<p>COORDINATES: NORTHING <u>939313.44</u></p>		<p>TOP ELEVATION <u>1350.40</u></p>	<p><u>4.58</u> TOP DEPTH (FEET)</p>
<p>STATIONING: STATION <u>None</u></p>		<p>BOTTOM ELEVATION <u>1350.26</u></p>	<p><u>4.72</u> BOTTOM (FEET)</p>
<p>PAVING THICKNESS <u>4"</u> PAVING TYPE <u>Asphalt</u></p>		<p>SOIL CONDITION <u>Dirt</u></p>	
<p>SIZE <u>Two 1.25"</u> TYPE <u>PE</u></p>		<p>FACILITY OWNER <u>City of Scottsdale Fiber Optic</u></p>

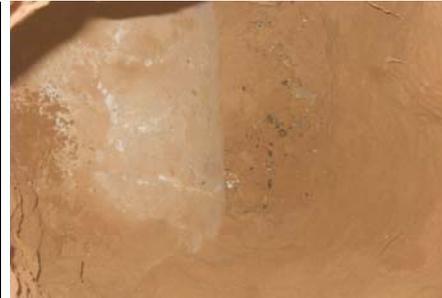
SITE BENCHMARK	CROSS SECTION - NOT TO SCALE												
<p>BM#1 = BCFL @ MILLER RD AND SHEA BLVD</p> <p>ELEV. = 1354.84</p>	<p>FACING <u>West</u></p>

COORDINATES: NORTHING 939288.45 EASTING 700049.45  
 STATIONING: STATION None OFFSET None  
 PAVING THICKNESS 4" PAVING TYPE Asphalt SOIL CONDITION Dirt  
 SIZE 12" TYPE ACP FACILITY OWNER City of Scottsdale Water

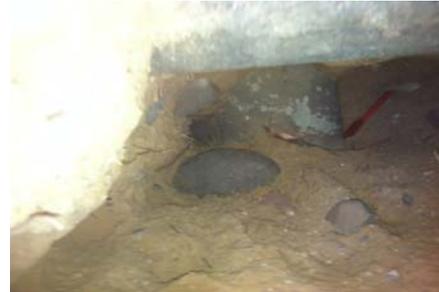
COORDINATES: NORTHING 942286.30 EASTING 701134.79  
 STATIONING: STATION None OFFSET None  
 PAVING THICKNESS None PAVING TYPE None SOIL CONDITION Dirt / Rocks  
 SIZE 8" TYPE DIP FACILITY OWNER City of Scottsdale Water

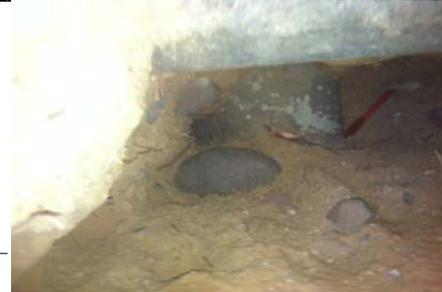
COORDINATES: NORTHING 942286.30 EASTING 701134.79  
 STATIONING: STATION None OFFSET None  
 PAVING THICKNESS None PAVING TYPE None SOIL CONDITION Dirt / Rocks  
 SIZE 6" TYPE DIP FACILITY OWNER City of Scottsdale Water

Found in same hole as #2.

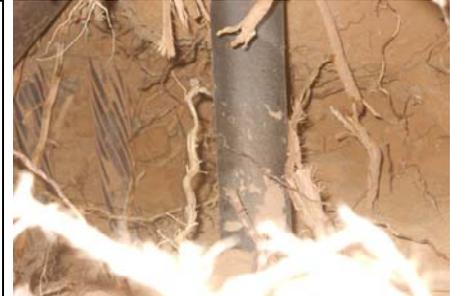
SITE BENCHMARK	CROSS SECTION - NOT TO SCALE	
<u>BM#1 = BCFL @ MILLER RD AND SHEA BLVD</u>	FACING <u>North</u>	
<u>ELEV. = 1354.84</u>	SURFACE ELEVATION <u>1355.95</u>	<p>WIDTH/O.D. <u>2"</u></p> <p><u>3.20</u> TOP DEPTH (FEET)</p> <p><u>3.37</u> BOTTOM (FEET)</p>
	TOP ELEVATION <u>1352.75</u>	
	BOTTOM ELEVATION <u>1352.58</u>	
RIBBON COLOR <u>Orange</u>

COORDINATES: NORTHING 939568.36 EASTING 700907.62  
 STATIONING: STATION None OFFSET None  
 PAVING THICKNESS None PAVING TYPE None SOIL CONDITION Dirt  
 SIZE 2" TYPE PE FACILITY OWNER Century Link
