| NO. | DATE | DESCRIPTION | BY |
|---|---|---|---|
| THE VANGUARD GROUP<br>THE NORTHSIGHT OFFICE CAMPUS<br>SCOTTSDALE, AZ. | | | |
| EXTERIOR SLATE TILE REPAIR | | | |
| REPAIR SECTIONS & DETAILS | | | |
| DRAWN<br>JAB | CHECKED<br>AR | APPROVED<br>JBC | DRAWING NO.<br>104 |

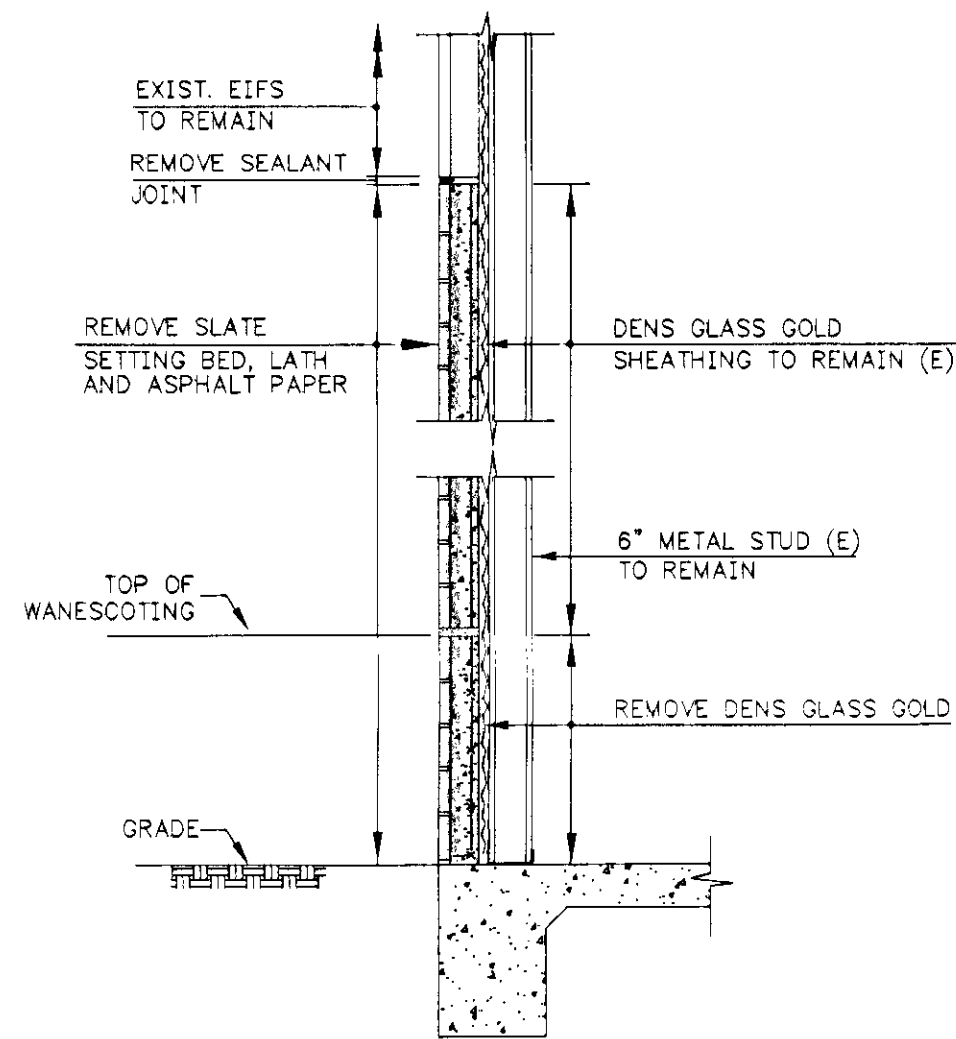
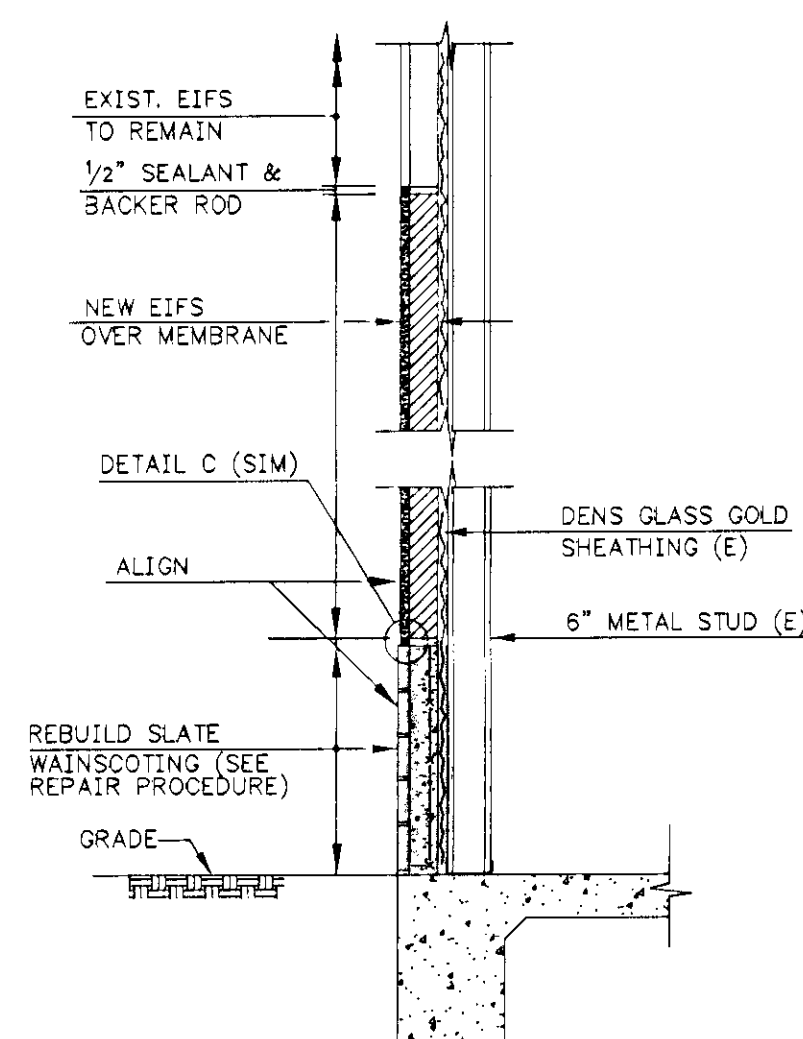
**SECTION 2/104**  
SCALE: 1/2"=1'-0"

**DEMOLITION**

**REBUILD**

- 1) REMOVE AND DISPOSE OF ALL EXISTING SLATE TILE.
- 2) REMOVE ALL EXISTING SETTING BED, METAL LATH, AND ASPHALT PAPER, AND DENS GLASS GOLD
- 3) INSTALL NEW 1/2" CEMENT BOARD, SETTING BED, METAL LATH, AND WATERPROOFING.
- 4) INSTALL NEW SLATE TILE ON SETTING BED APPLY WITH NOTCHED TROWEL AND BACK BUTTER.
- 5) GROUT SLATE TILE JOINTS AND CLEAN.
- 6) INSTALL EIFS AND SEALANT.

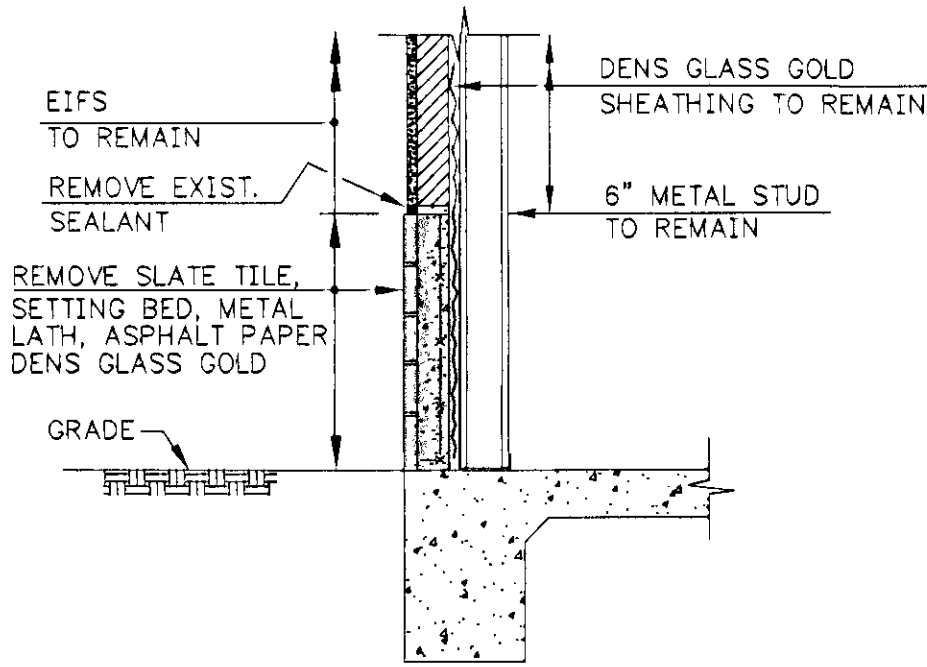
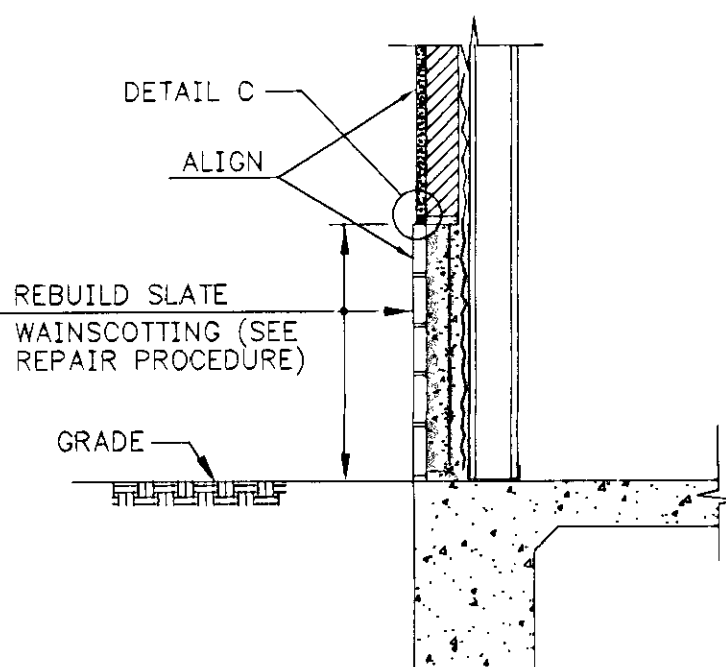
**SECTION 3/104**  
SCALE: 1/2"=1'-0"

**DEMOLITION**

**REBUILD**

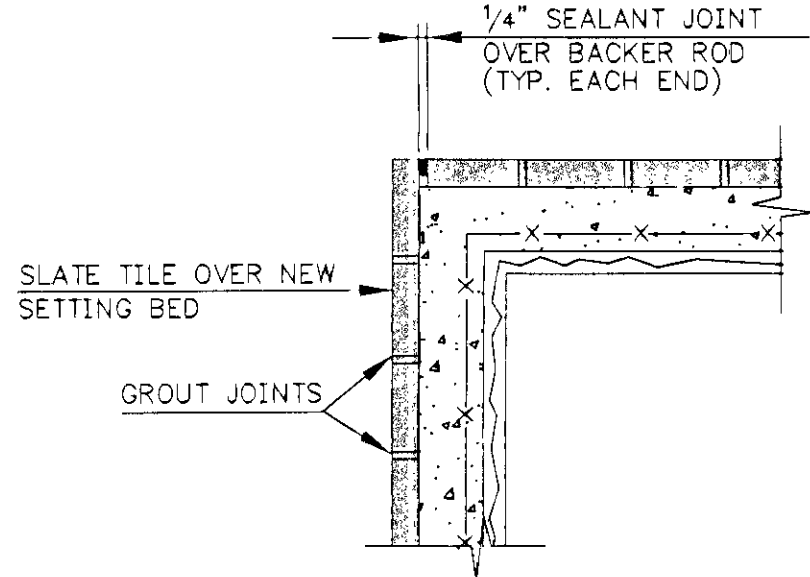
**DETAIL 'A'**  
SCALE: 1"=1'-0"

**WAINSCOTING OUTSIDE CORNER**

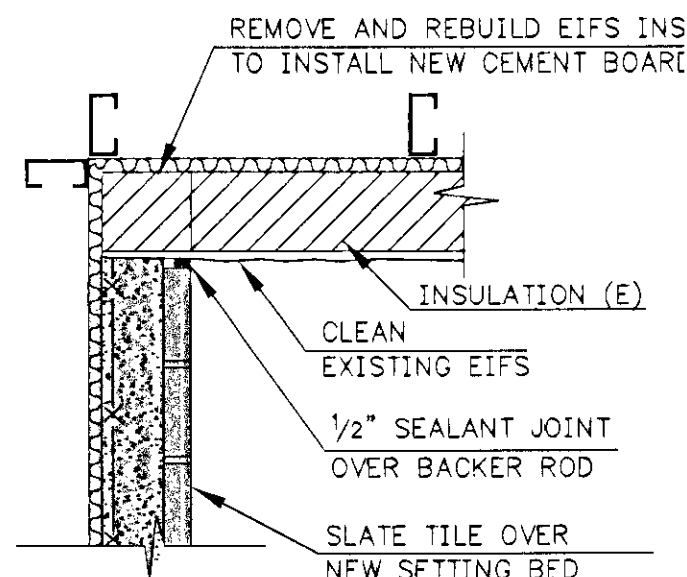
**DETAIL 'B'**  
SCALE: 1"=1'-0"

**WAINSCOTING INSIDE CORNER**

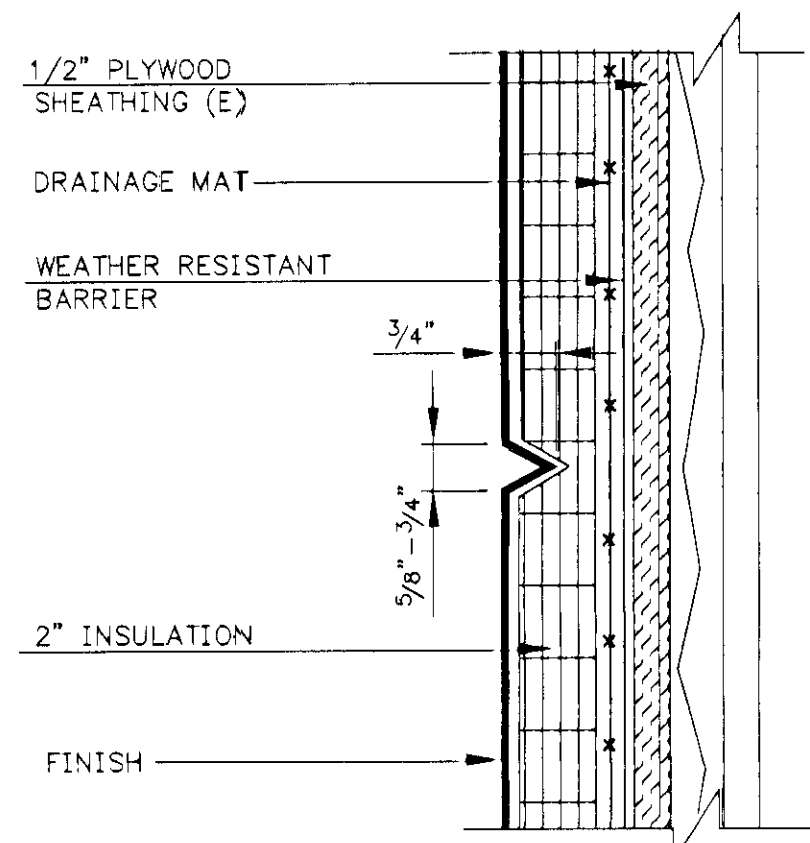
**DETAIL 'D'**  
SCALE: 1/2"=1'-0"  
**NEW REVEAL IN EIFS**
