NATIVE PLANT INVENTORY
TREE RELOCATORS, INC.
 6502 N. 81st Place Scottsdale, AZ 85250
 Office: 480-947-6118
 Toll Free: 800-361-4824
 Fax: 480-361-4824
 treerelocators@cox.net

Subject: Westland Resources, Inc.
 Parcel 1 & Parcel 2
 SW Corner First Street & Goldwater Blvd.

WINERY SUITES OF SCOTTSDALE
 6961 E 1ST ST. SCOTTSDALE, AZ 85251

AERIAL VIEW WITH NATIVE PLANT INVENTORY PLAN

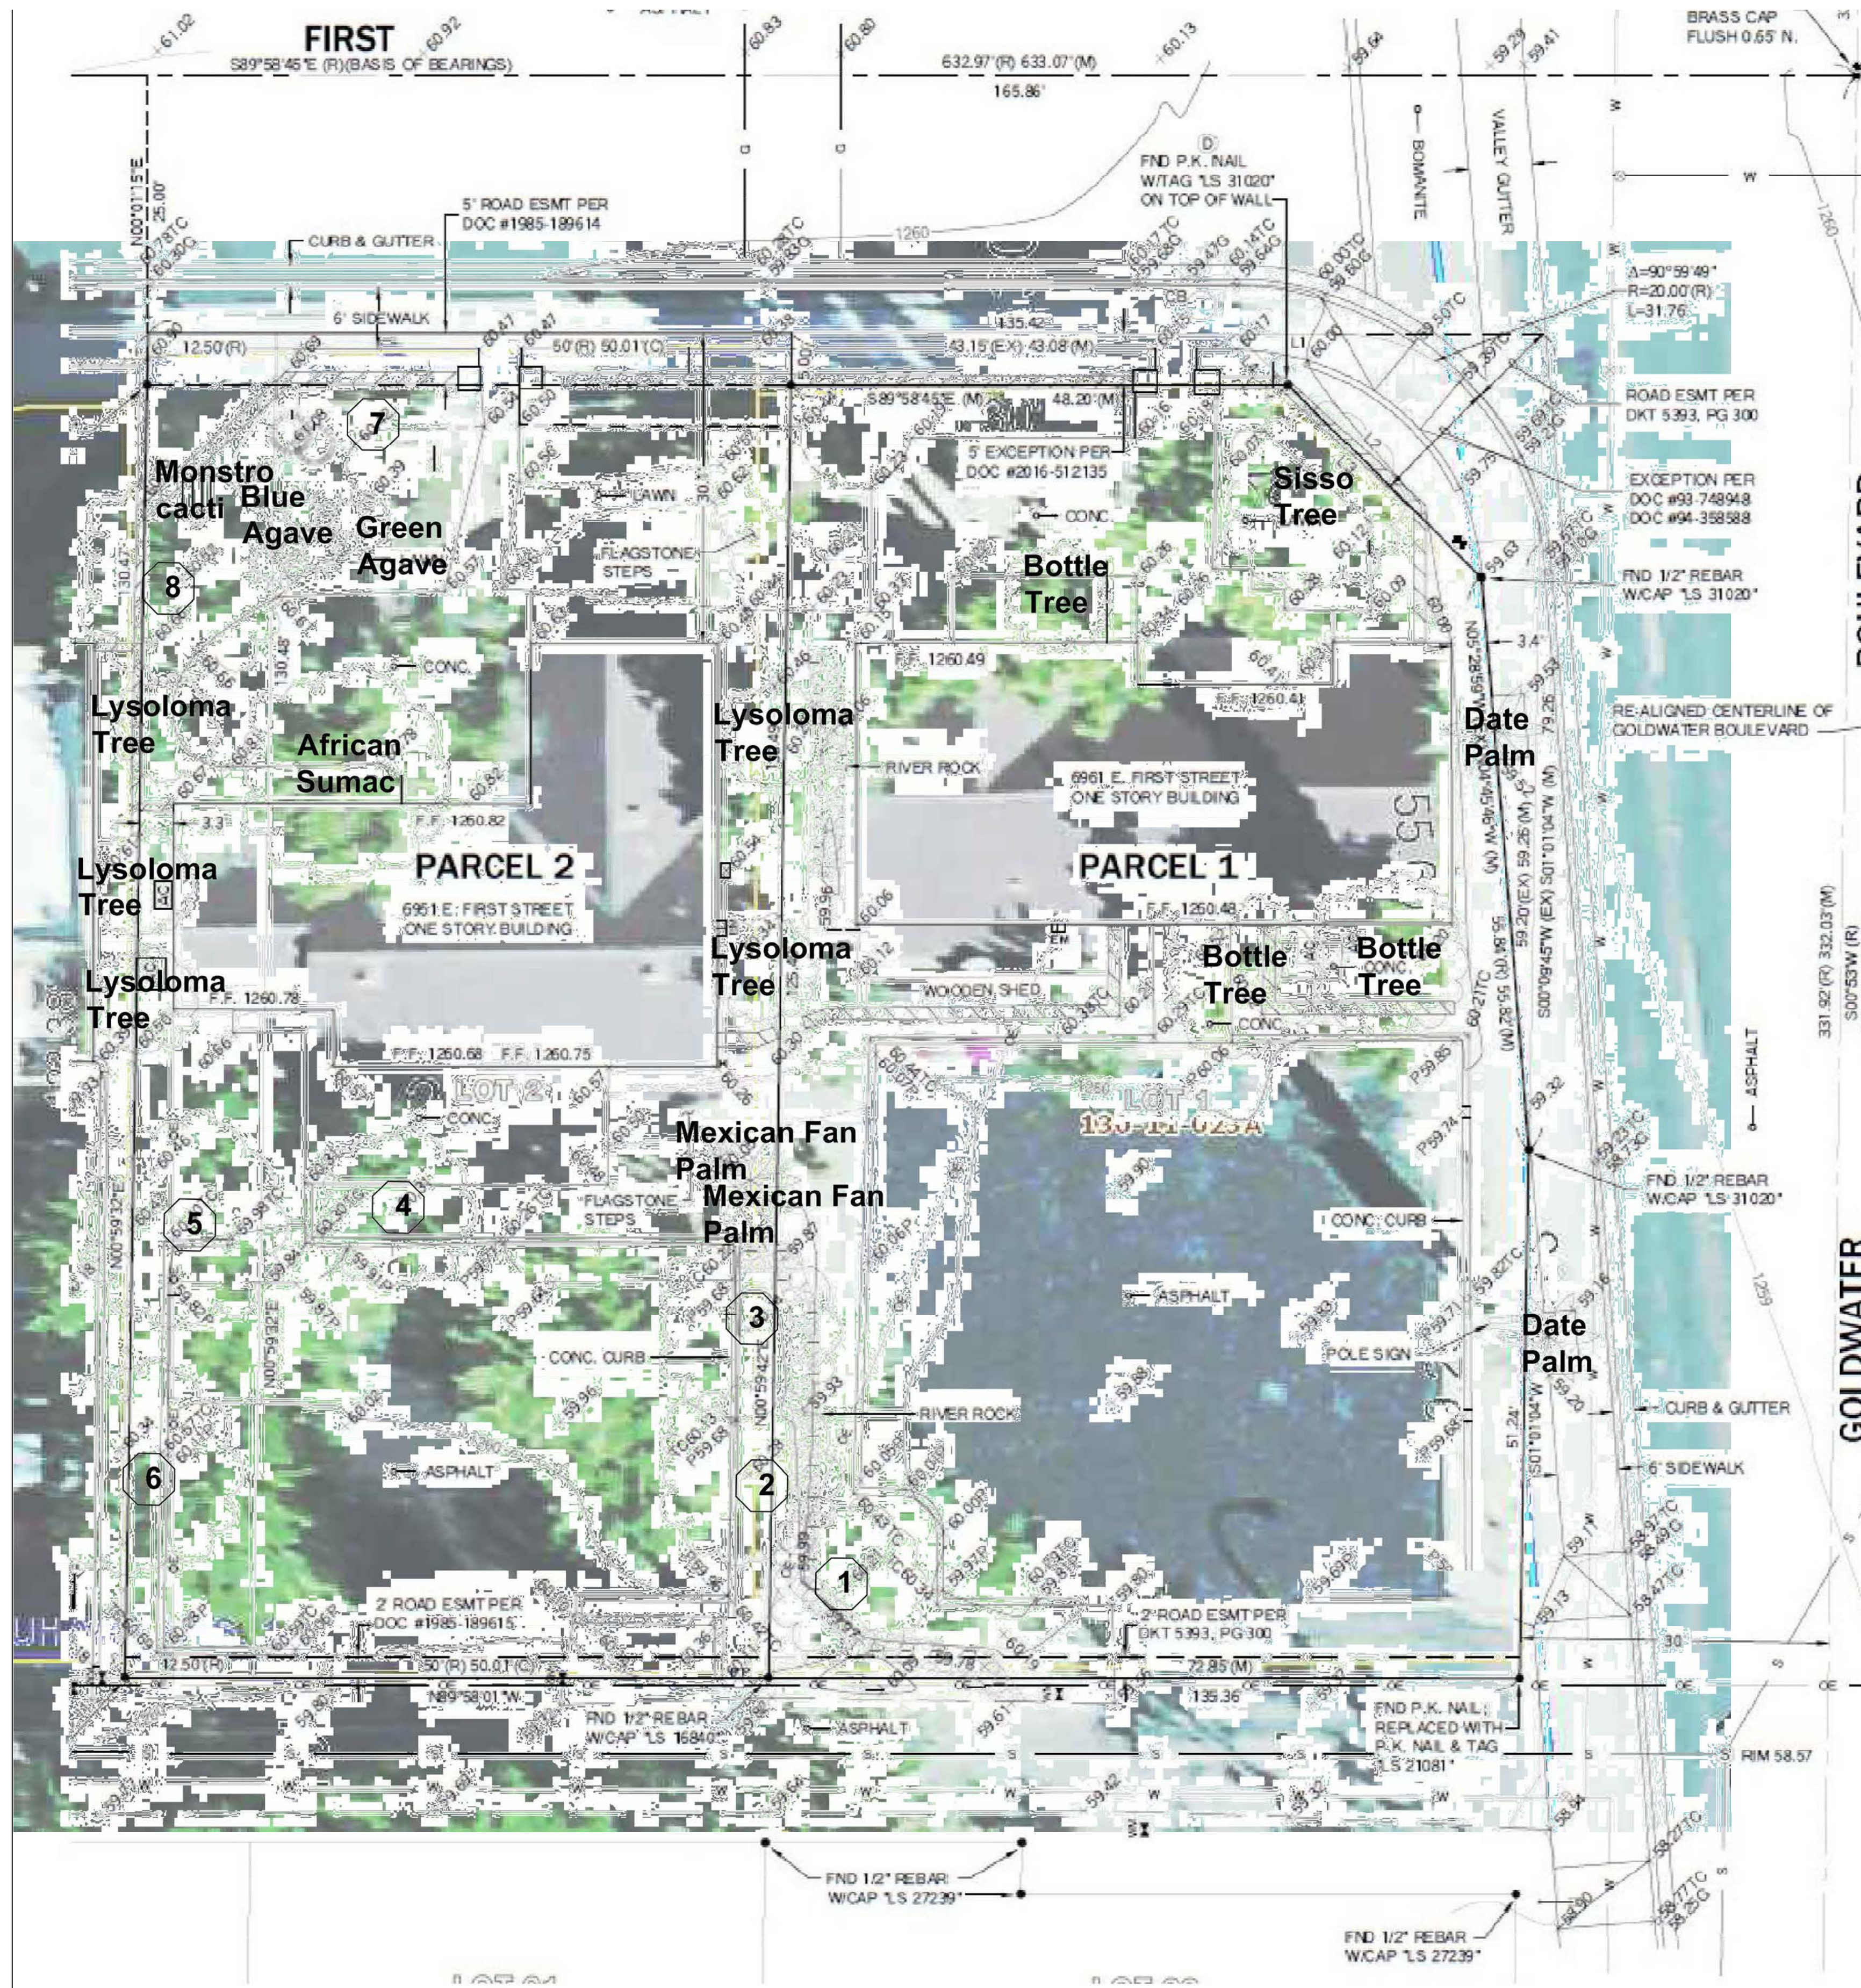
Remarks: I have looked over the native plants on site at the described location. I have determined that:

Tag#	Size	Species	Condition	Disposition	# Arms	Height	Width	Comments
1	10"	Mesquite	Poor	Unsalvageable				Structure
2	14"	Mesquite	Poor	Unsalvageable				Exposed Roots
3	14"	Mesquite	Poor	Unsalvageable				Angled Trunk
4	10"	Mesquite	Good	Salvageable				
5	17"	Mesquite	Poor	Unsalvageable				Split Trunk
6	17"	Mesquite	Poor	Unsalvageable				Angled Trunk
7	6.5"	Cercus Cacti	Poor	Unsalvageable				Disease
8	15"	Mesquite	Poor	Unsalvageable				Angled Trunk

Indicates Existing Native Plant

Plant Totals	Tree	Cacti
Remain in Place	0 0%	0 0%
Salvage	1 14%	0 0%
Destroy	6 86%	1 100%
Total	7	1

NOTE: The construction of the proposed underground garage will cause the entire site to be excavated and disturbed, leaving no room for a temporary nursery. The salvaged tree will be removed from site so as not to be damaged during construction.

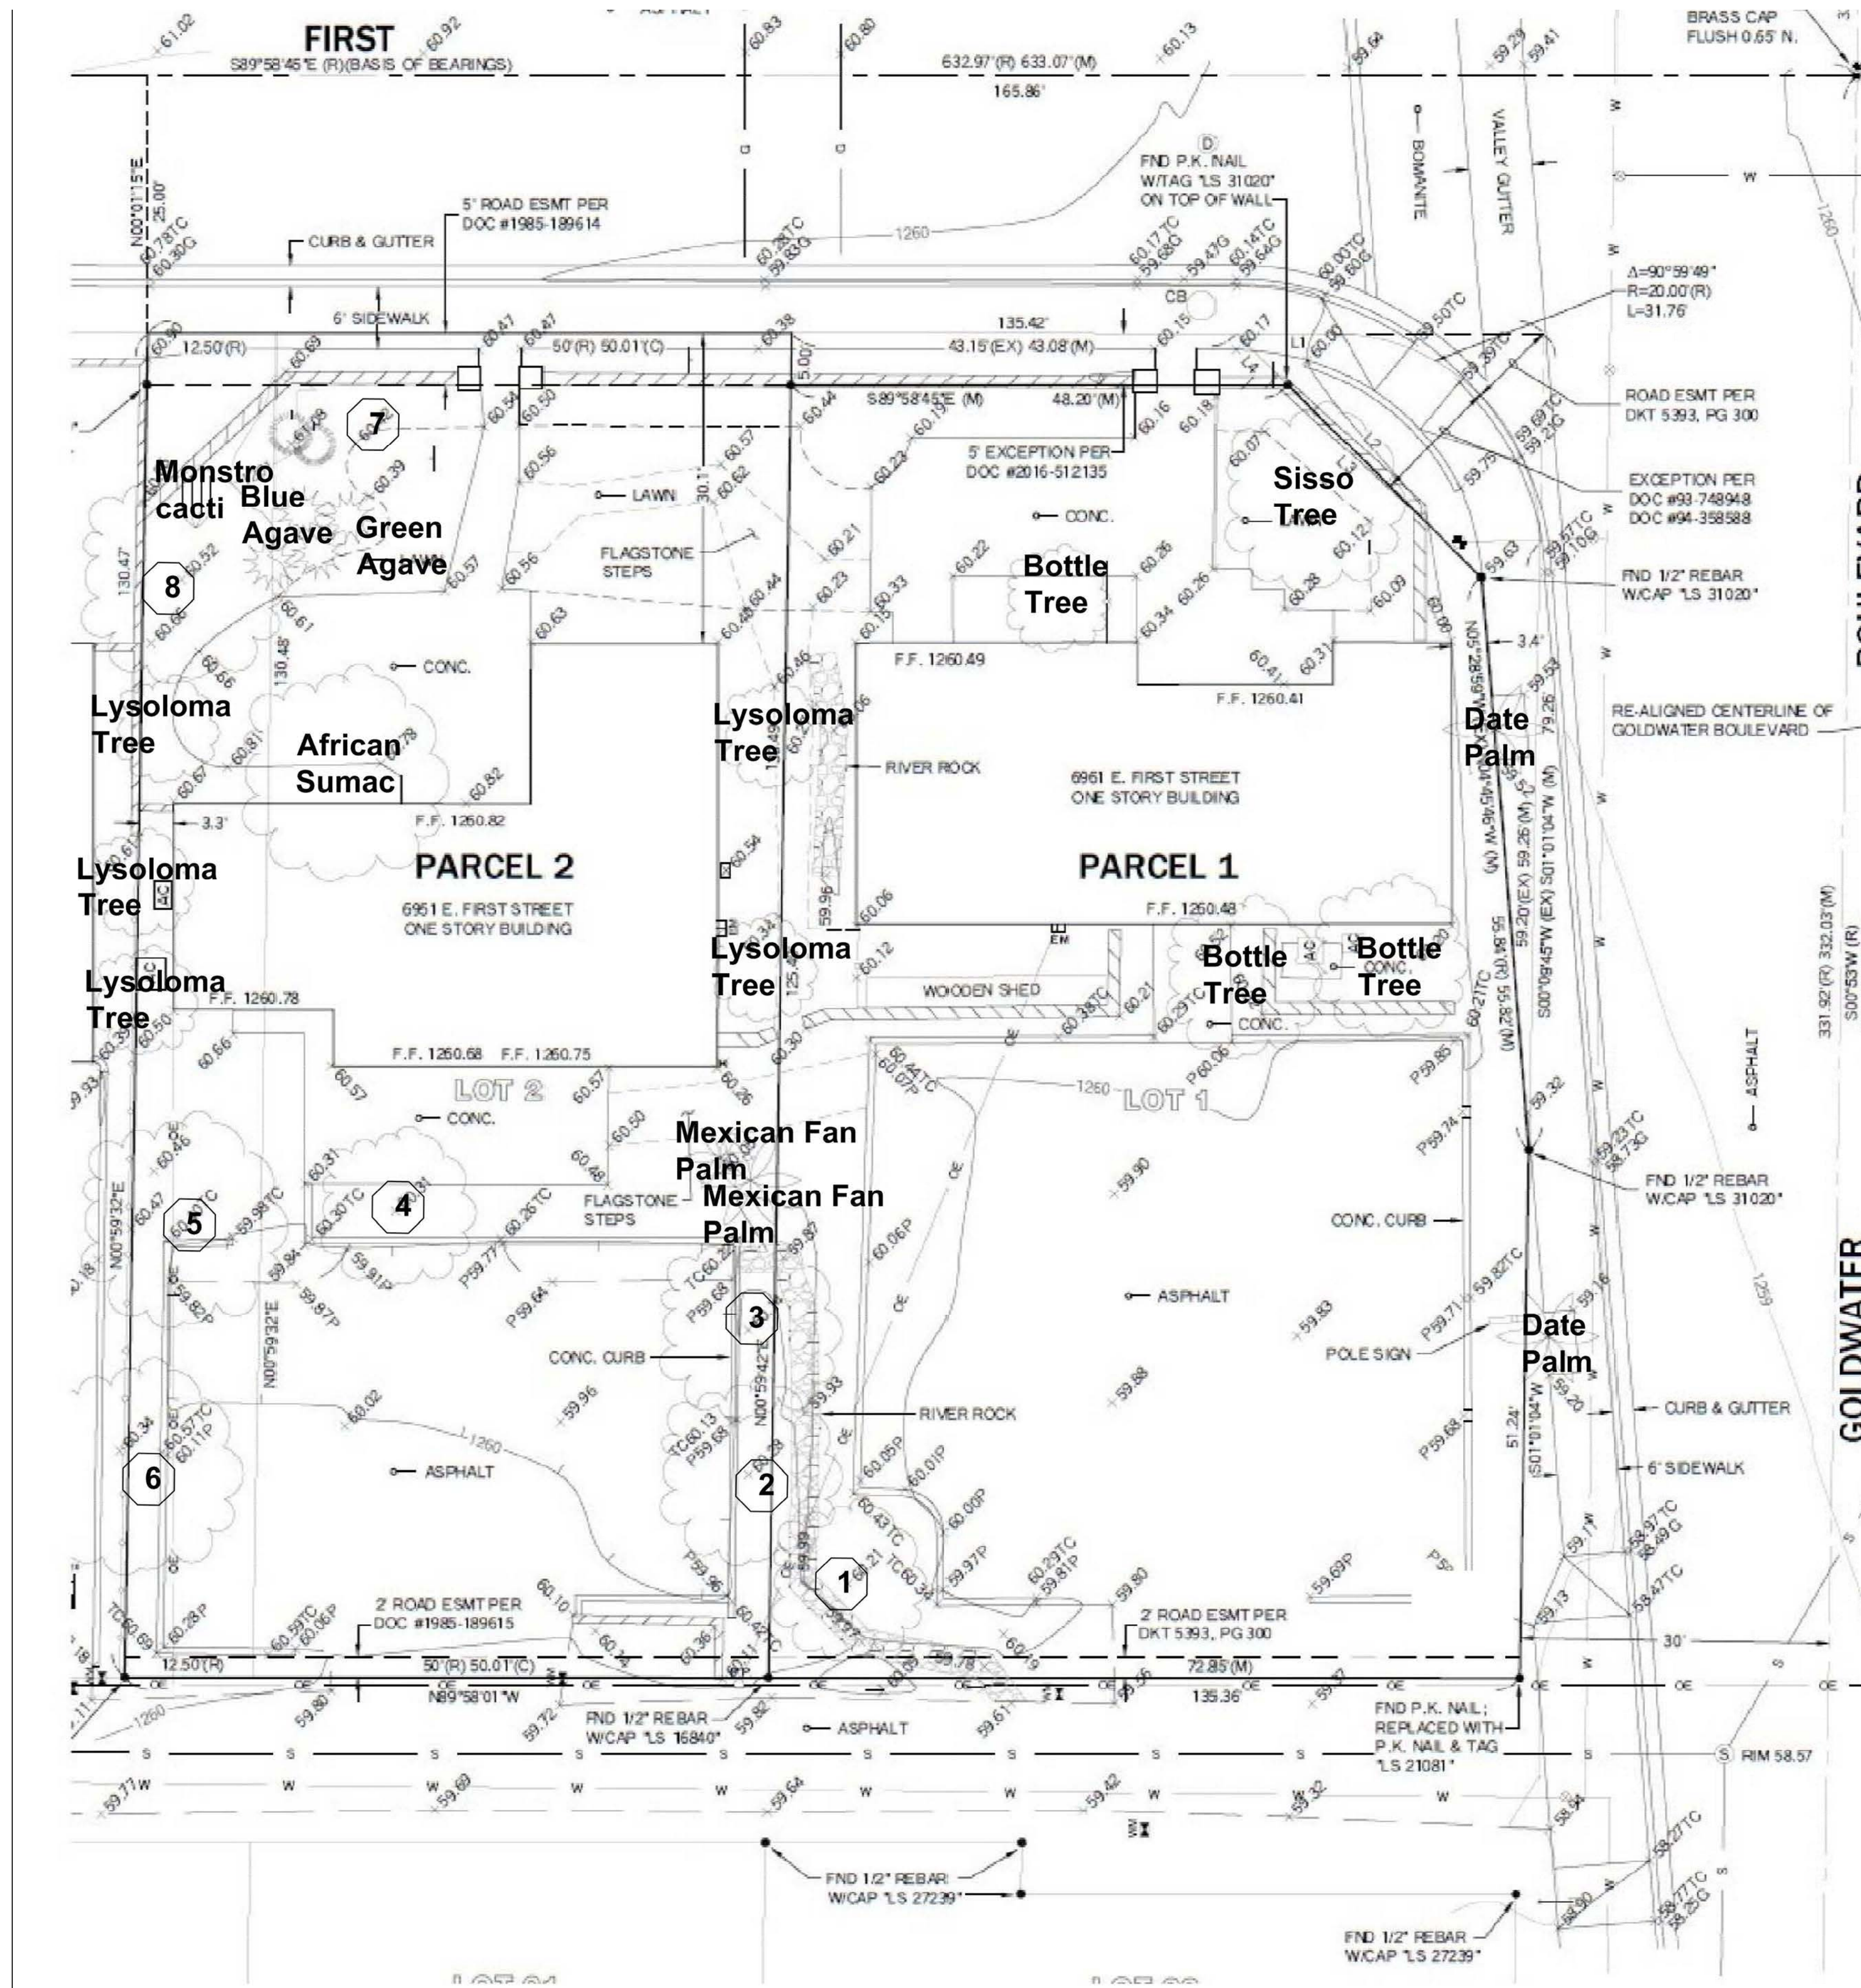
SITE SURVEY PLANT WITH NATIVE PLANT INVENTORY PLAN

Remarks: I have looked over the native plants on site at the described location. I have determined that:

Tag#	Size	Species	Condition	Disposition	# Arms	Height	Width	Comments
1	10"	Mesquite	Poor	Unsalvageable				Structure
2	14"	Mesquite	Poor	Unsalvageable				Exposed Roots
3	14"	Mesquite	Poor	Unsalvageable				Angled Trunk
4	10"	Mesquite	Good	Salvageable				
5	17"	Mesquite	Poor	Unsalvageable				Split Trunk
6	17"	Mesquite	Poor	Unsalvageable				Angled Trunk
7	6.5"	Cercus Cacti	Poor	Unsalvageable				Disease
8	15"	Mesquite	Poor	Unsalvageable				Angled Trunk

Indicates Existing Native Plant

Plant Totals	Tree	Cacti
Remain in Place	0 0%	0 0%
Salvage	1 14%	0 0%
Destroy	6 86%	1 100%
Total	7	1

NOTE: The construction of the proposed underground garage will cause the entire site to be excavated and disturbed, leaving no room for a temporary nursery. The salvaged tree will be removed from site so as not to be damaged during construction.
