# HISTORIC PRESERVATION COMMISSION REPORT

**Case Name:** The Kimsey Building Historic Preservation Plan

**Case Number:** 55-HP-2021

**Location:** 7120 E Indian School Rd

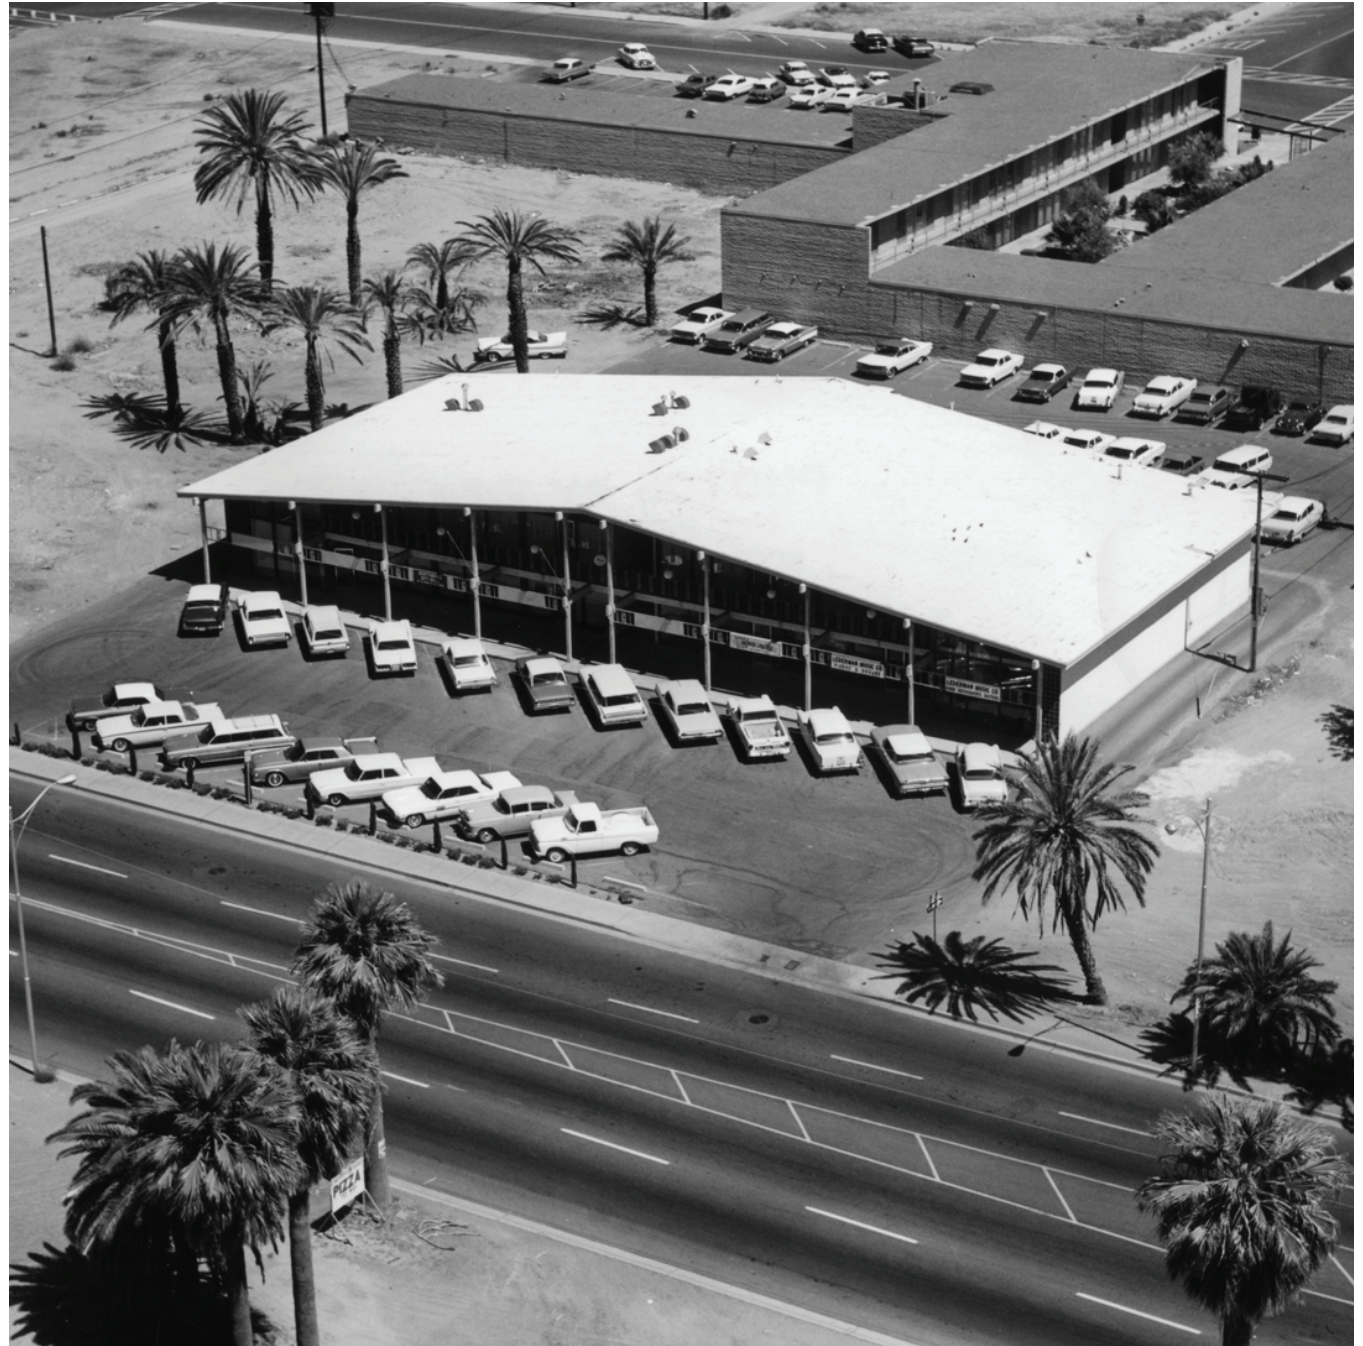
*Oblique aerial view of the Kimsey Building in about 1963 when occupied by Scottsdale City Hall, Lederman Music, and Olan Mill Photography.*

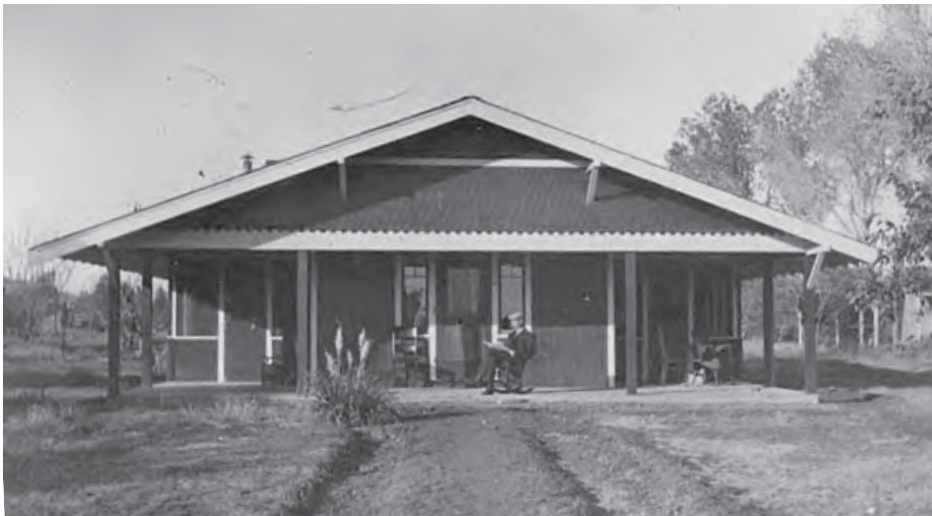
Elizabeth & William E. Kimsey farmhouse, circa 1916, was demolished in 1961 for construction of the Kimsey Building. (Scottsdale Heritage Collection at the Scottsdale Public Library; SCOT-SHS-2012-0156A)

The most obvious visual aspect of the Kimsey Building is its iconic isosceles triangular shape of the roof and its symmetrical façade with a central breezeway. But what inspired that triangular form? Kimsey family lore and historic archival research bring forth a historic photograph of Mr. & Mrs. William E. Kimsey's modest one-story, wood-frame farmhouse in about 1916.

Amazingly, the front façade of the little Kimsey cottage possessed character-defining patterns that can still be seen in the front façade of the Kimsey Building. The now missing cottage was comprised of:

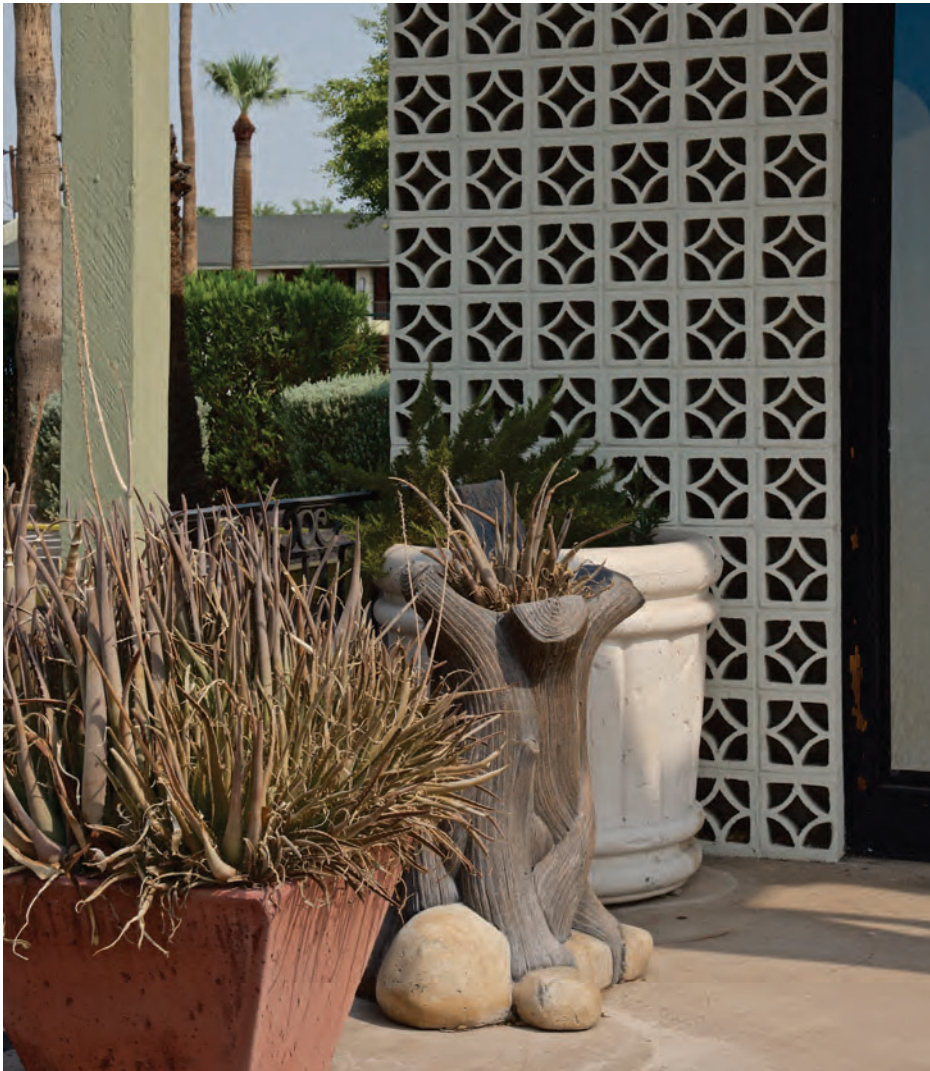
**MUST PRESERVE**

\*Asterisk indicates a highly significant historic Character-defining Element (CDE)

These Historic Preservation Priorities should help in evaluating appropriateness of proposed rehabilitation treatments in preserving the historic integrity of building and elements. The modal verbs “must, should, and may” respectively denote obligations, suggestions, and possibilities.

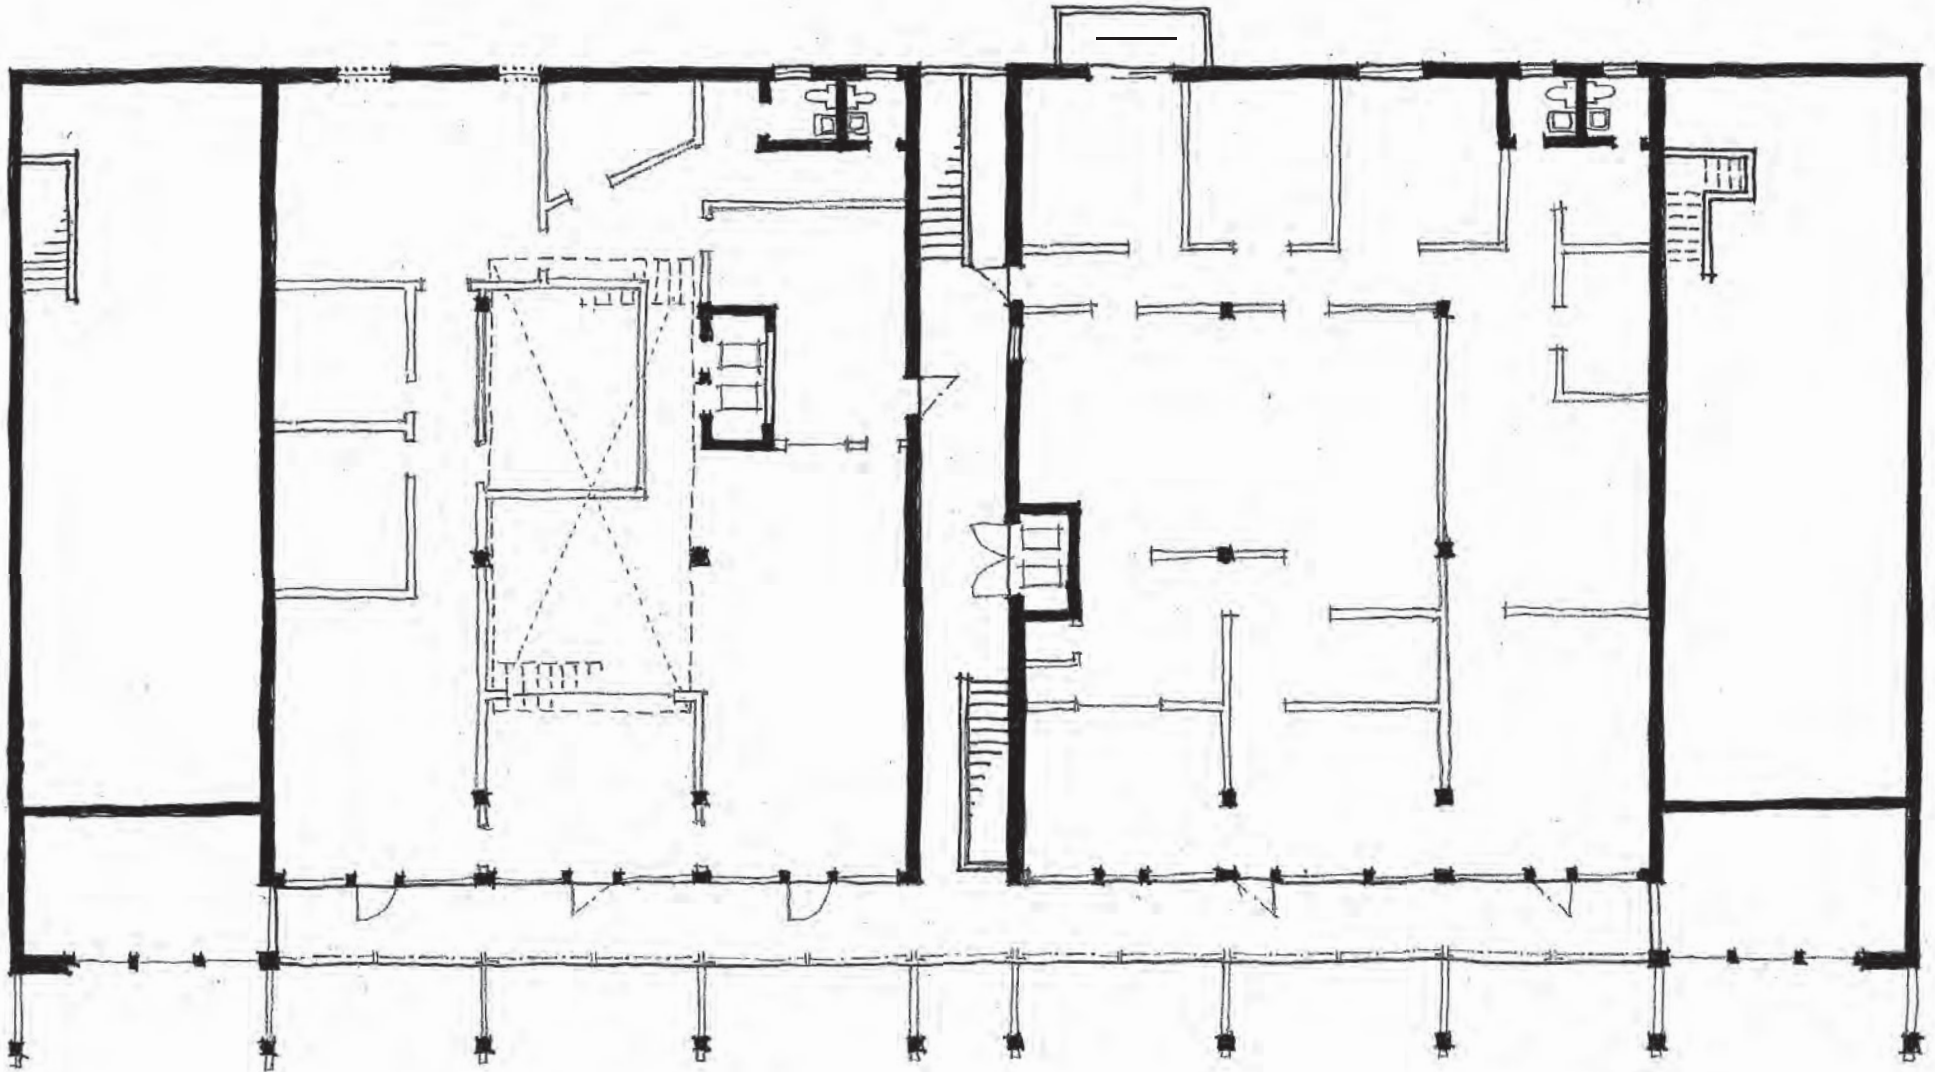
As-Found plan 2020

## SECOND FLOOR

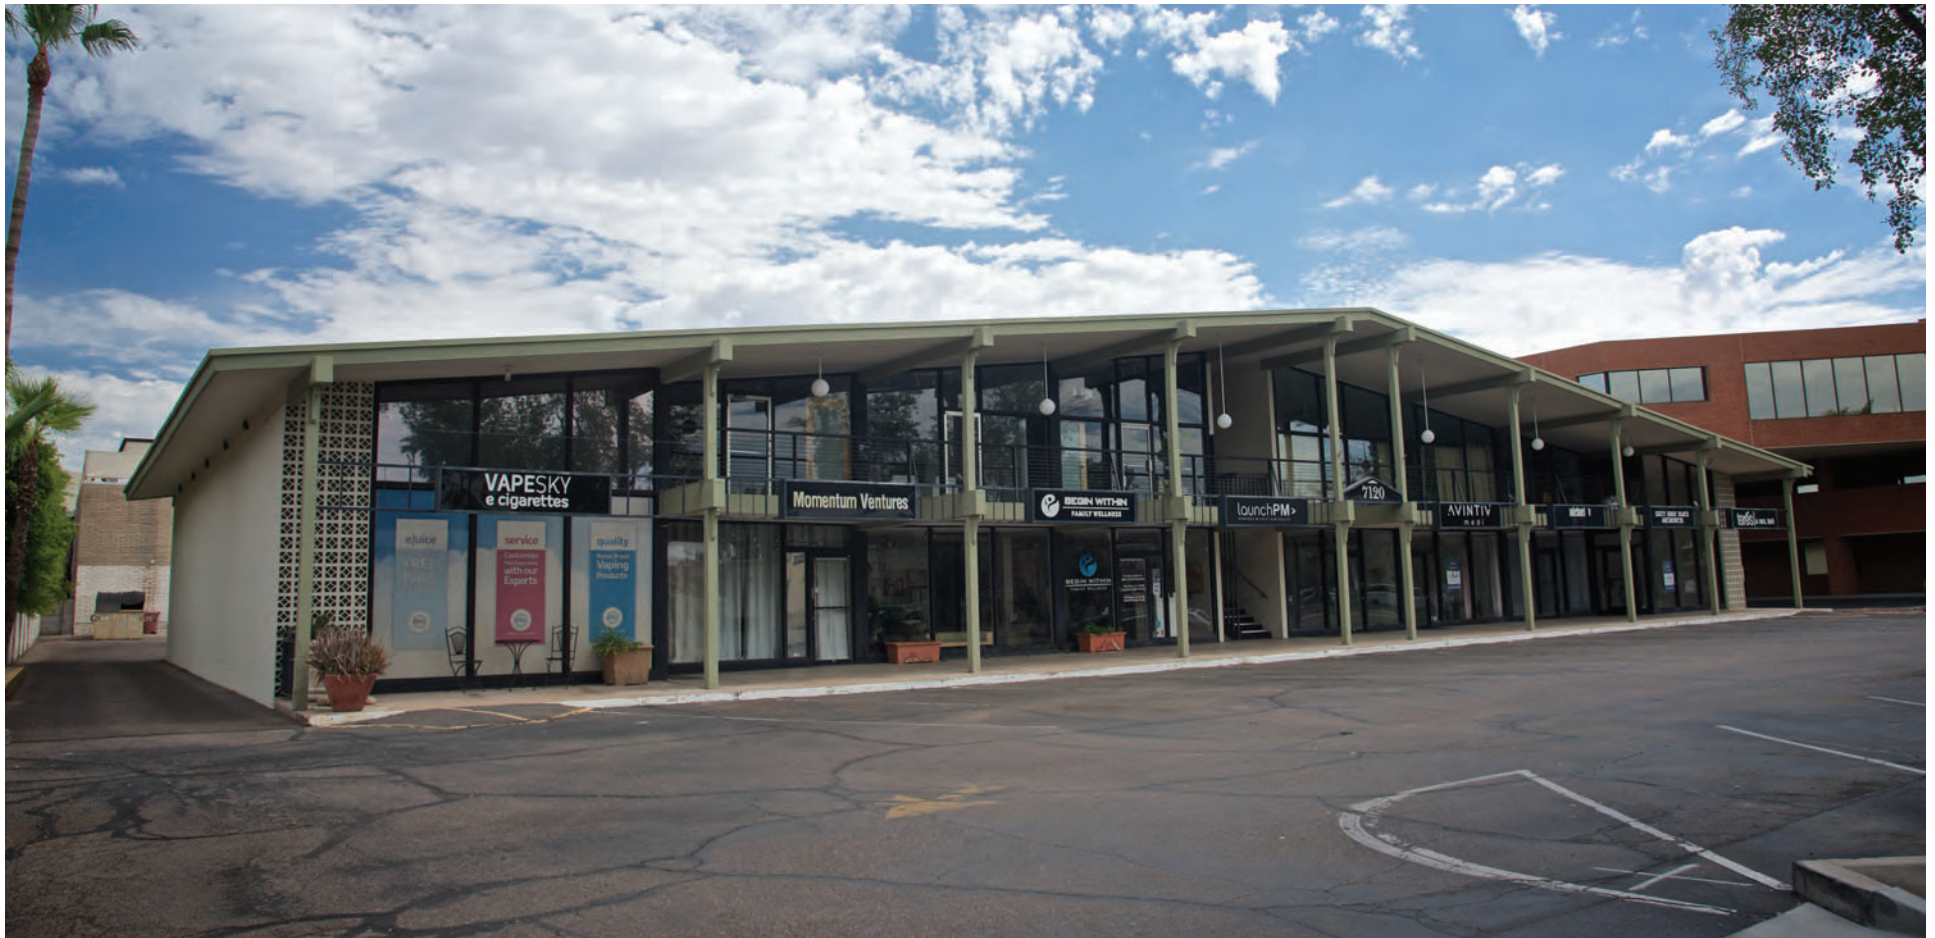
Kimsey Building front façade and parking. (August 2020)

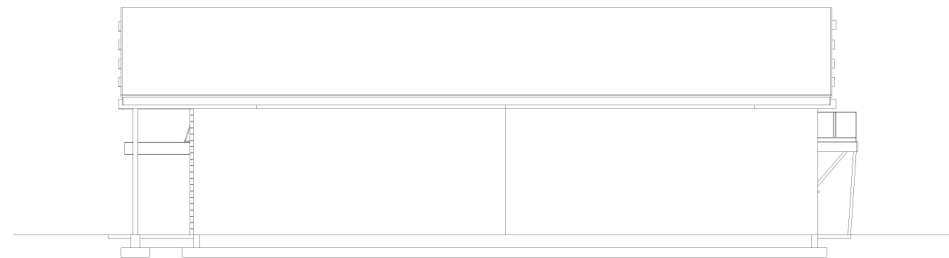
Side facade (east elevation)

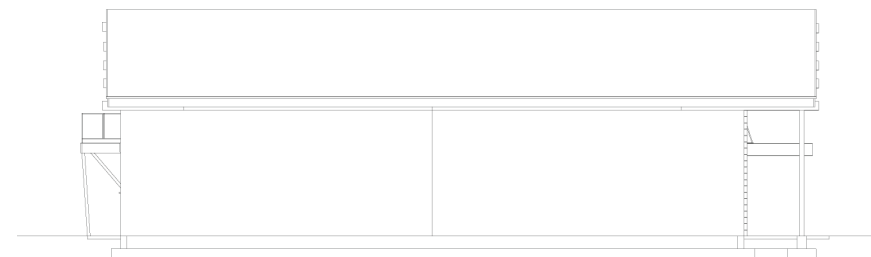
Side facade (west elevation)

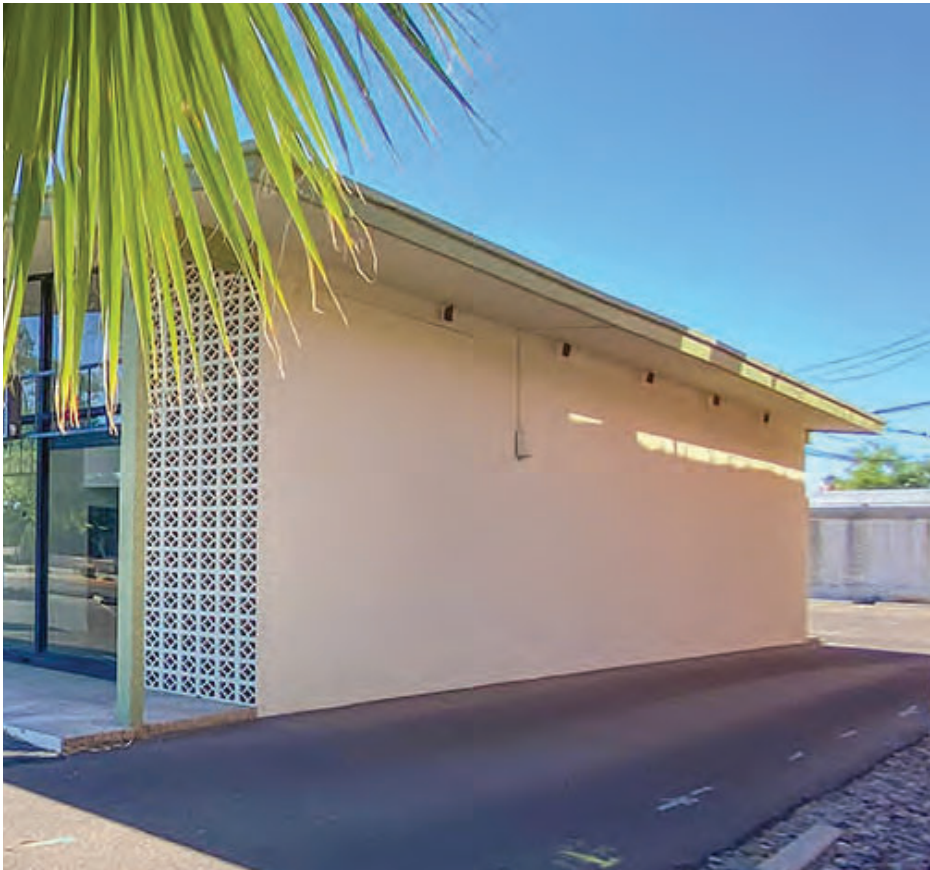
East facade  
having no openings  
or architectural  
features.

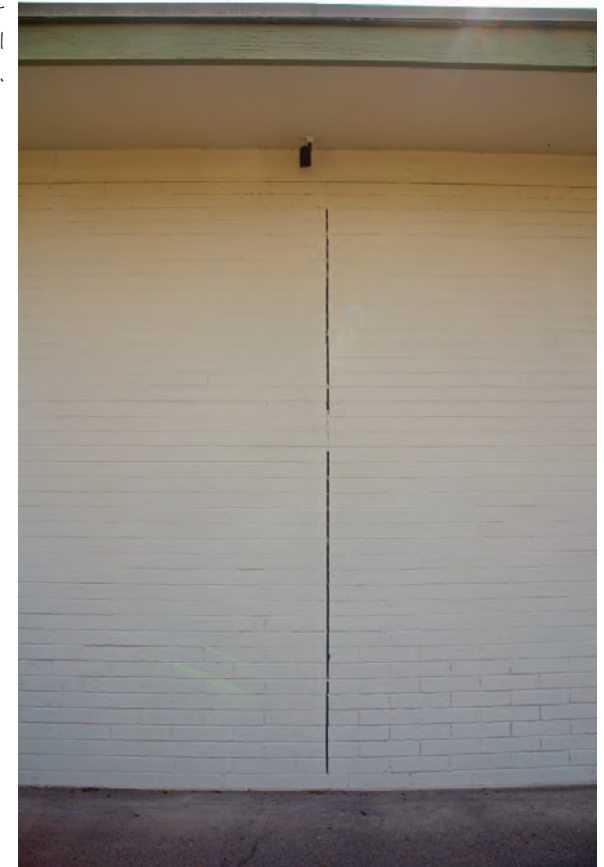
Structural masonry joint  
revealing horizontal steel  
reinforcing "ladders".

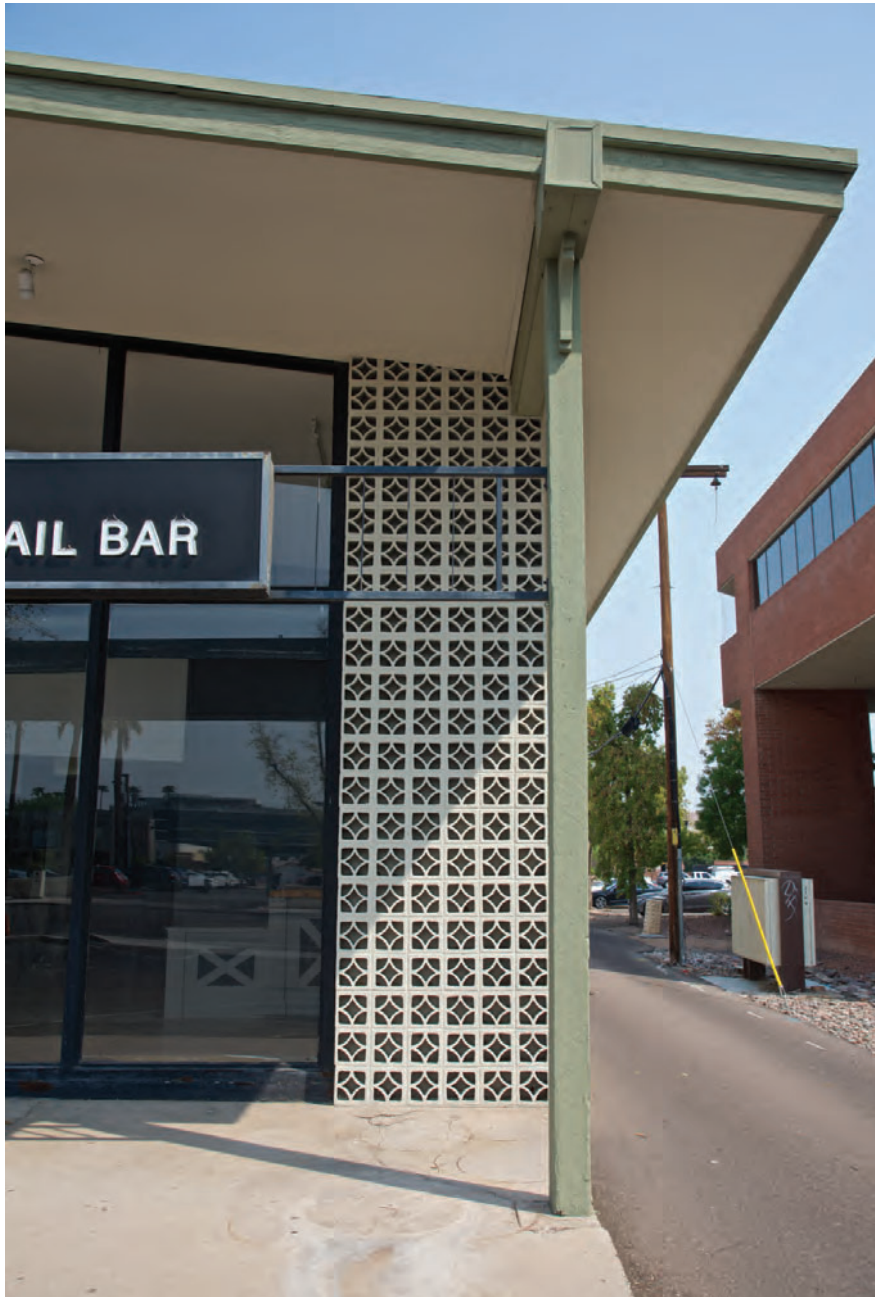
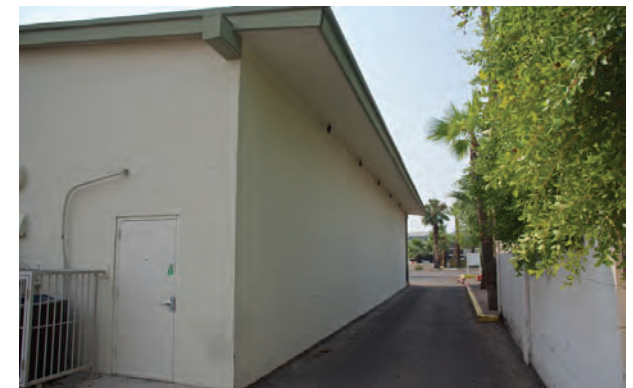
*Standard concrete block walls enclose the side and rear elevations.*

*Character-defining ornamental masonry panels flank the storefronts.*

Painted gypsum board ceilings, concrete block walls, and non-historic outdoor carpeting are finishes in the second-floor breezeway. Steel doors have been relocated and added in the breezeway.

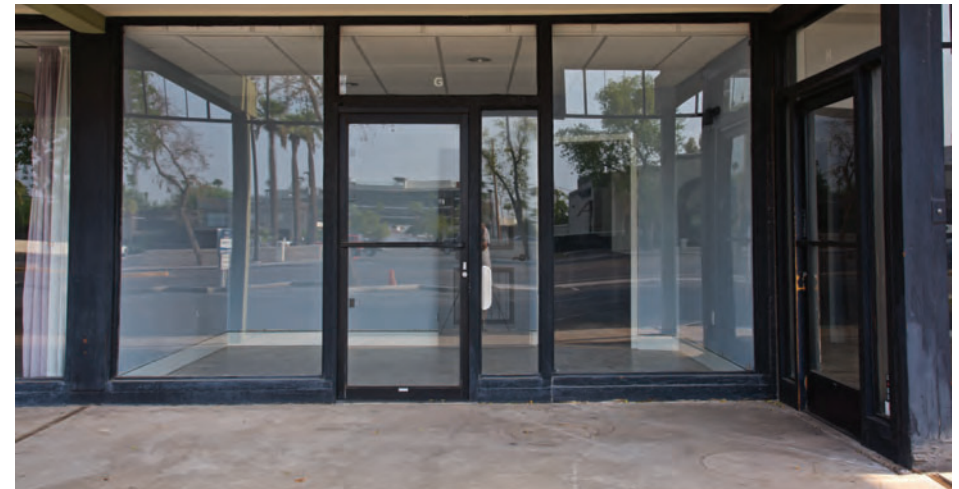
Bronze-anodized aluminum doors have replaced many of the original mill-finished aluminum doors in the wood storefronts.

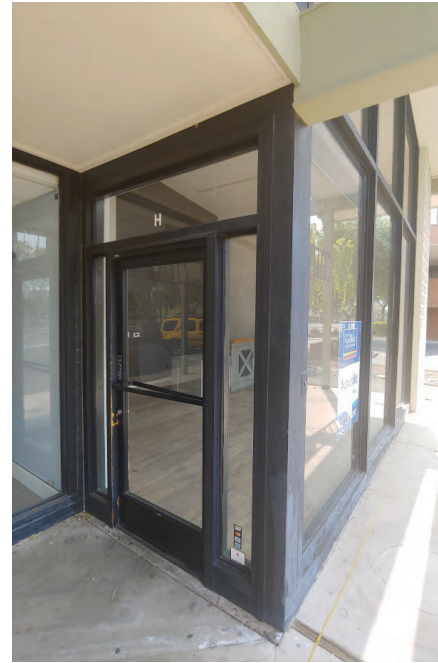
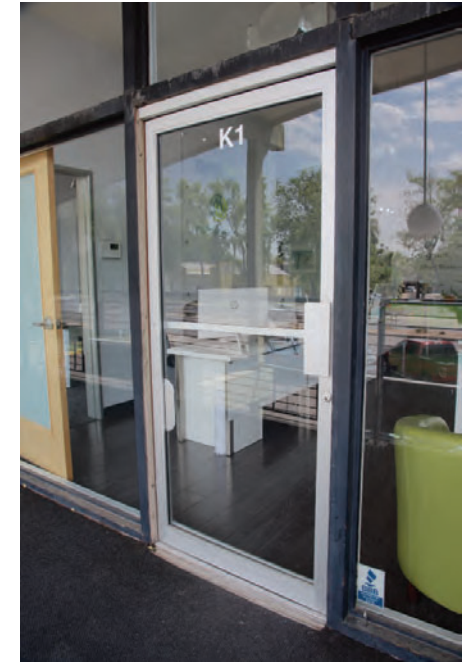
Compare loss of integrity where dark doors replace original mill-finished aluminum doors.

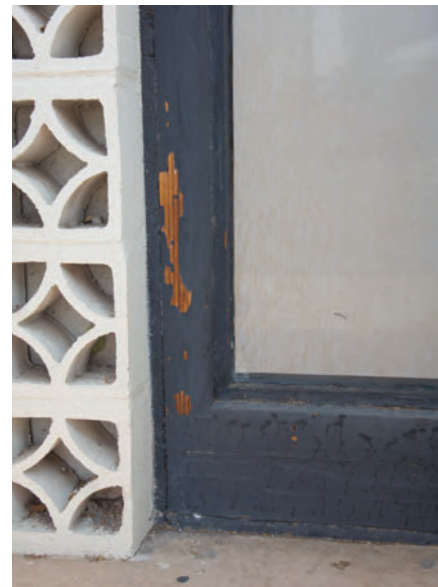
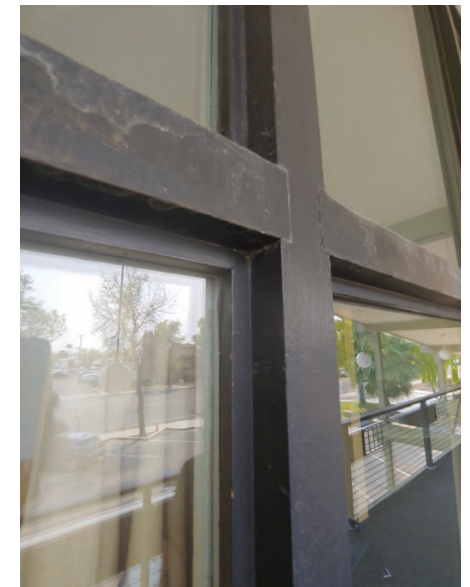
Expert workmanship survives in the joinery of the original wood storefronts.

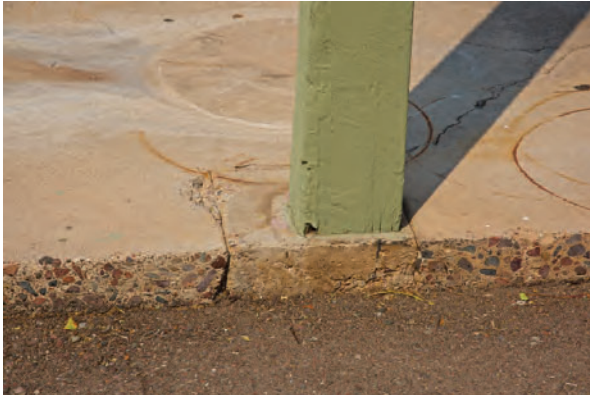
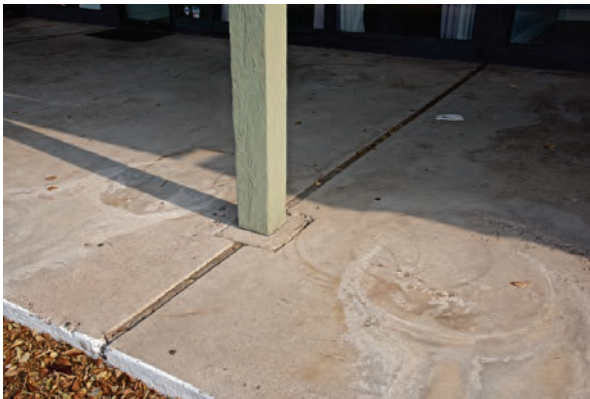
The character-defining concrete slab and redwood headers of the porch terrace have sustained staining, deterioration, and modification that affect their integrity of materials.

- Repair the wood porch structure by reinforcing the materials and by limited replacement in kind—or with compatible substitute material—of those extensively deteriorated or missing parts of repeated features where there are surviving prototypes such as railings, balustrades, and stairs.

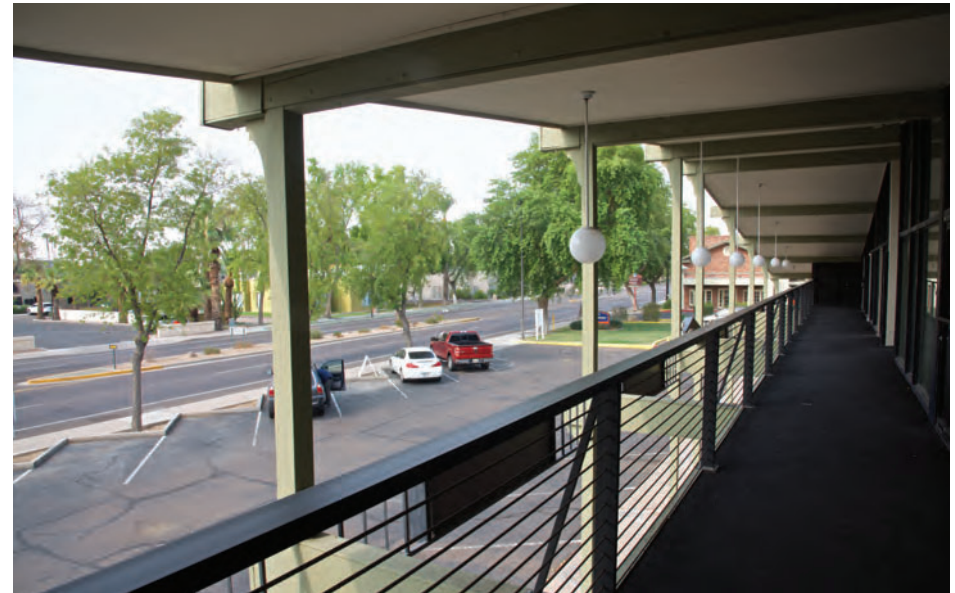
The storm damage of 2000 resulted in the replacement of the original cast iron balcony guardrails with a new aircraft cable system.

Note that the original balcony floor framing, decking, flooring, and ceilings, are in-kind replacements for those severely damaged in the microburst windstorm during the 2000 monsoon. The original cast iron decorative balustrade was replaced with a code-compliant guard system of aircraft tension cables and steel posts and railings compatible with the character of the building. A 16-foot-long remnant of the original cast iron railing survives at the small balcony on the rear façade.

- Repair the post-historic-period wood balcony decking and flooring by reinforcing the materials and by limited replacement in kind—or with compatible substitute material—of those extensively deteriorated parts.
- Consider replacing missing parts of repeated features where there are surviving prototypes such as railings and balustrades. Modify the replacement replicas to meet current building code requirements.

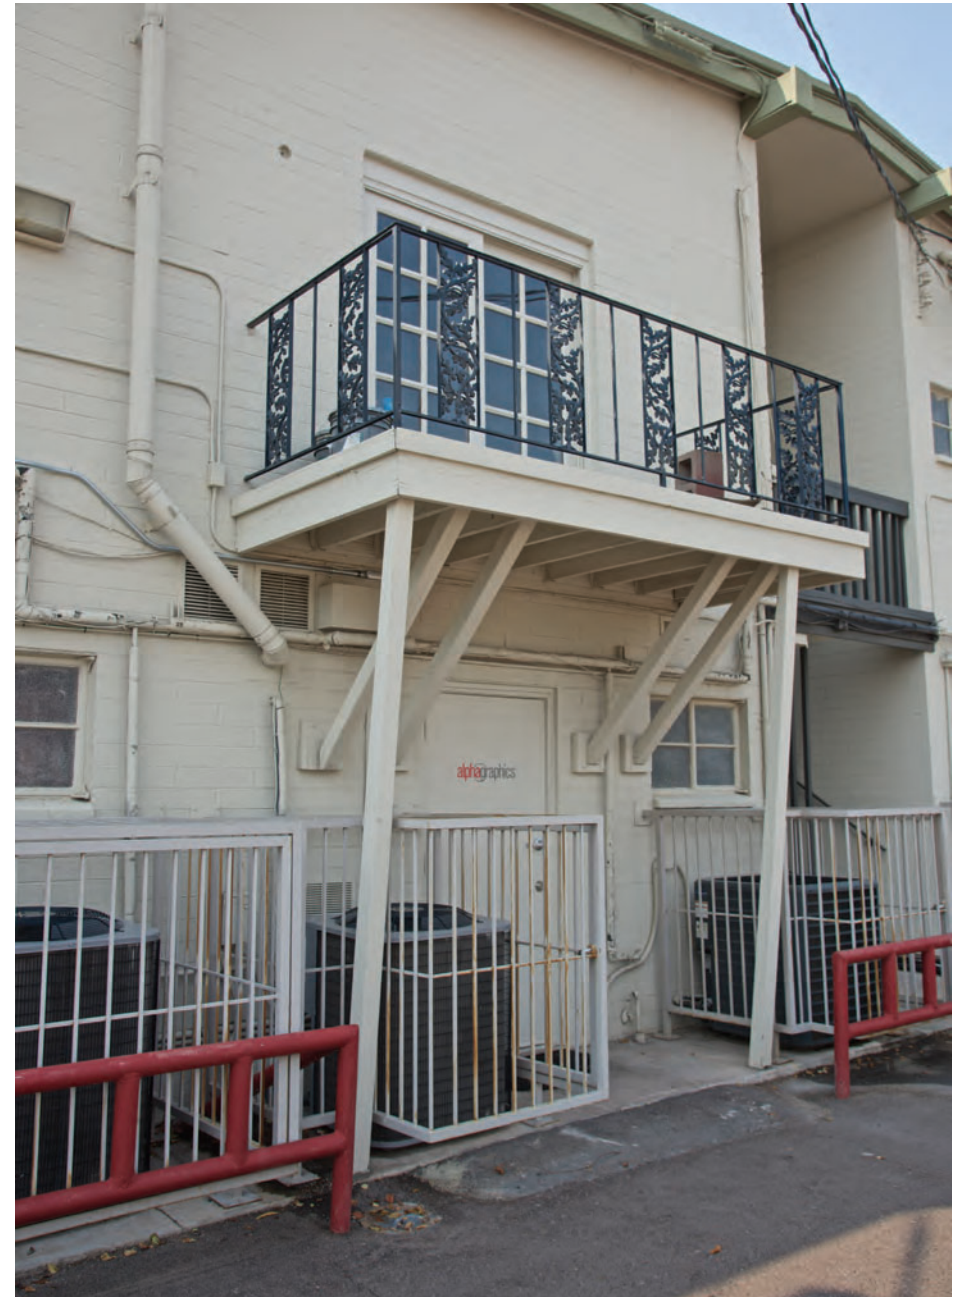
*A remnant of the original cast iron balcony guardrails survives at the rear balcony.*

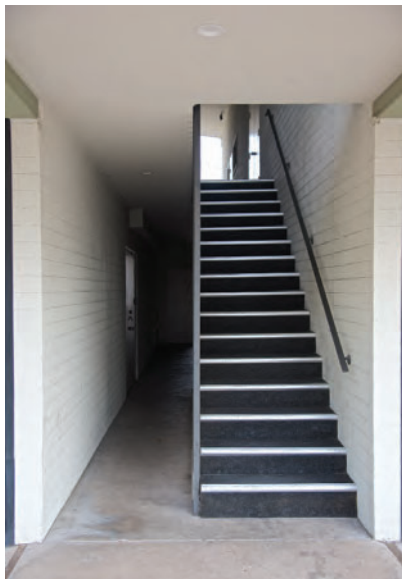
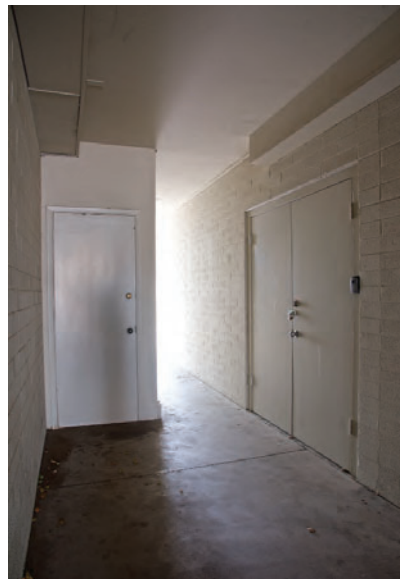
The original wood stairways in the breezeway have been unclosed for mechanical equipment leaving the wood spindles to convey the Modern character.

- Retain the two-story volume of the open breezeway and repair features and finishes by reinforcing the historic materials or by limited replacement of materials in kind. Consider using a compatible substitute material for extensively deteriorated or missing parts that convey the visual appearance of the surviving parts of the breezeway.
- At the breezeway, remove mechanical equipment beneath the two wood stairways. Replace deteriorated wood stair treads, risers, and stringers with new materials and proportions to meet building code compliance. Reuse the decorative wood balusters (square spindles) that appear to suspend the stringers or replicate them with compatible new materials for a new design compatible with the historic character of the building.

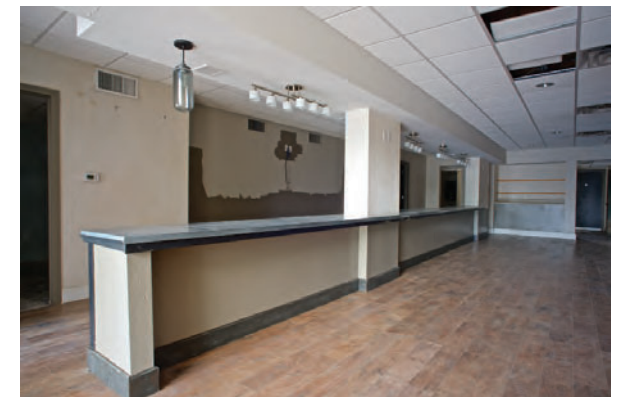
*An interior structural masonry wall has been partially removed from between the two easternmost bays to install base cabinets and countertops.*

*The end bays have a high ceiling at their entrances and a hidden loft above the original low ceiling.*

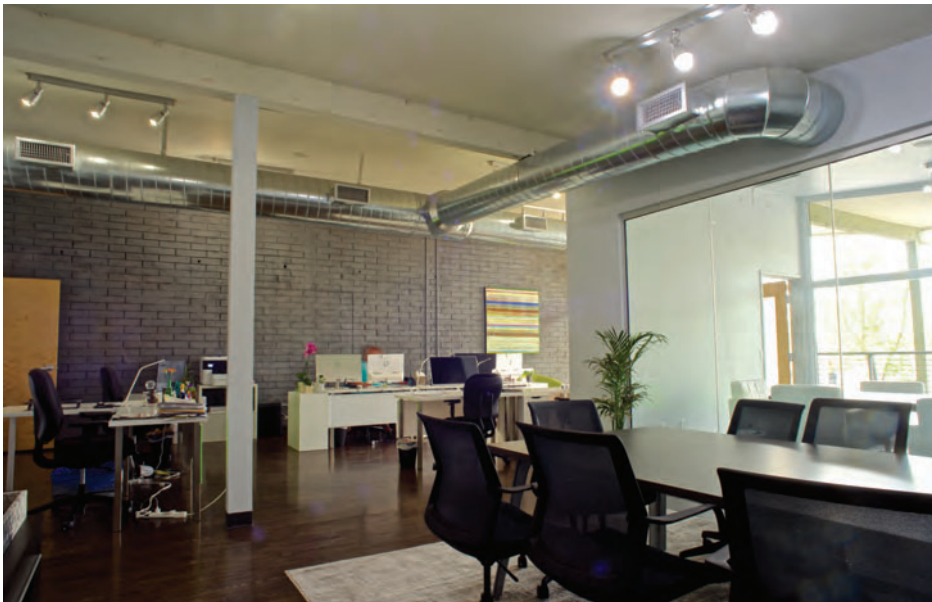
Tenant improvements in several leased spaces (2020) appropriately interpret the open plan and daylighting feeling characteristic of the Modern period.

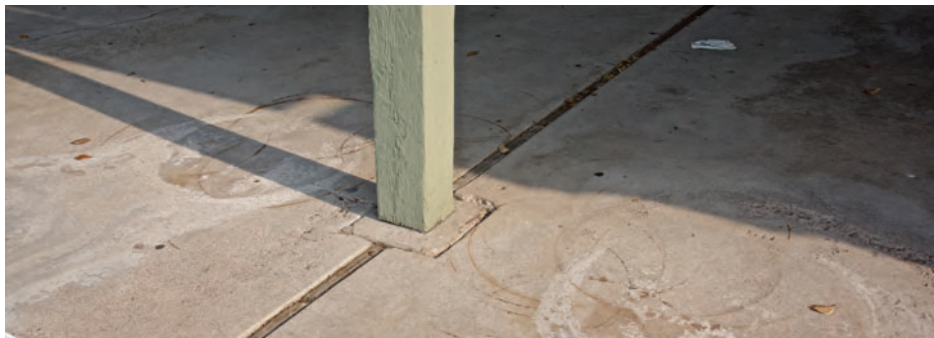
As an essential aspect of the building design for flexibility of tenant improvements, the structural system combining concrete block walls and post-and-beam framing is important in defining the building's overall historic character. The masonry and wood-framing components are significantly displayed on the front façade porch as an illustration of the structural concept within. It may be possible that the post-and-beam system here was either exposed or implied within the tenant improvement partitions and ceilings. The post-and-beam system is significant to the history of building technology for Contemporary-style architecture and as a signature element of design for architect Ralph Haver.

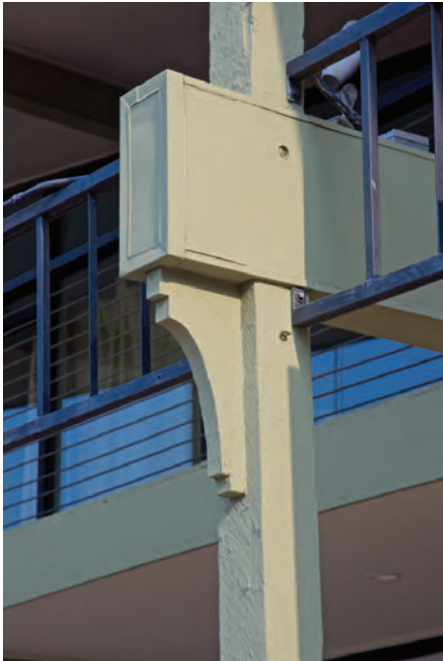
The simple post-and-beam structural system characteristic of Contemporary-style homes and commercial buildings by architect Ralph Haver allow flexibility for tenant improvements without affecting design integrity.

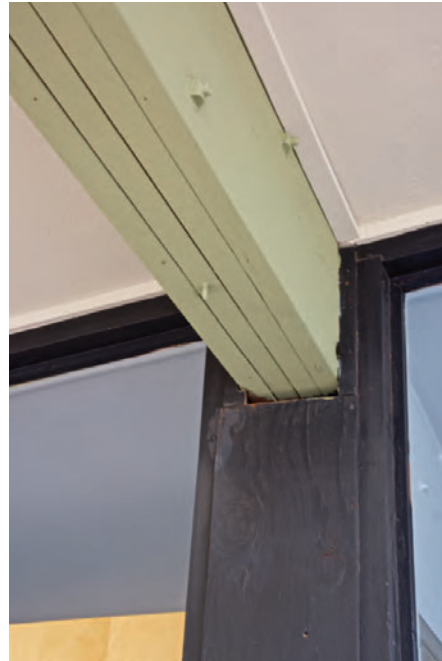
The original curved corbel design is an unusual detail for Contemporary-style beams that may be an architectural salute to the gable brackets of the earlier Kimsey farmhouse.

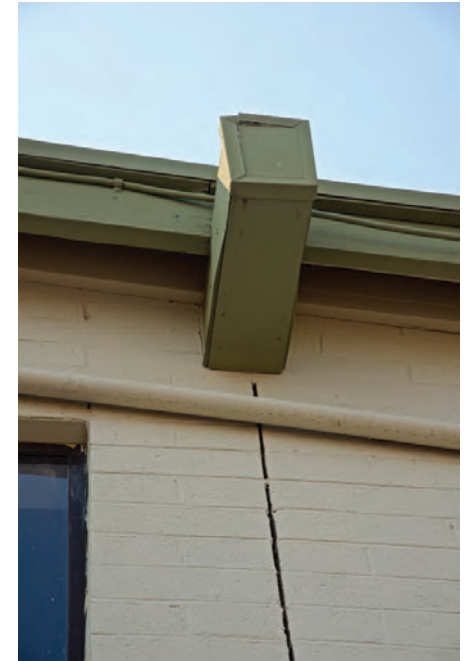
The economical laminated beams supporting the roof and second floor have been sheathed to protect from weather and to enhance their appearance.

Surprisingly, the beam connections at posts and walls have no visible metal connectors.

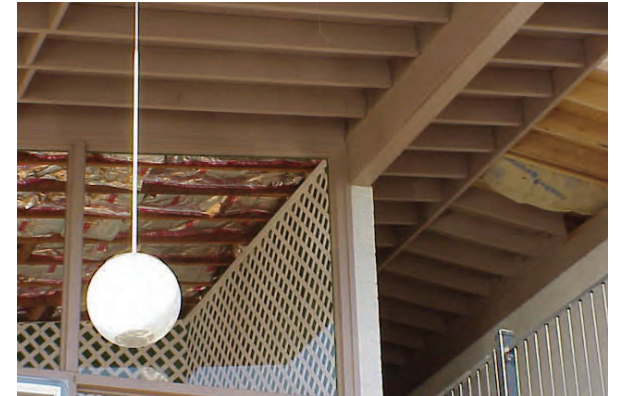
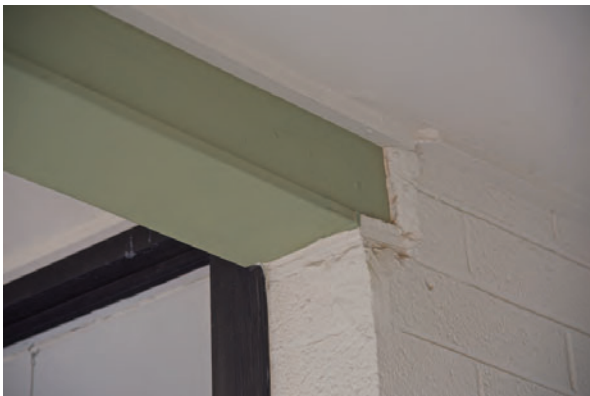
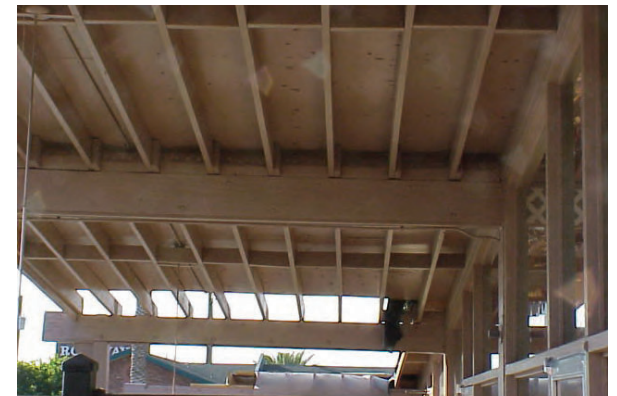
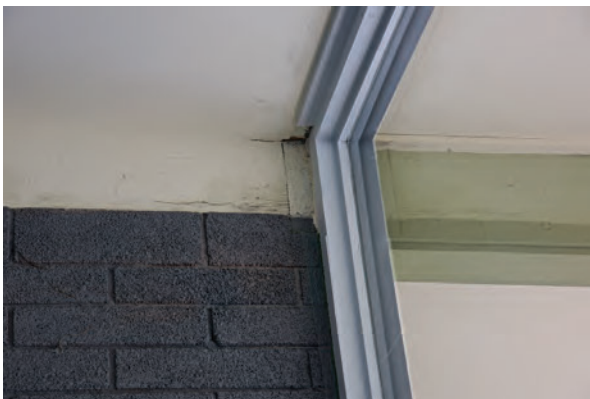
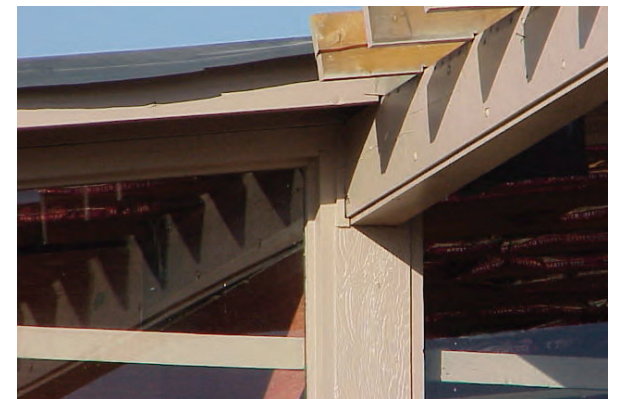
Construction photos from the roof and balcony repairs of 2000 disclose no clues of connectors.

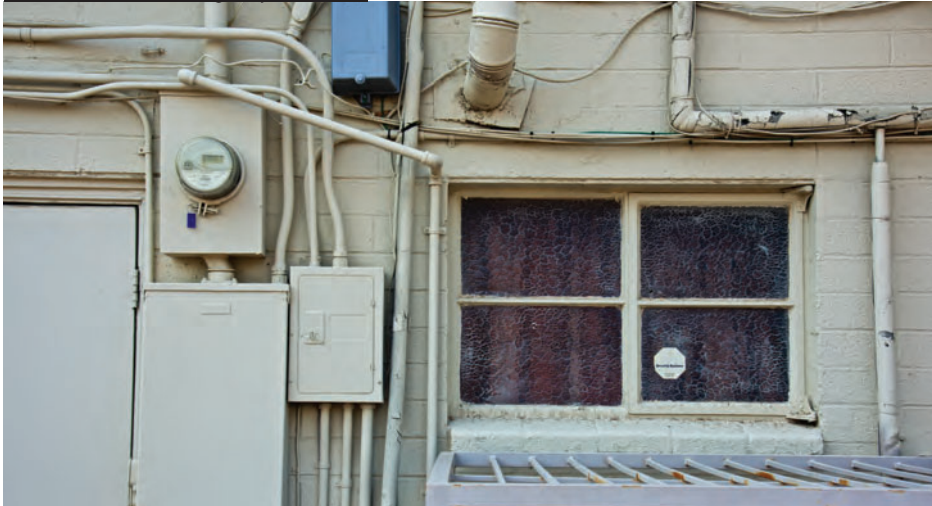
many generations of electrical system modifications are evident on the rear elevation

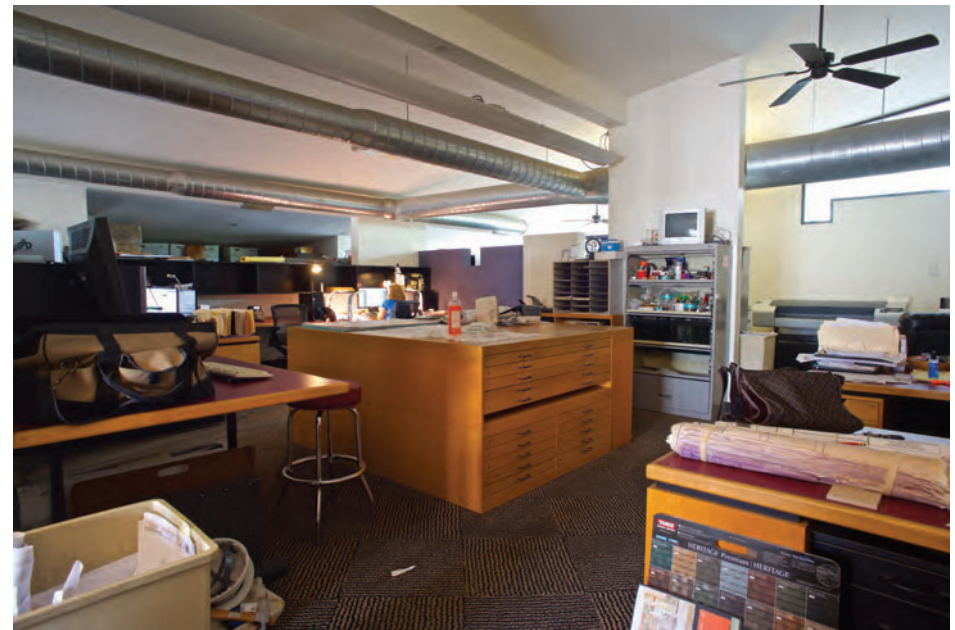
Round air ducts suspended in plain sight within the vaulted ceilings retain the Modern spatial characteristics and systems honesty of Contemporary-style interiors.
